# Appendix G

## Roof Assessment

October 16, 2018

Re: UW-Madison Camp Randall Fieldhouse Roofing Assessment

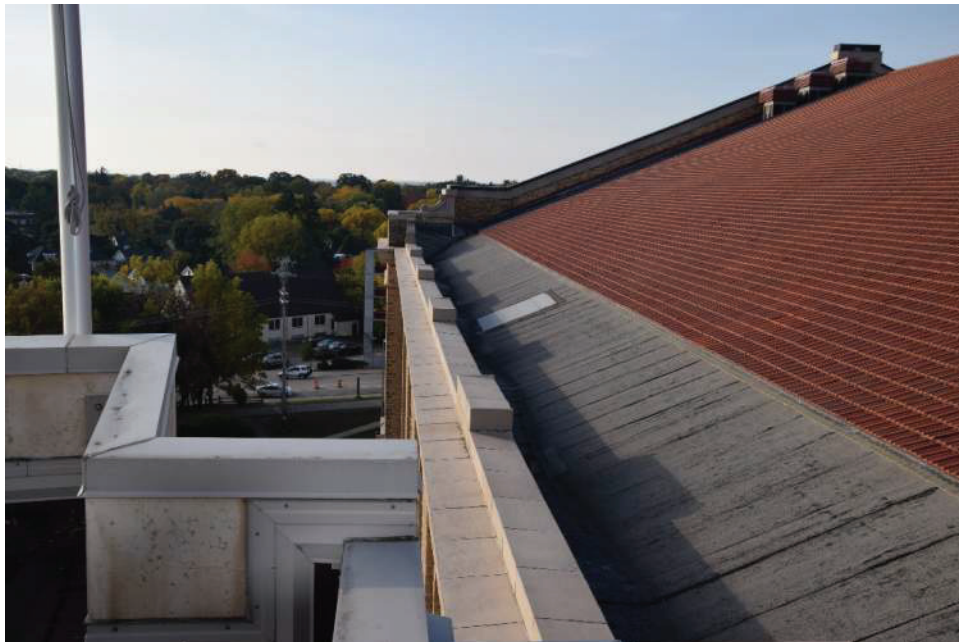
East roof slope, east parapet. Large patch was reportedly installed during the scoreboard replacement which required cutting a large access hole through the roof.

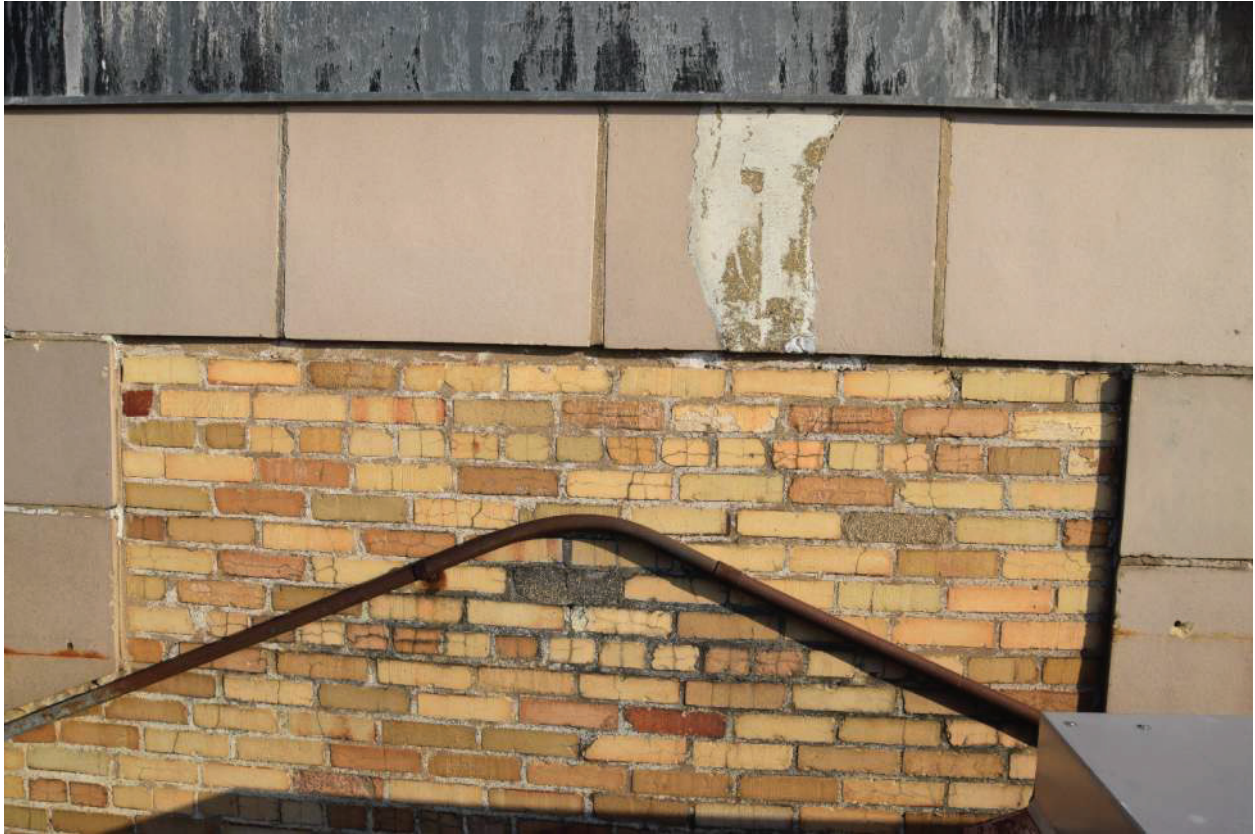
- a. Terra cotta elements are largely in good condition with some finish deterioration observed. However, all terra cotta mortar joints were observed to be failed or in some mode of failure.

- b. Brick masonry is generally in fair to poor condition and requires significant repair and restoration.
5. The sheet metal coping at the top of the parapets does not turn-down onto the terra cotta and could potentially allow moisture under the sheet metal.

Masonry at peak of roof at north parapet. Brick masonry is in fair-to-poor condition; terra cotta mortar joints are in poor condition.

1. The masonry parapet should be repaired / restored prior to or in conjunction with any roofing system replacement. New roof-to-wall reglet flashings should be supplied by the roofing / sheet metal contractor and installed by the masonry restoration contractor.

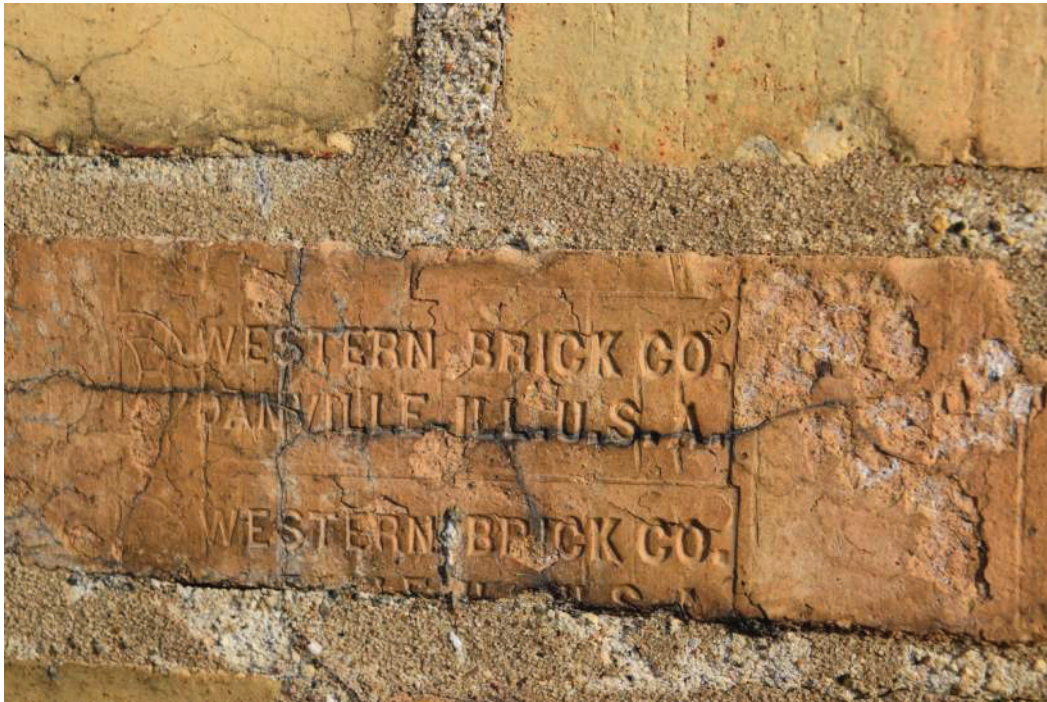
Photo of brick from "Western Brick Co, Danville ILL U.S.A.", typical

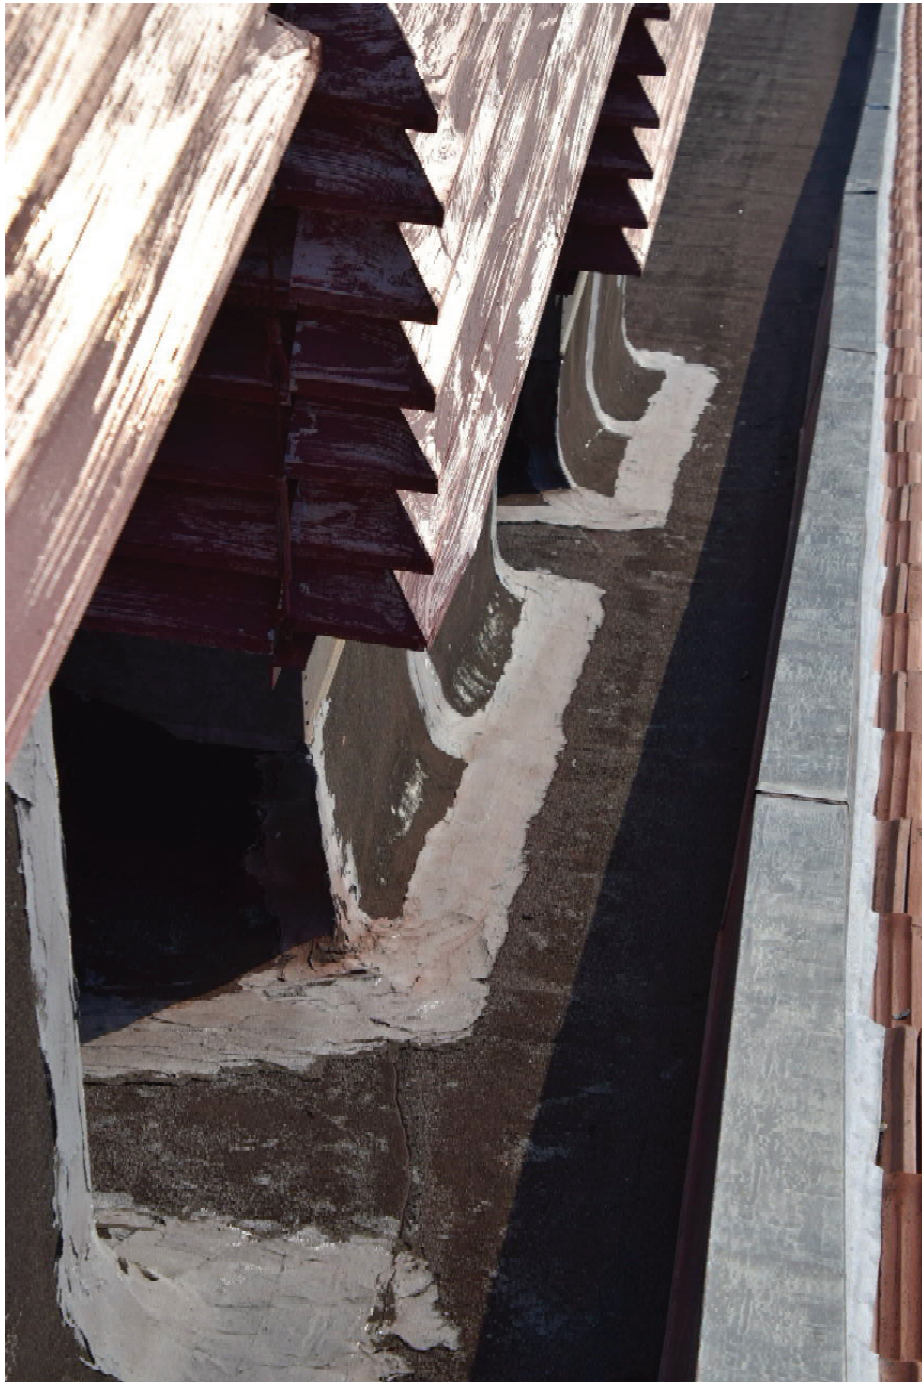
Multiple reinforced mastic "dope and rag" repairs at ventilator curb flashings, north parapet

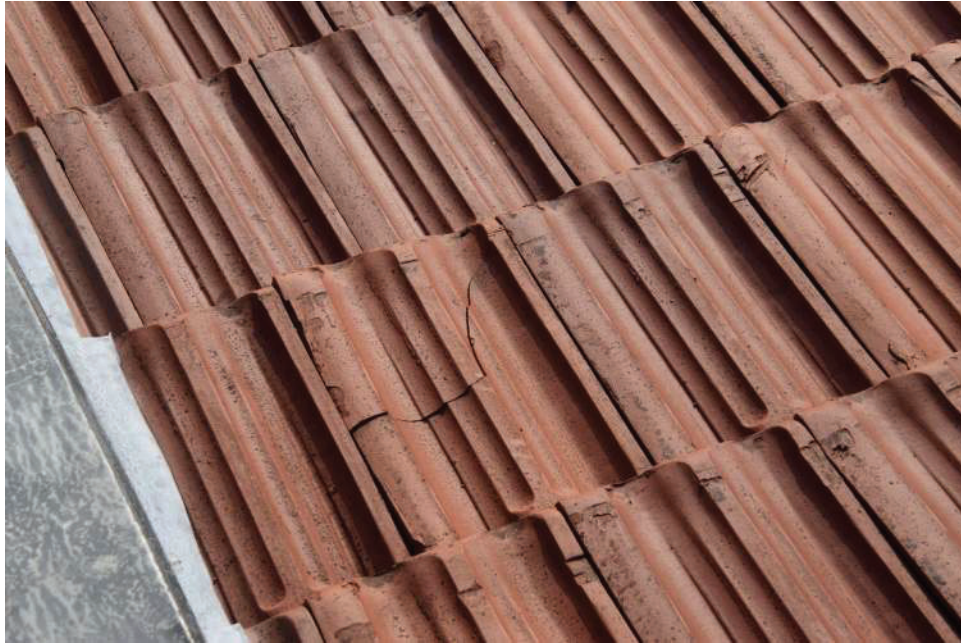
- b. Where observed, wood battens appear to be in good condition.
  - c. A few broken clay tiles were observed throughout the field of the roof. However, the clay tile appears to be in good to excellent condition based on visual assessment.

Cracked roof tile observed at north parapet area.

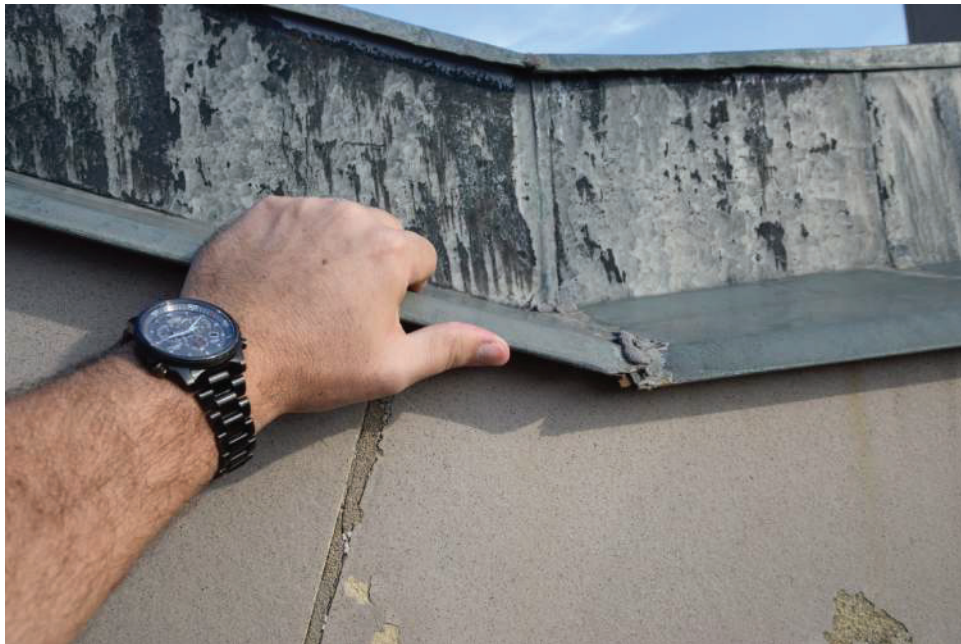
Sheet metal coping and flashing joint in questionable condition.

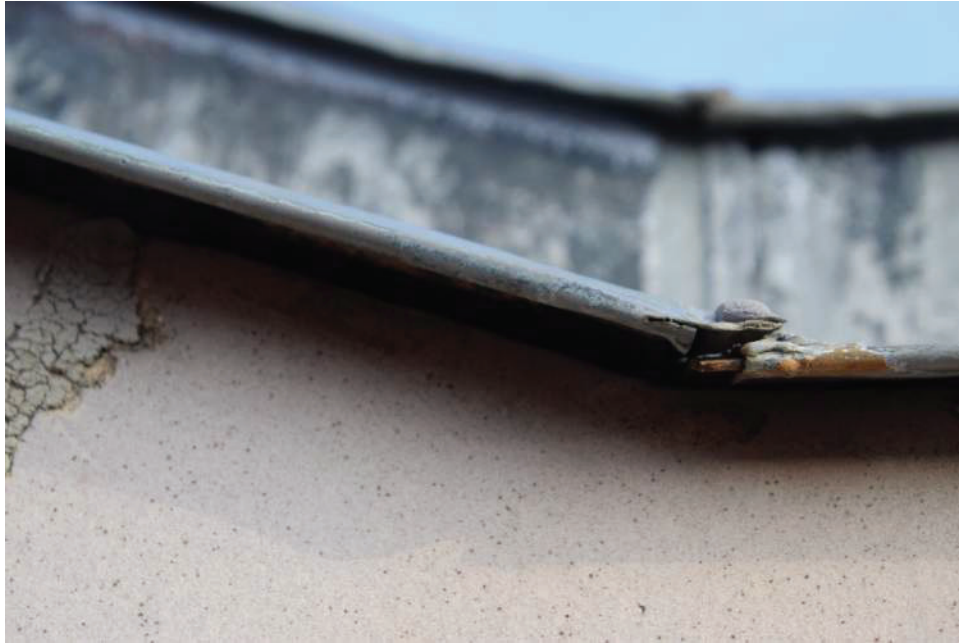
Close-up of photo, above. Sheet metal flashing does not appear to sufficiently overhang terra cotta elements.

5. New sheet metal flashing should be installed at the top of the parapet walls at the terra cotta to improve weather resistance.

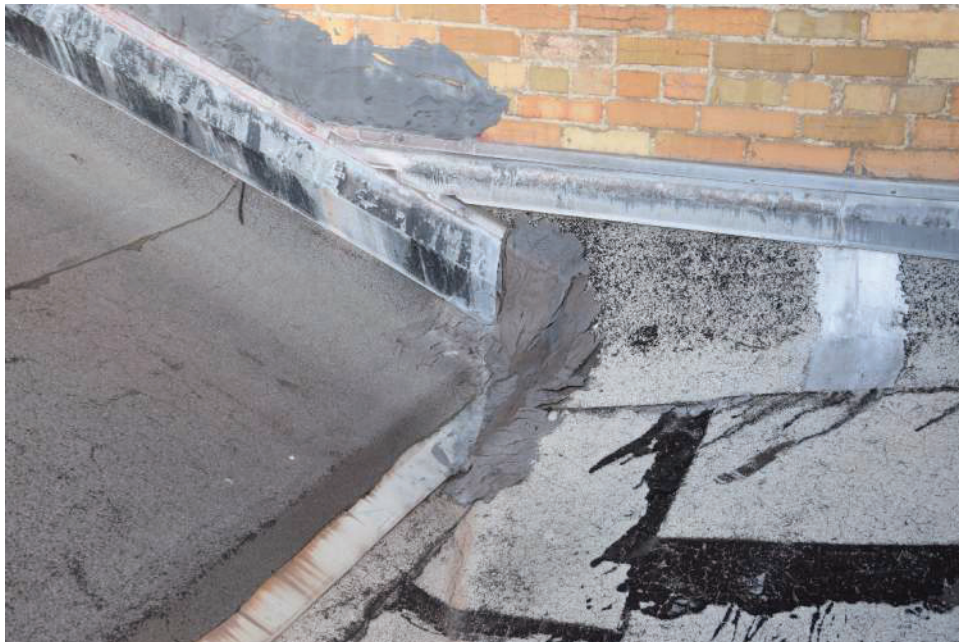
- a. Multiple repairs are evident though out the low-slope roofing system.
  - b. The granulated cap sheet has experienced significant granule loss.
  - c. Multiple roof drain repair attempts are evident. Roof drains on the west slope reportedly leak frequently.

Multiple BUR roofing repairs at north parapet wall.

2. Low-slope roofing systems should be replaced with a robust, redundant, multi-ply roofing system. Recommended systems include a two-ply modified bitumen roofing system with a reinforced, fluid-applied poly-methyl-methacrylate (PMMA) finish with embedded granule surfacing. This system will provide required properties to resist low-term snow / ice / water flows and puncture resistance, resistance to foot-traffic, slip resistance, and superior flashing ability.

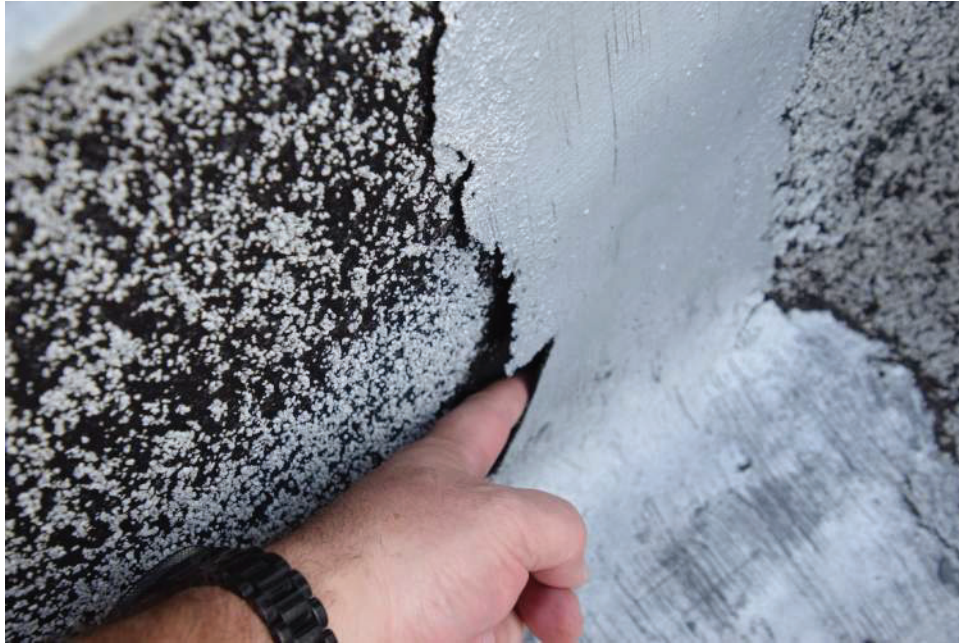
BUR mastic repairs beginning to fail, north parapet wall.

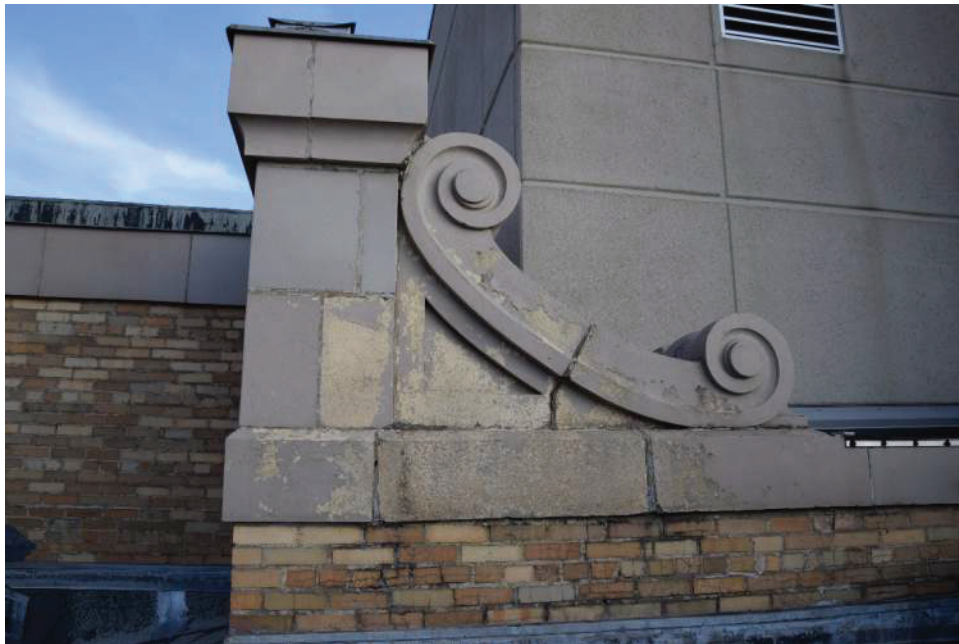
Terra cotta ornamentation, brick masonry in poor condition.

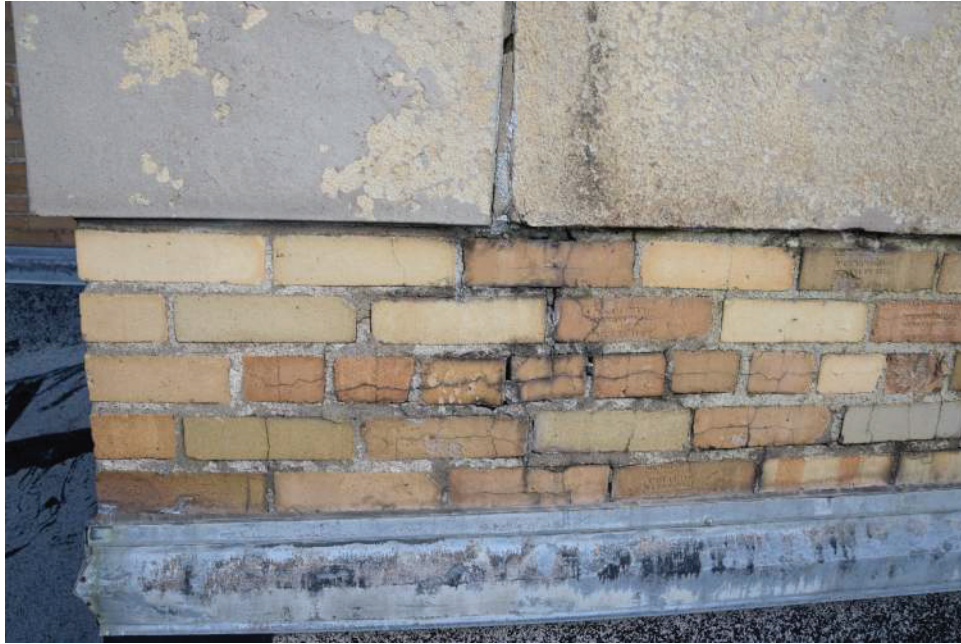
Close-up of photo above.

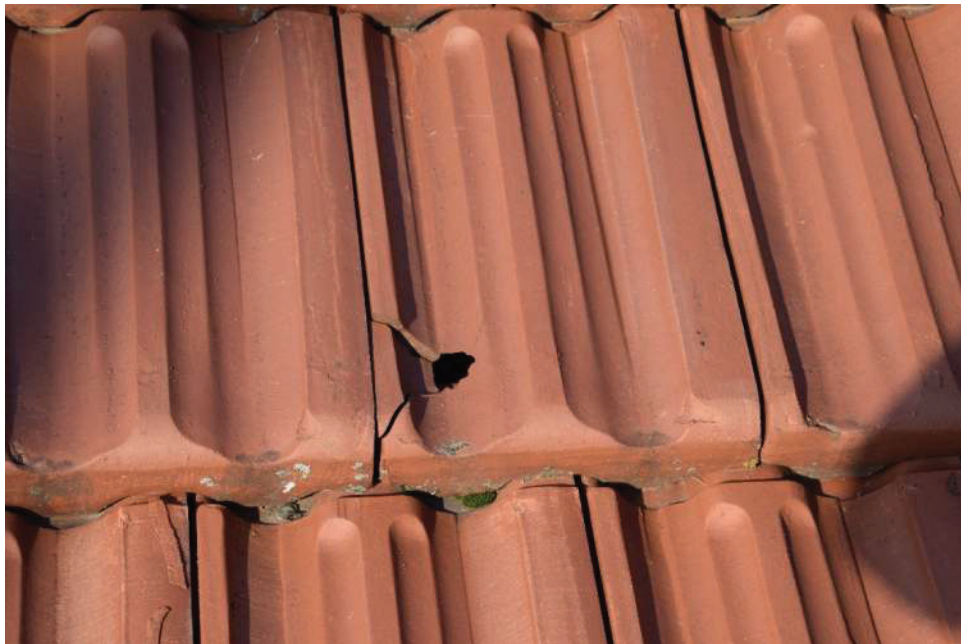
Broken / penetrated tile observed at lower roof / east parapet area.

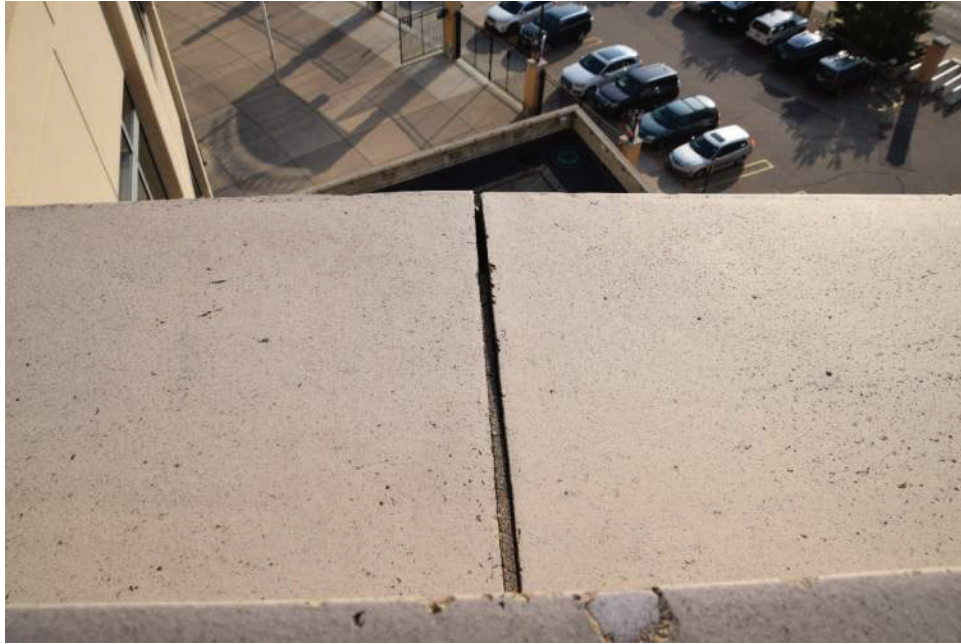
Open joint at terra cotta coping, typical.

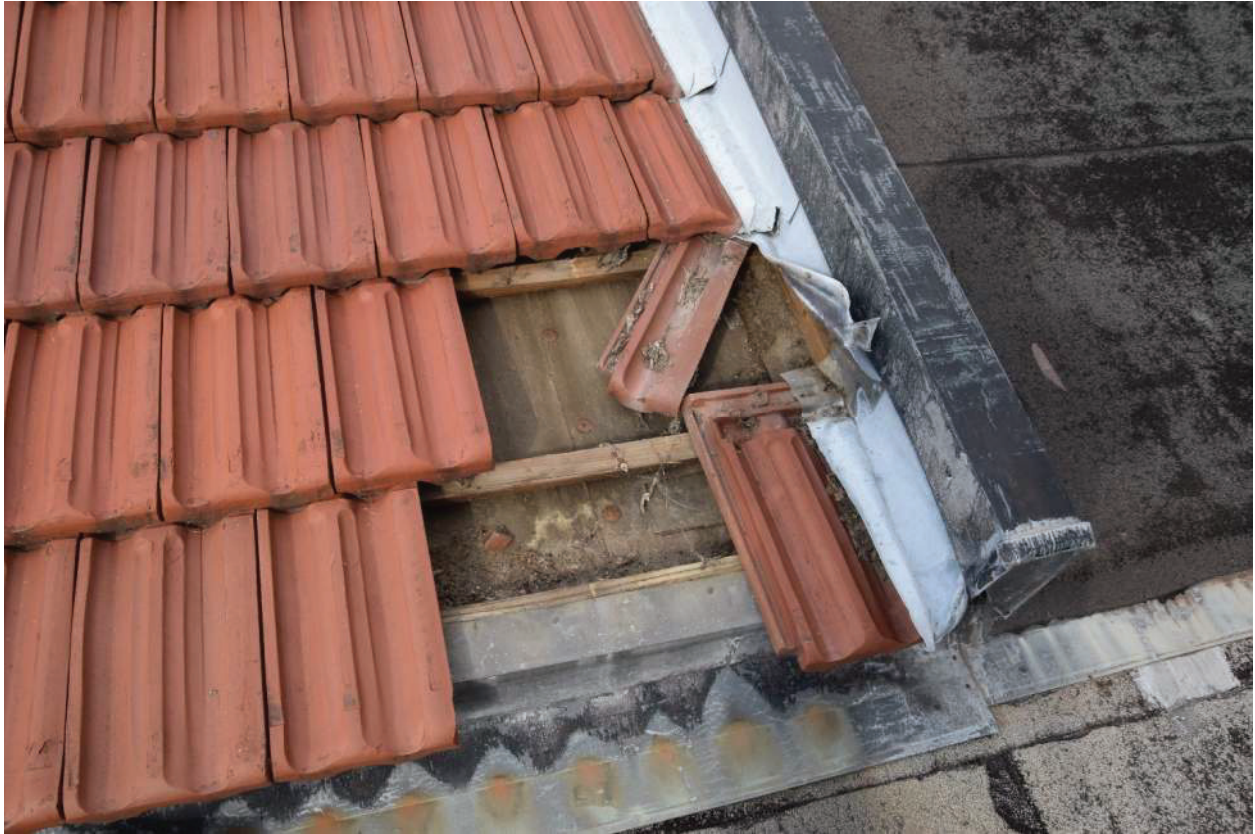
- a. The clay tile is laid on a vertical and horizontal batten system. The battens are secured to the roof deck; the clay tile is laid onto the battens. Where observed, no fasteners were used to secure the tile to the battens. This system allows for water to drain out of the system and promotes ventilation to dry the system between weather events.

Selective tile removal at lower edge, east slope, north parapet. Tile is laid (not nailed) on battens on (likely) multiple layers of roofing felt. Battens run horizontally and vertically (not in photo) across roof to allow maximum drainage and ventilation under tile.

4. The existing clay tile roofing will need to be disturbed at its perimeters to properly integrate the new low-slope roofing systems. New edge details should be designed and implemented to allow for future roofing system repair and replacement without requiring the clay tile roofing to be disturbed. Given the clay tile is not nailed to the existing battens, minimal damage or clay tile breakage should occur.

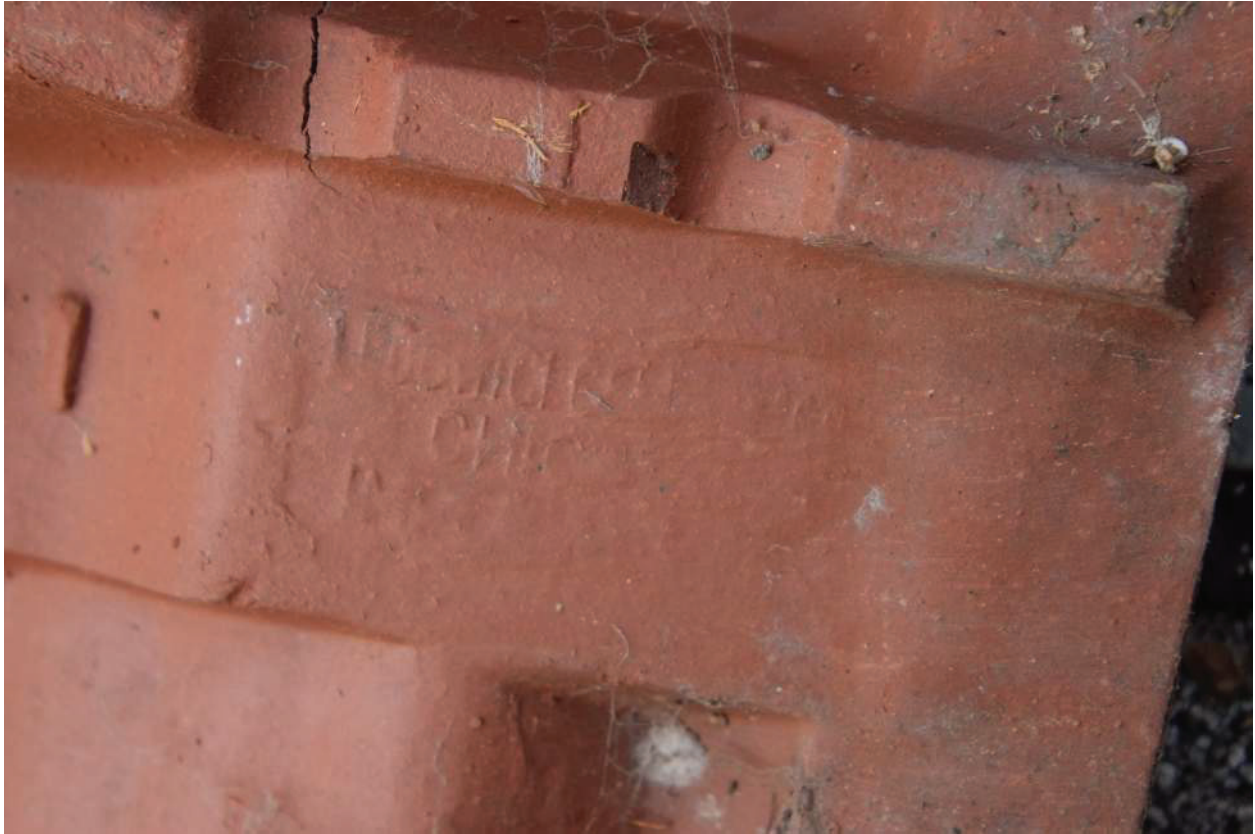
Tile is Interlocking French tile by Ludowici Tile.

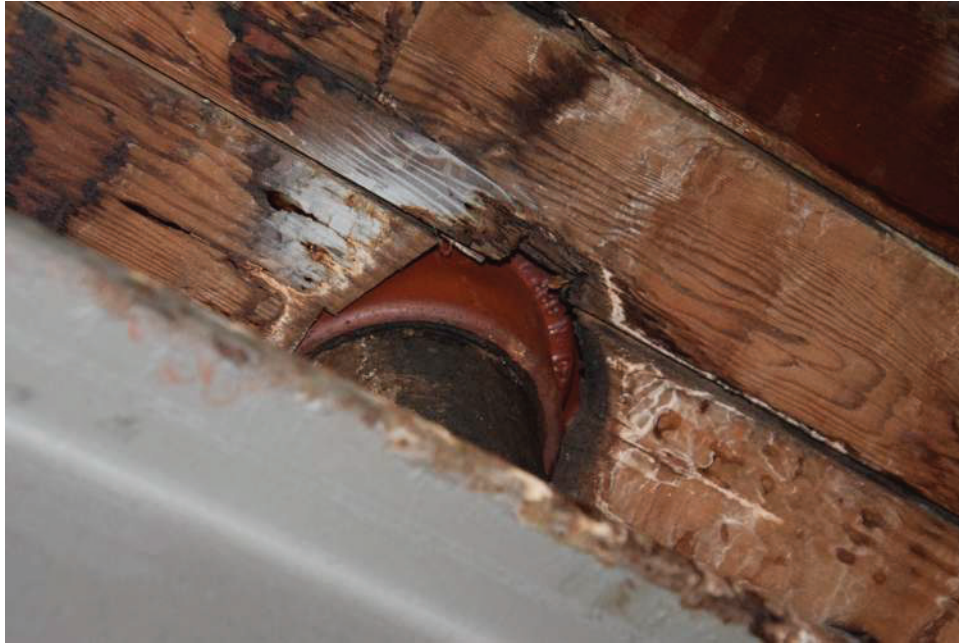
Interior photo of problematic roof drain, west slope.

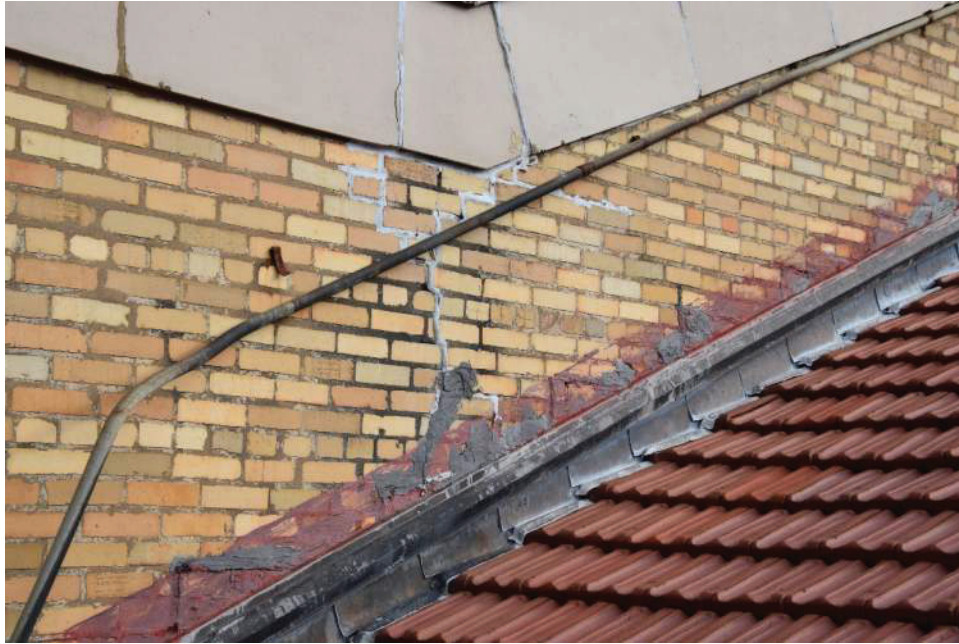
West slope, north parapet. Masonry in poor condition; multiple repair attempts evident.

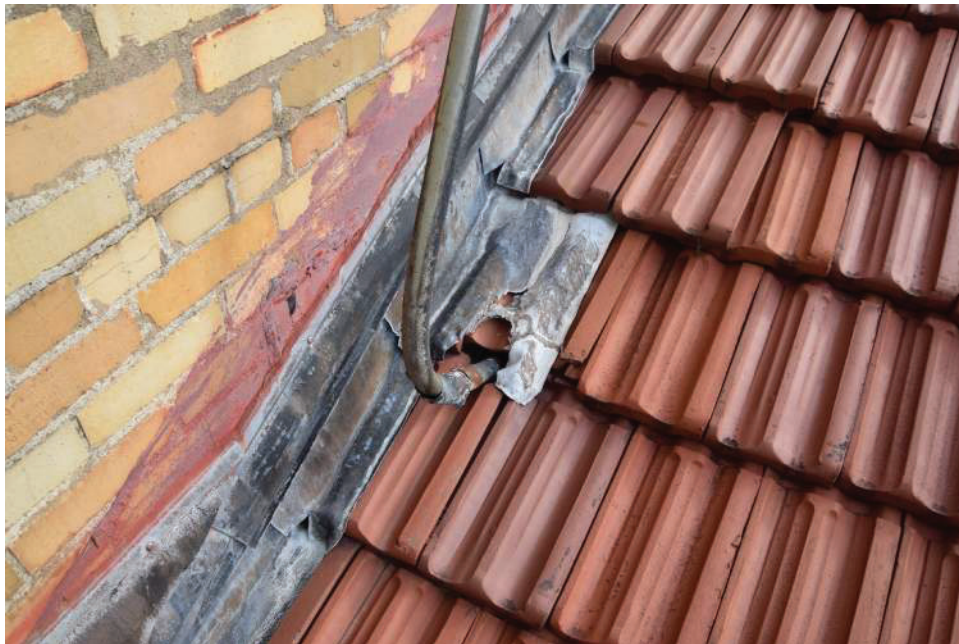
Conduit penetration through tile roofing, north parapet. Penetration flashing in questionable condition.

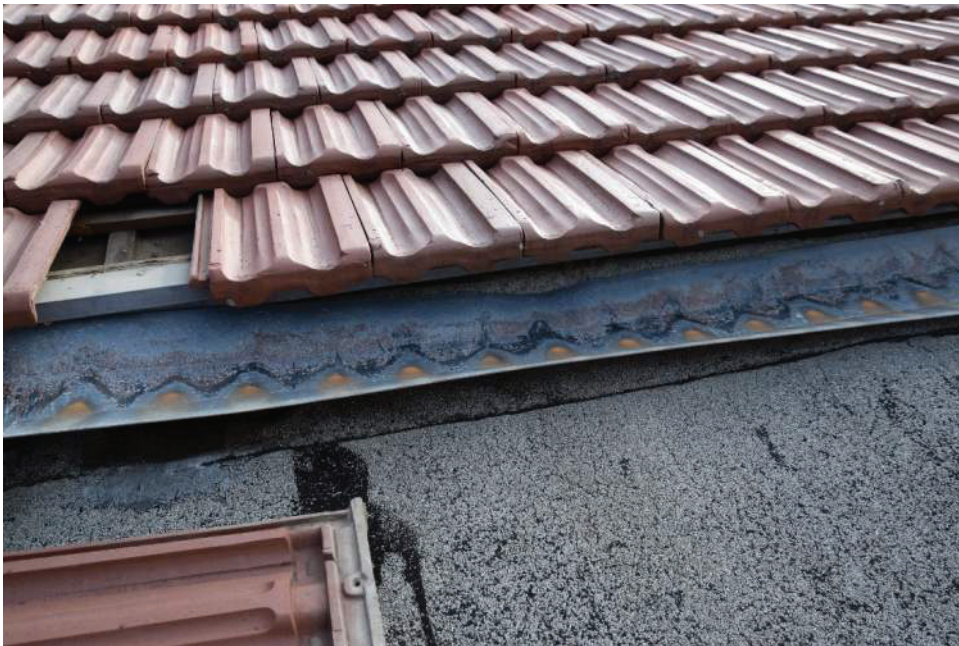
Sheet metal counter-flashing detached from receiver / drip flashing. Tile removed to expose flashing condition. Tile roofing assembly appears consistent with east slope assembly.

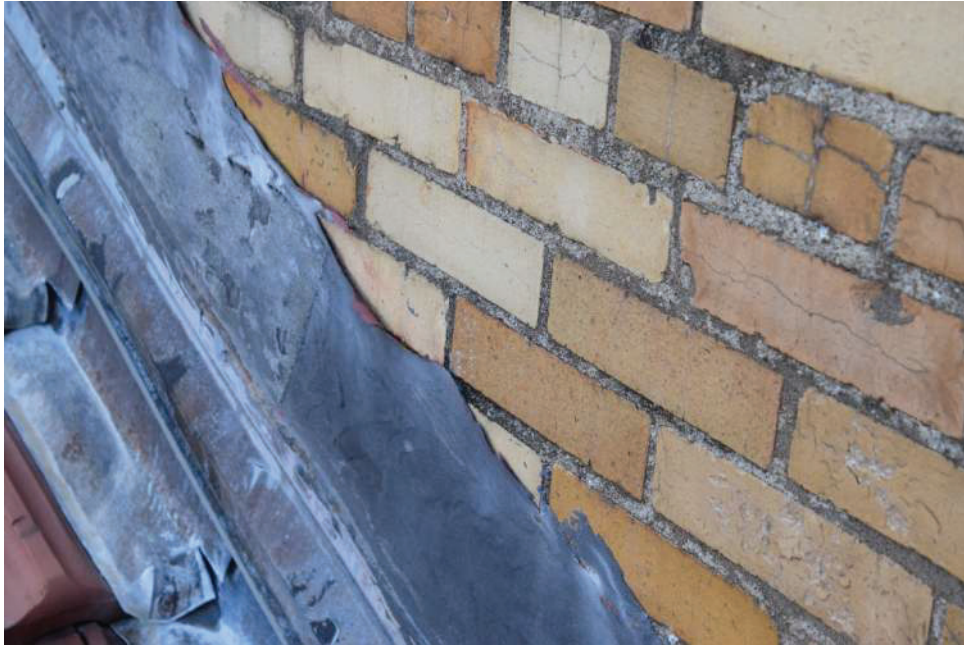
West slope, south parapet wall. Mastic repair above sheet metal reglet is failing. Mastic will begin to collect water and direct it into the masonry and flashing as the mastic peels off the wall.

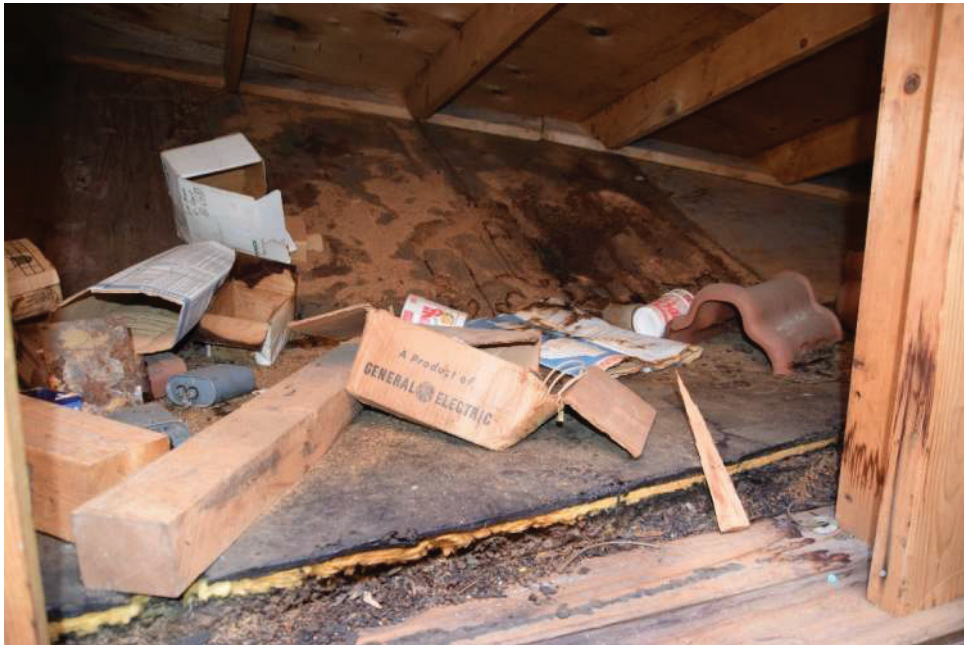
Original roof structure, roofing assembly observed from the west slope access scuttle. Roof saddle construction is newer vintage than other framing, sheathing present.

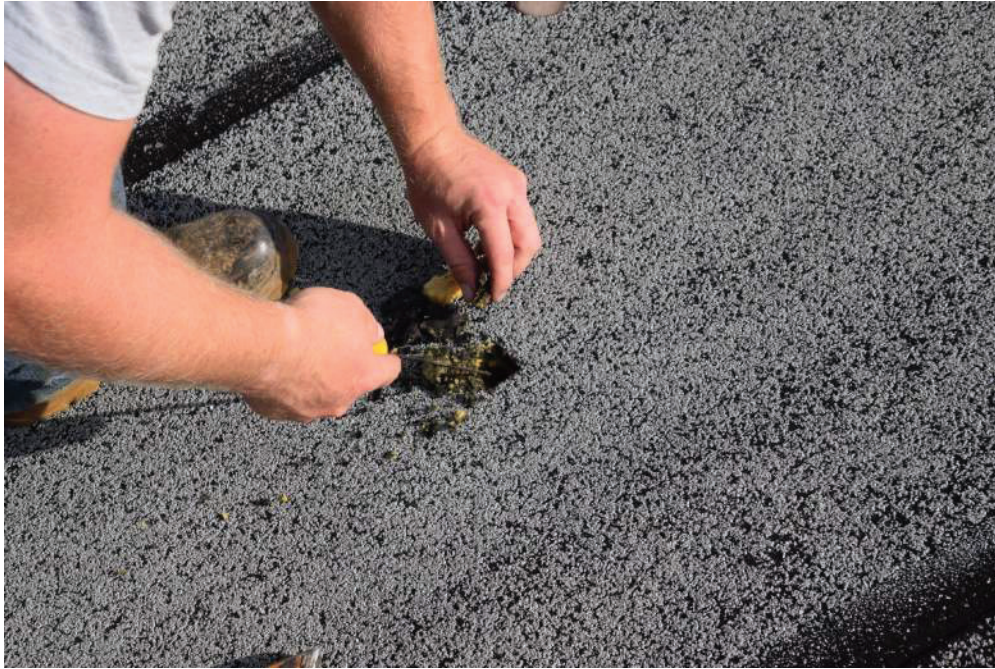
- e. Clay tile roof flashings appear to be in generally good condition.
3. The low-slope membrane system at the eave / gutter edges and the east slope parapets consists of a 4-ply BUR roofing system with a granulated cap sheet installed over (approx.) 1" of rigid fiberglass insulation over varying thicknesses of cork. At both core sample locations, total roofing system thickness was approximately three (3) inches.

Roofing core taken at west slope.

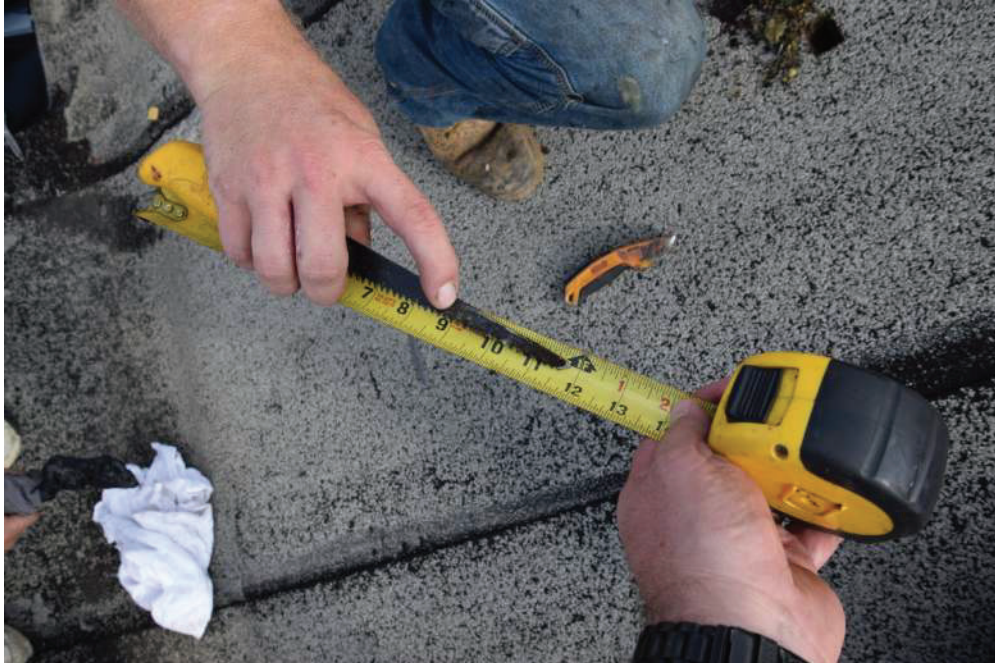
Core depth approximately 2".
