Exterior Condition Survey

Exterior Condition Survey for the University of Wisconsin Field House

Madison, Wisconsin

DRAFT – October 10, 2018rev

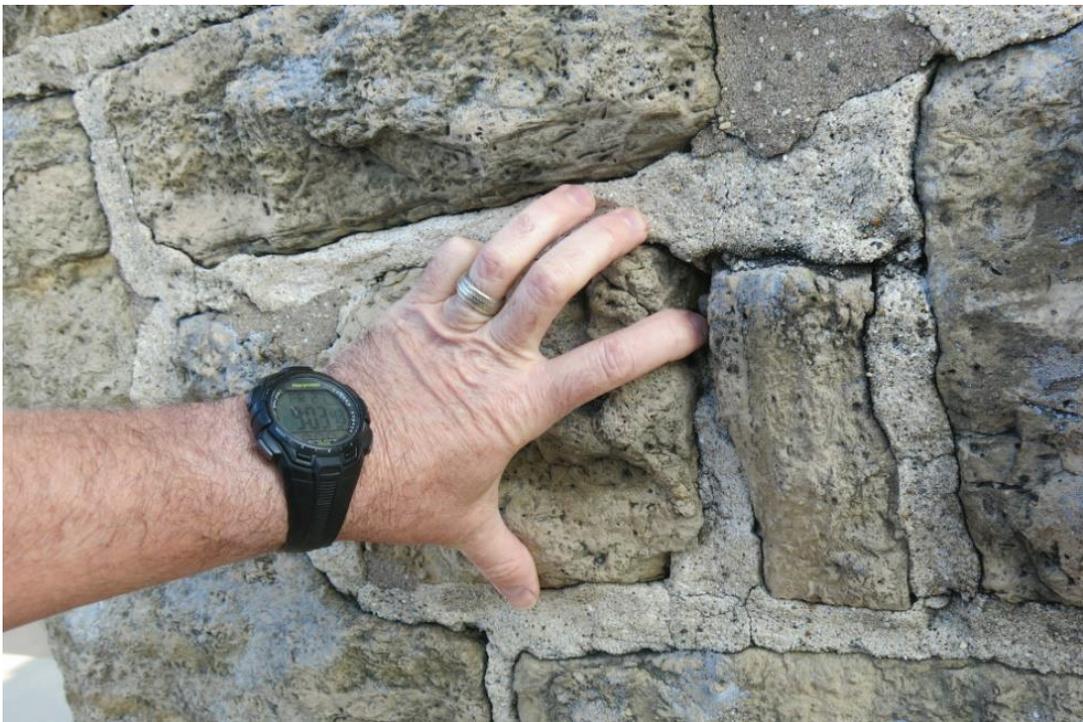
Deteriorated mortar on the South elevation.

The terra cotta mortar is typically in a bad state, with open or deteriorated joints. Much of the mortar for the terra cotta has been replaced with caulking, which can trap moisture behind it and cause additional damage to the terra cotta. Caulking can be used for wash joints or skyward facing joints but should not be used for standard joints as it traps water behind it and can cause damage to the glaze as well as the terra cotta unit itself. Replacement of all of the mortar joints for the terra cotta is recommended.

A base quantity/percentage of repointing should be carried out for each elevation, minimally say 5%. The mortar should be installed and allowed to cure until it's thumbprint hard, then tamped with a churn brush. The churn brush packs the mortar as well as exposing the aggregate giving it a weathered appearance, allowing it to visually blend with surrounding elements.

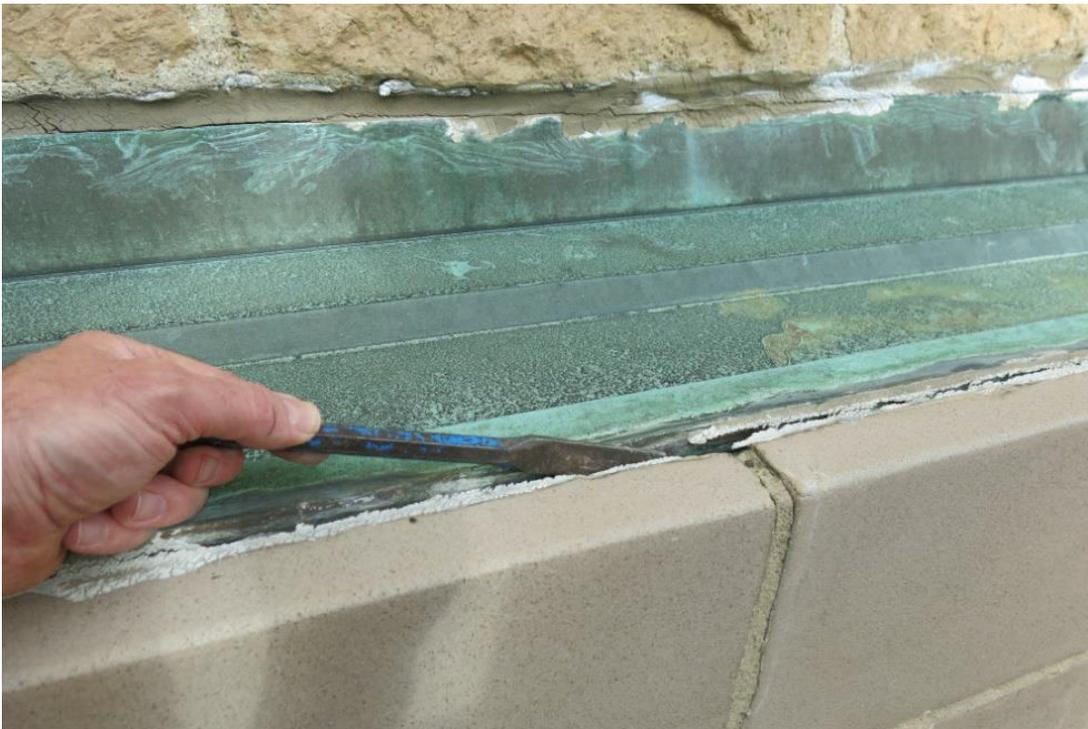
Caulk has been used throughout the building for repairs, including at flashing, windows and on the terra cotta. Much of the caulk has failed or has nearly reached the end of its service life. Please note that we recommend all of the caulking be replaced.

Failed caulking at terra cotta/copper flashing joint and copper/stone joint.

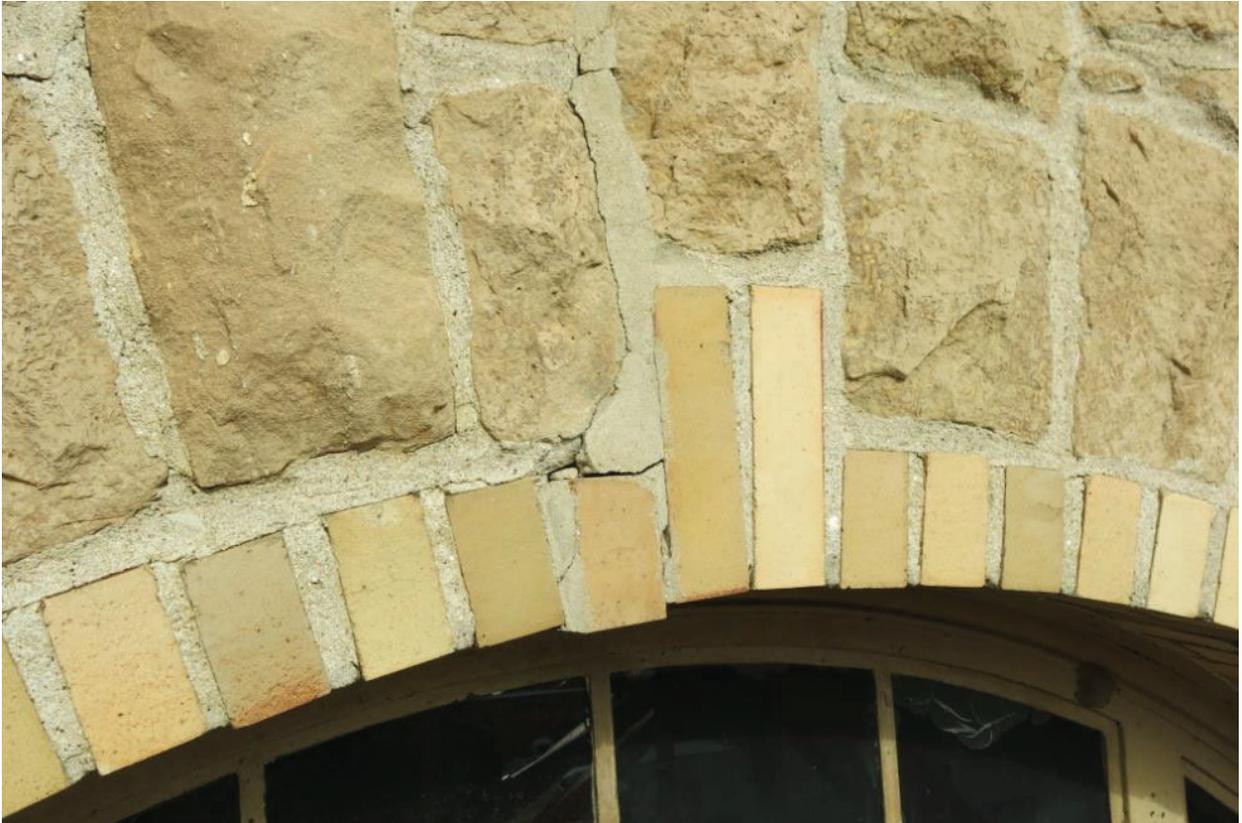
The brick found at the window surrounds was generally found in good condition and it appears that no brick replacement is required. There is no evidence that the brickwork at the window surrounds was added later. The only notable concern with the brickwork is on the East elevation second bay from the north, where there is a large crack that extends through the brick arch. One course of brick has dropped approximately a half inch in the underside of the arch.

Crack at brick window arch. Note brick that has dropped.

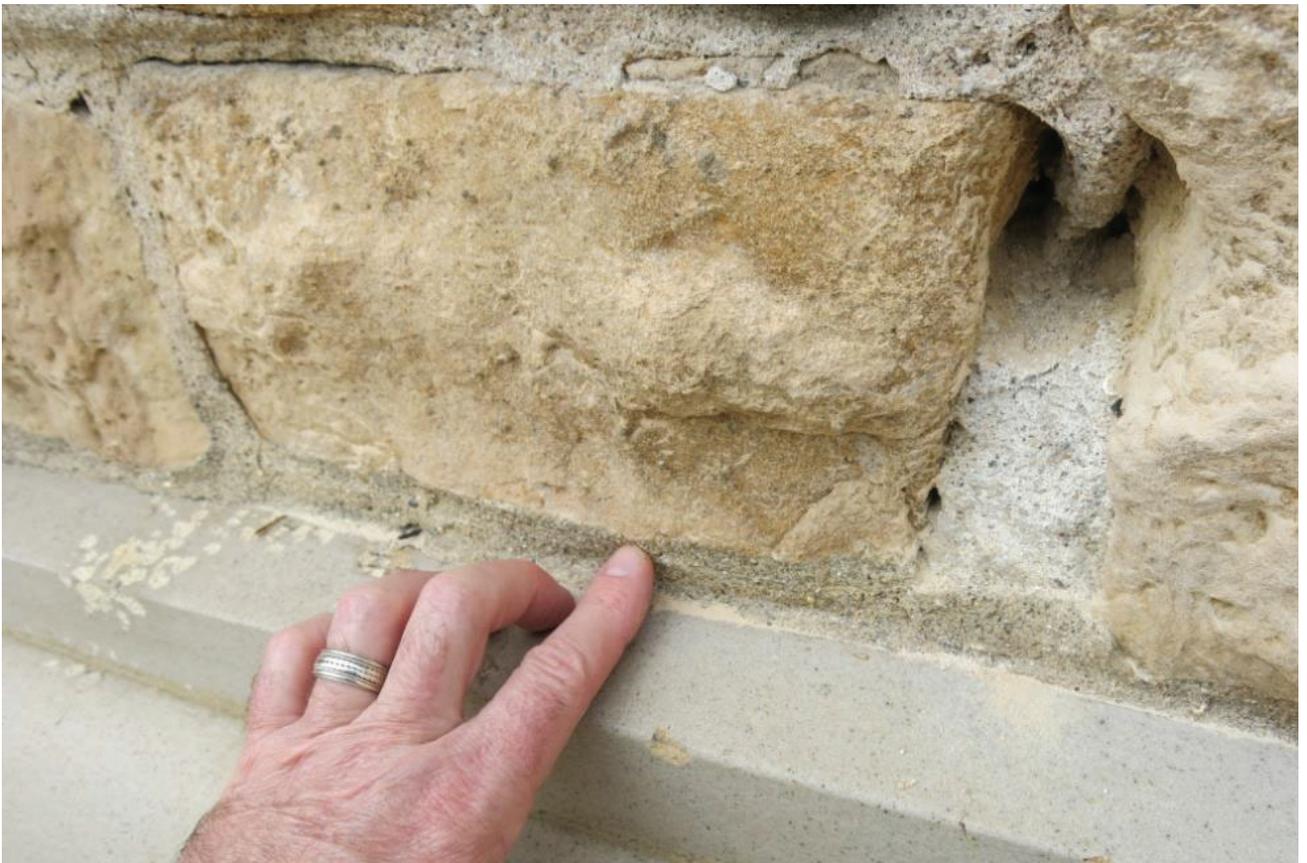
In general, the sandstone was found to be in good condition. Some deterioration was present, including sugaring and loss of stone. This deterioration is typically found near grade and at the parapet walls and was most likely caused by rising damp and salts near grade, as well as exposure/weathering at the parapets. Some of the stone has lost a considerable amount of material at the face and should be considered for possible replacement. A good source of available and appropriate replacement sandstone, however, will need to be located.

Deteriorated stone.

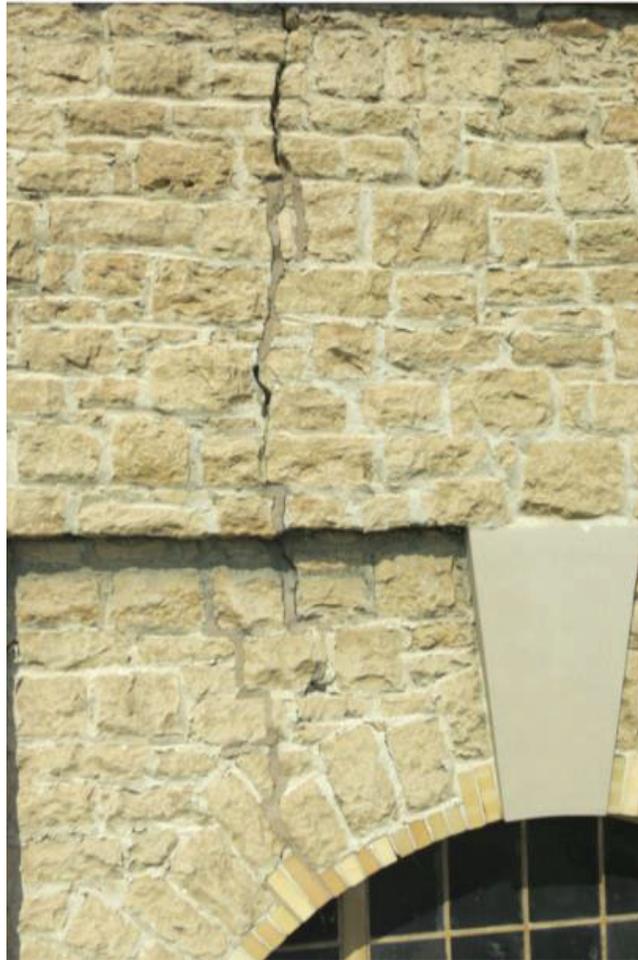
A number of cracks were found on the building, usually one per bay, and typically extending from grade to the door surround, and through to the lancet windows (where present). These cracks also extended through the arched windows, and up through the cornice. Of concern, a majority of cracks appeared open despite having been previously filled or repointed. A previous structural report indicates the cracks have been monitored over a length of time with no observed movement but installing crack monitors for future observation is recommended. The regularity of the cracking suggests it may be design-related, making it a good candidate for closer examination by a Structural Engineer.

Crack(s) above window arch

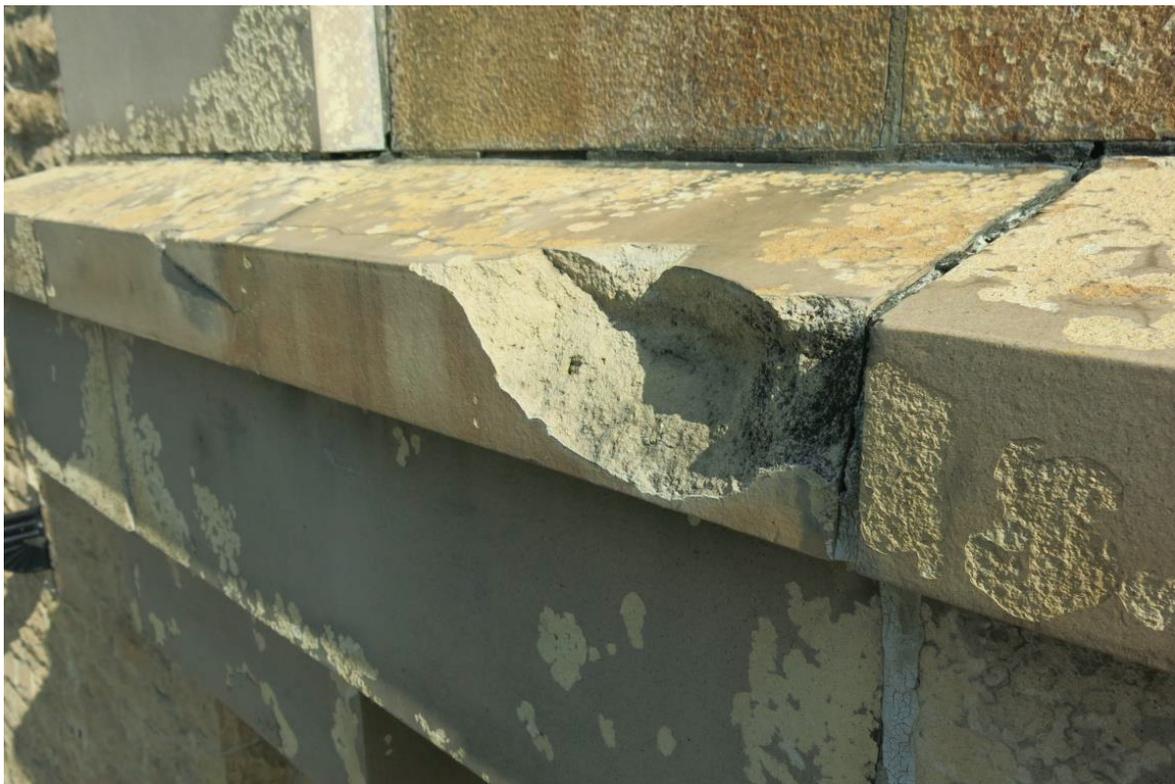
Figure 1

Additionally, glazing on the terracotta has spalled on many units. This is common especially near grade and at some of the high-weathering areas. (photo 2559)

Repair of the terra cotta units – Jahn M100; Edison Coatings Custom System 45.

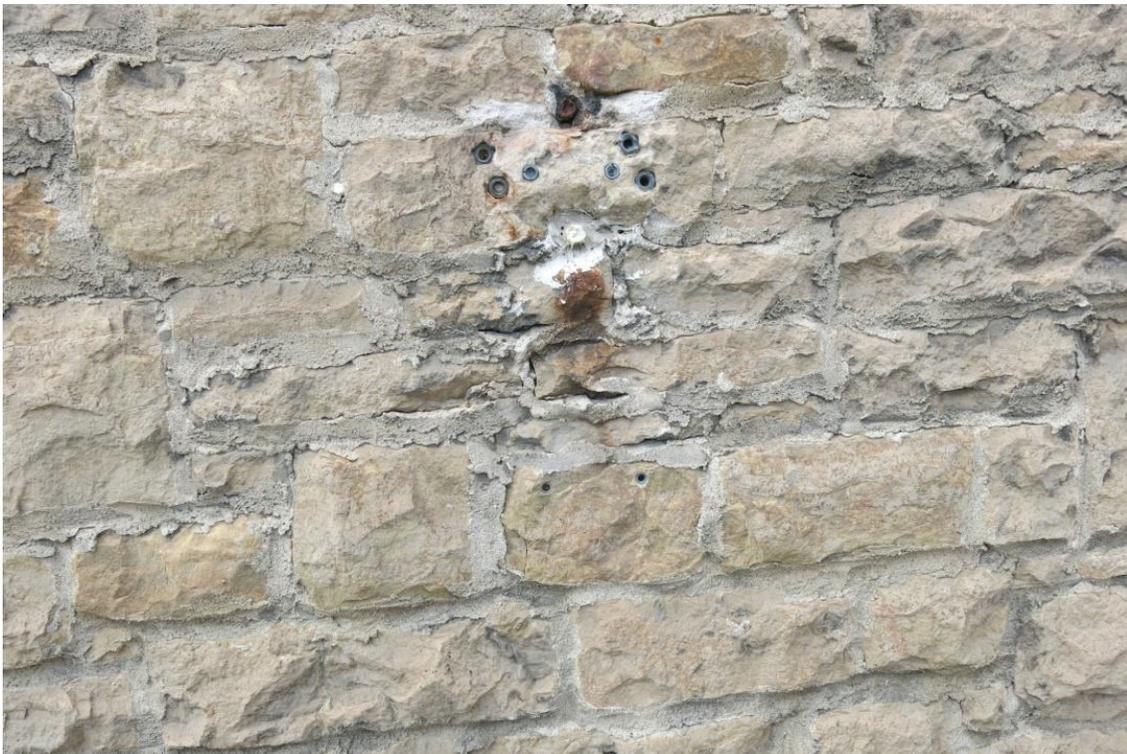
Metal anchors and attachments are found throughout the building. Although these once served a purpose, they are now superfluous. One location where attachments were found is on each pier, below the existing lighting, where earlier lighting was once located. Ferrous stains were found around most these anchors. These anchors should be removed, and the holes infilled with mortar or a stone repair material.

[Anchors/attachments on East elevation.](#)

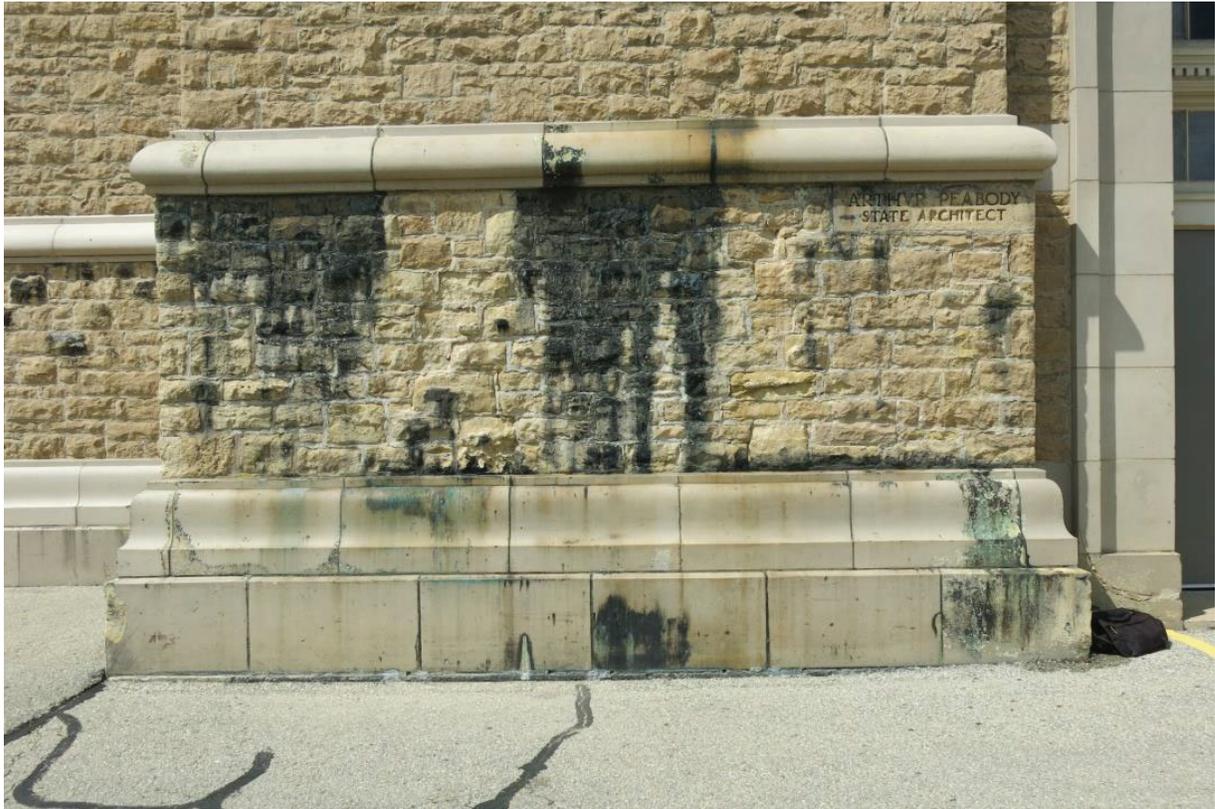
Various kinds of stains and soiling were found on the building. These included biological growth, ferrous staining, cuprous staining, and atmospheric soiling. Much of this staining and soiling was located near grade.

Various types of staining/soiling on the South elevation.

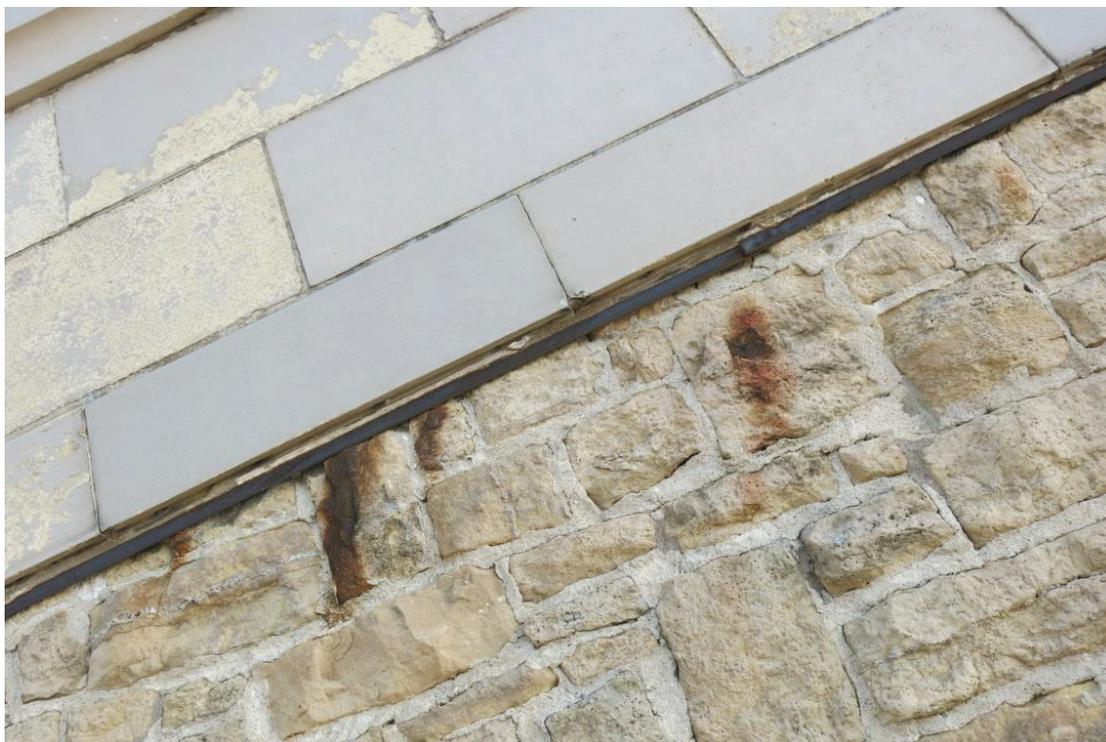
Ferrous staining is found on the building at multiple locations. Typically, it is found on lower sections of the building, and was primarily caused by run-off from the metal flashing and metal anchors above. This staining can probably be removed with proprietary stain remover or poultice, such as ProSoCo Ferrous Stain Remover. Additionally, the problematic flashing should either be cleaned and painted, or replaced.

Ferrous staining on stone below metal flashing on South gable.

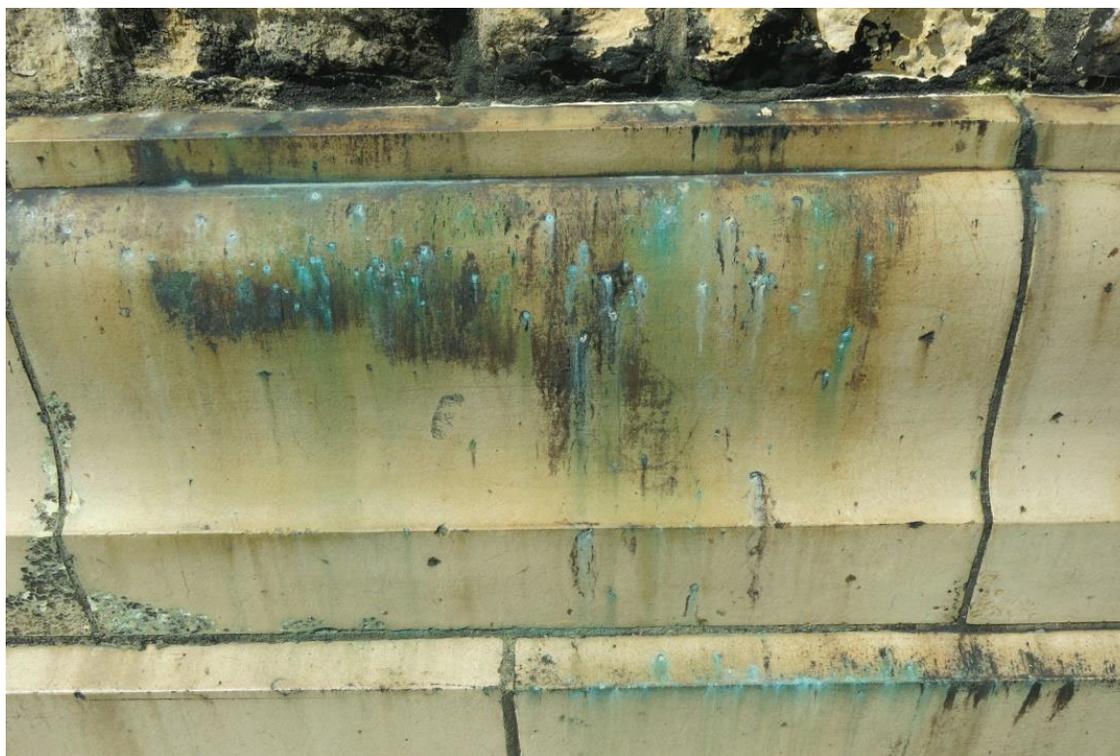
Terra cotta near grade: Note cuprous as well as ferrous staining.

Cuprous and Ferrous staining – remove with proprietary stain removers or poultice

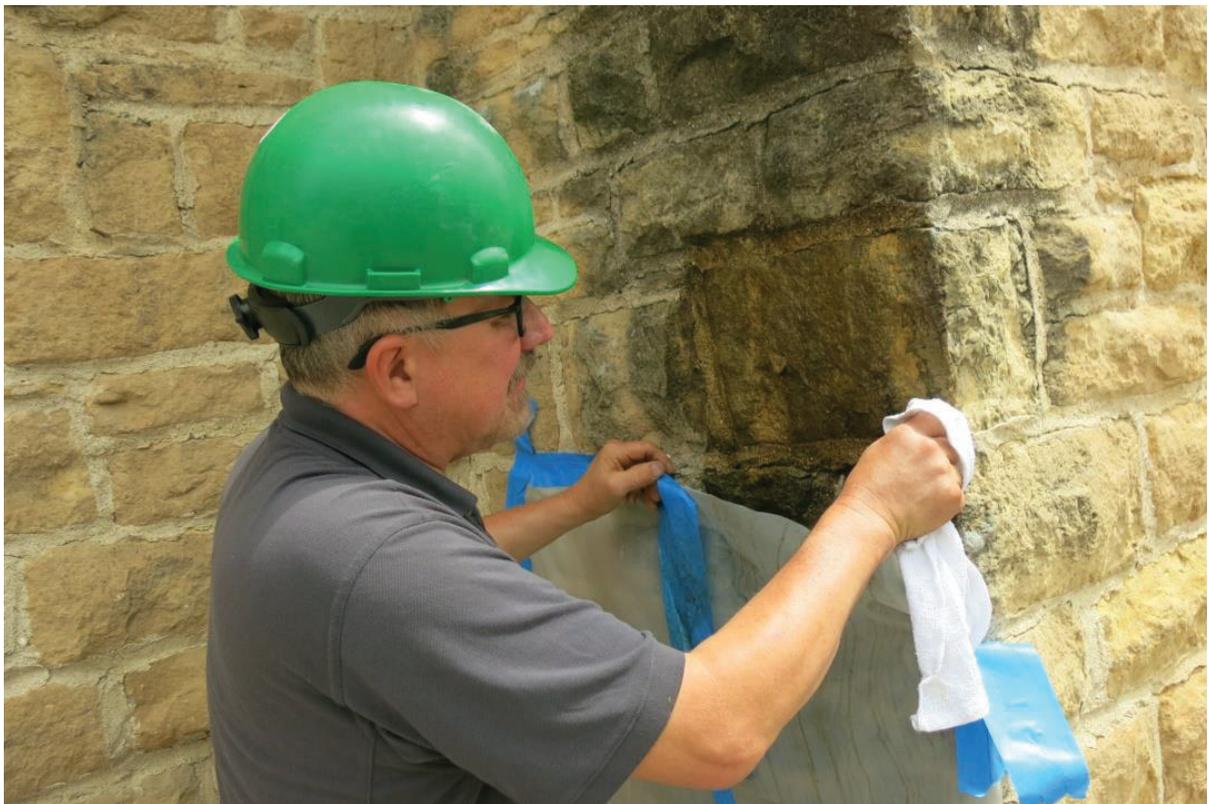
Cleaning tests were performed on Bay W7 near grade attempting to remove the black bio/soiling using a proprietary biocide (D/2) with promising results. Both sandstone and terrace cotta were test cleaned. The product was applied and allowed to dwell on the substrate for a period of five minutes and then was agitated with a bristle brush and reapplied and agitated again. Run-off was removed with towels to prevent biocide from running onto the stones below.

Cleaning test on dark biological staining on sandstone.

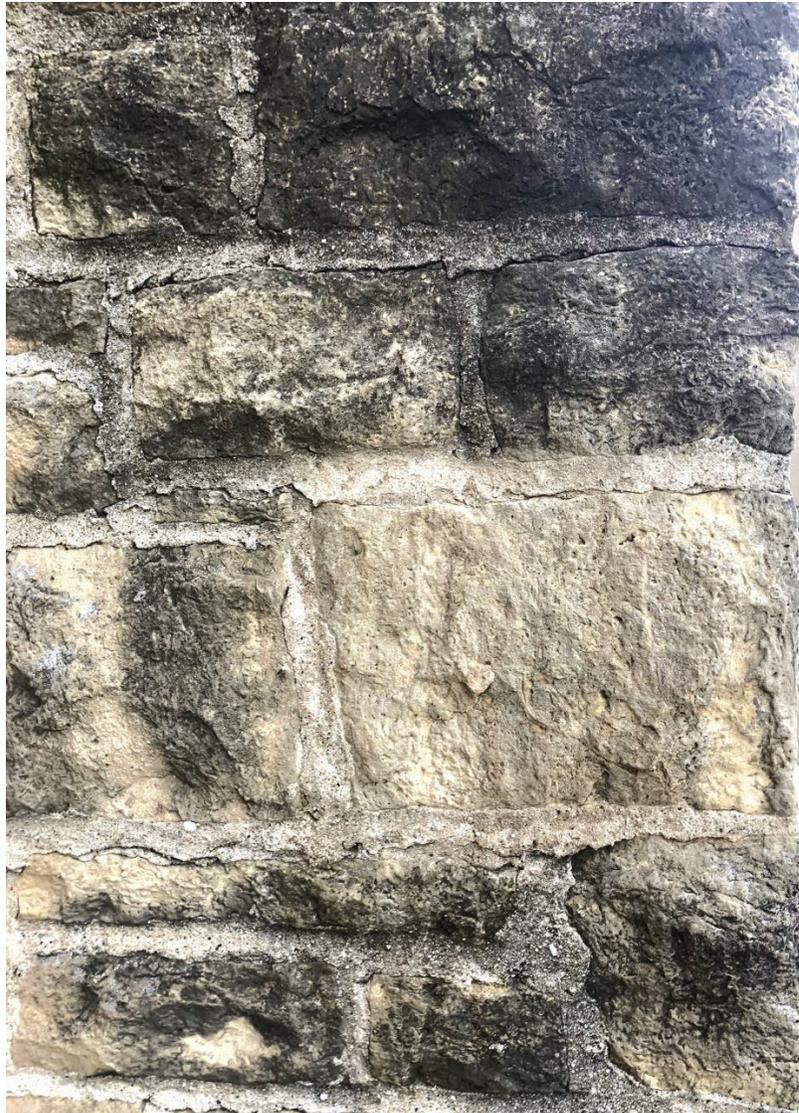
Detail of sandstone after cleaning with an antimicrobial

Further cleaning tests will need to be carried out prior to treatment to determine the efficacy of other potential methods and materials.
