EXTERIOR CONDITION ASSESSMENT

For the purposes of this Historic Structure Report, all assessments were made through on-site visual observations conducted in May and July of 2018, high definition photography, and drone photography. Original drawings from 1929 were analyzed and compared to as-built conditions throughout the entire process in an effort to better understand and assess the design intent versus the actual constructed environment.

South Elevation Assessment

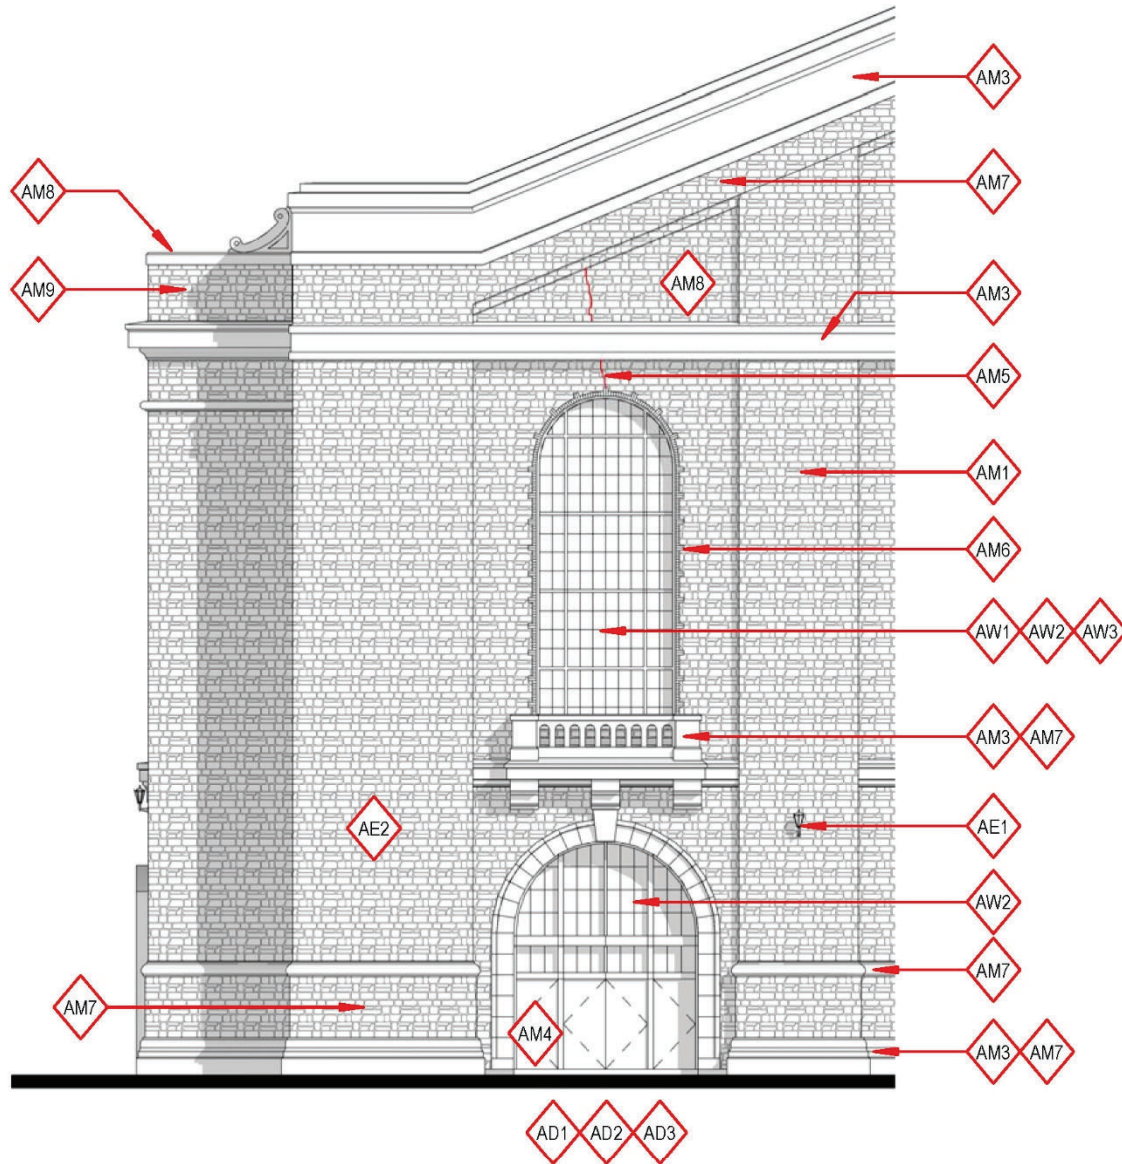
CONDITION ASSESSMENT SUMMARY - SOUTH ELEVATION - BAY S1

DOORS	ELECTRICAL	MASONRY	WINDOWS
AD1 NON-ORIGINAL HOLLOW METAL DOORS ARE IN GOOD CONDITION	AE1 NON-ORIGINAL LIGHT FIXTURE - ORIGINAL FIXTURE MOUNTING HARDWARE REMAINS	AM1 EVIDENCE OF PREVIOUS TUCKPOINTING EFFORT WITH NON-MATCHING MORTAR	AW1 DETERIORATED FINISH AT METAL WINDOW FRAME
AD2 ORIGINAL WOOD FRAME IN FAIR CONDITION WITH DETERIORATION PRESENT AT GRADE	AE2 LIGHT FIXTURE MISSING - ORIGINAL FIXTURE MOUNTING HARDWARE REMAINS	AM3 EVIDENCE OF TERRA COTTA SPALLING	AW2 GLAZING UNITS HAVE BEEN PAINTED ON THE INTERIOR FACE
AD3 SEALANT AT DOOR PERIMETER IN POOR CONDITION		AM4 FRACTURED TERRA COTTA UNIT(S)	AW3 SEALANT AT WINDOW PERIMETER IN POOR CONDITION
		AM5 DIAGONAL STEP CRACKING PRESENT	
		AM6 BRICK AT THE PERIMETER OF THE WINDOW APPEARS TO BE IN GOOD CONDITION	
		AM7 MASONRY STAINING PRESENT	
		AM8 DETERIORATION OF SKYWARD FACING JOINTS OBSERVED	
		AM9 DETERIORATED MORTAR JOINTS PRESENT

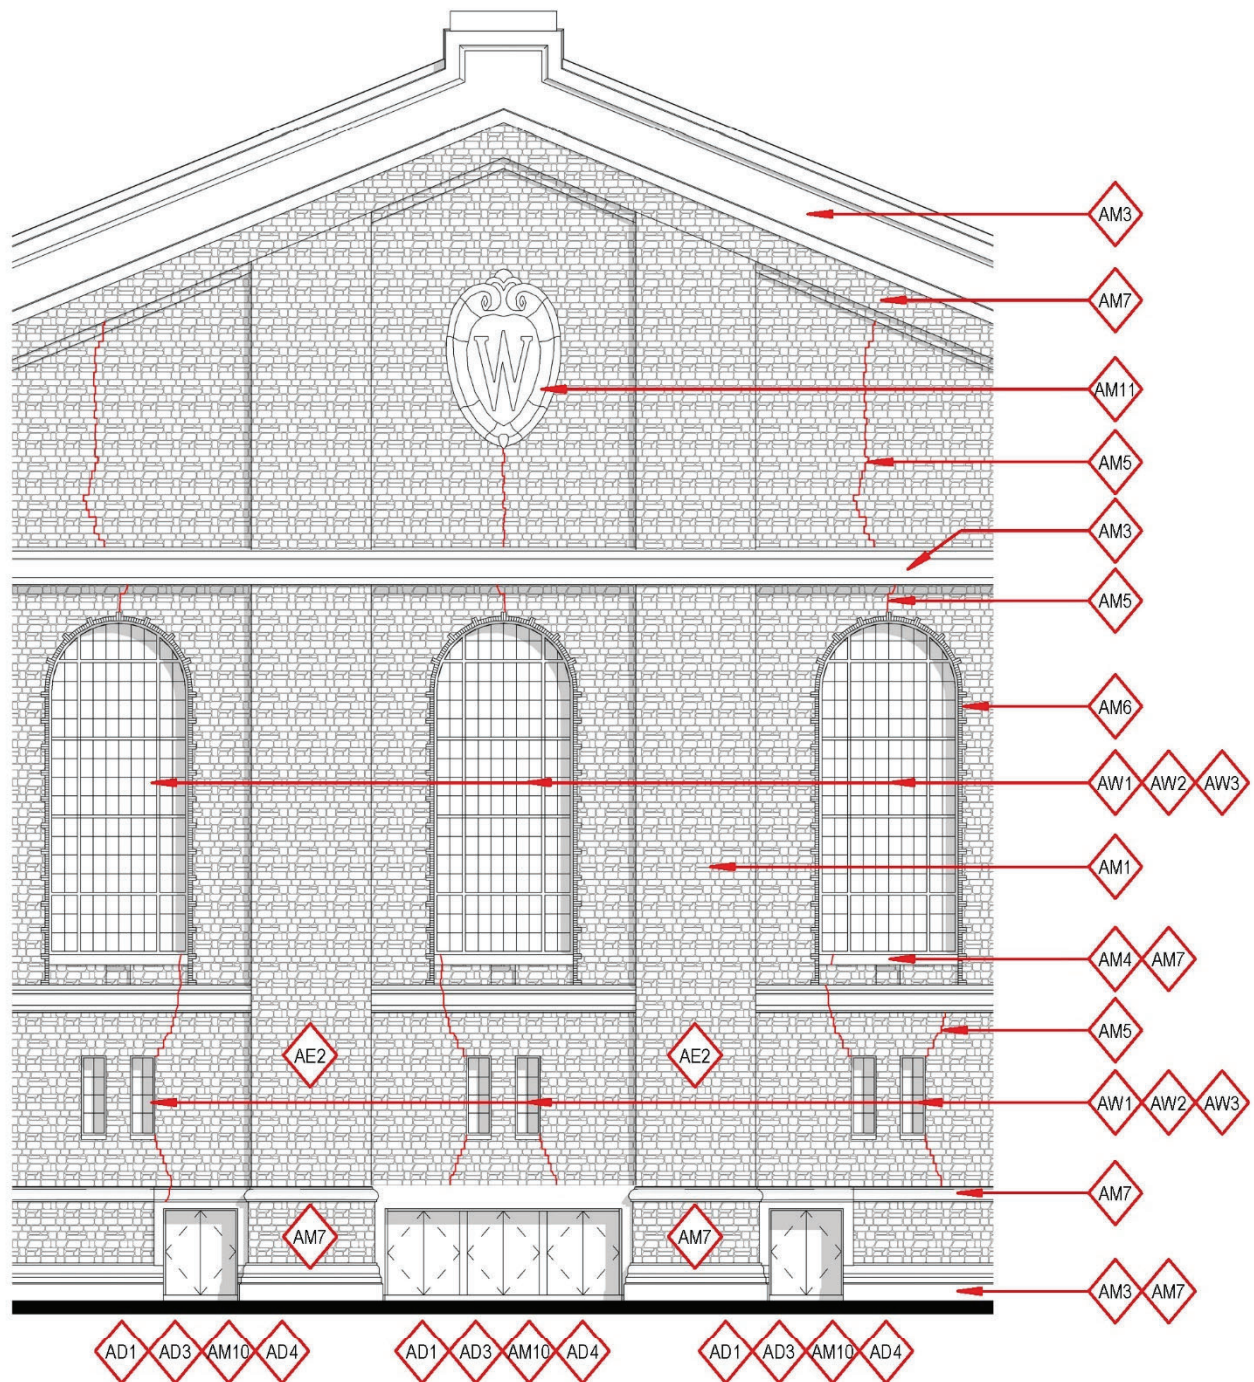
CONDITION ASSESSMENT SUMMARY - SOUTH ELEVATION - BAY S2

DOORS	ELECTRICAL	MASONRY	WINDOWS
AD1 NON-ORIGINAL HOLLOW METAL DOORS ARE IN GOOD CONDITION	AE2 LIGHT FIXTURE MISSING - ORIGINAL FIXTURE MOUNTING HARDWARE REMAINS	AM1 EVIDENCE OF PREVIOUS TUCKPOINTING EFFORT WITH NON-MATCHING MORTAR	AW1 DETERIORATED FINISH AT METAL WINDOW FRAME
AD3 SEALANT AT DOOR PERIMETER IN POOR CONDITION		AM3 EVIDENCE OF TERRA COTTA SPALLING	AW2 GLAZING UNITS HAVE BEEN PAINTED ON THE INTERIOR FACE
AD4 NON-ORIGINAL PLASTER DOOR SURROUND IN FAIR CONDITION		AM4 FRACTURED TERRA COTTA UNIT(S)	AW3 SEALANT AT WINDOW PERIMETER IN POOR CONDITION
		AM5 DIAGONAL STEP CRACKING PRESENT	
		AM6 BRICK AT THE PERIMETER OF THE WINDOW APPEARS TO BE IN GOOD CONDITION	
		AM7 MASONRY STAINING PRESENT	
		AM10 FLASHING AND SEALANT IN POOR CONDITION	
		AM11 CRACK OBSERVED IN "W" CARTOUCHE

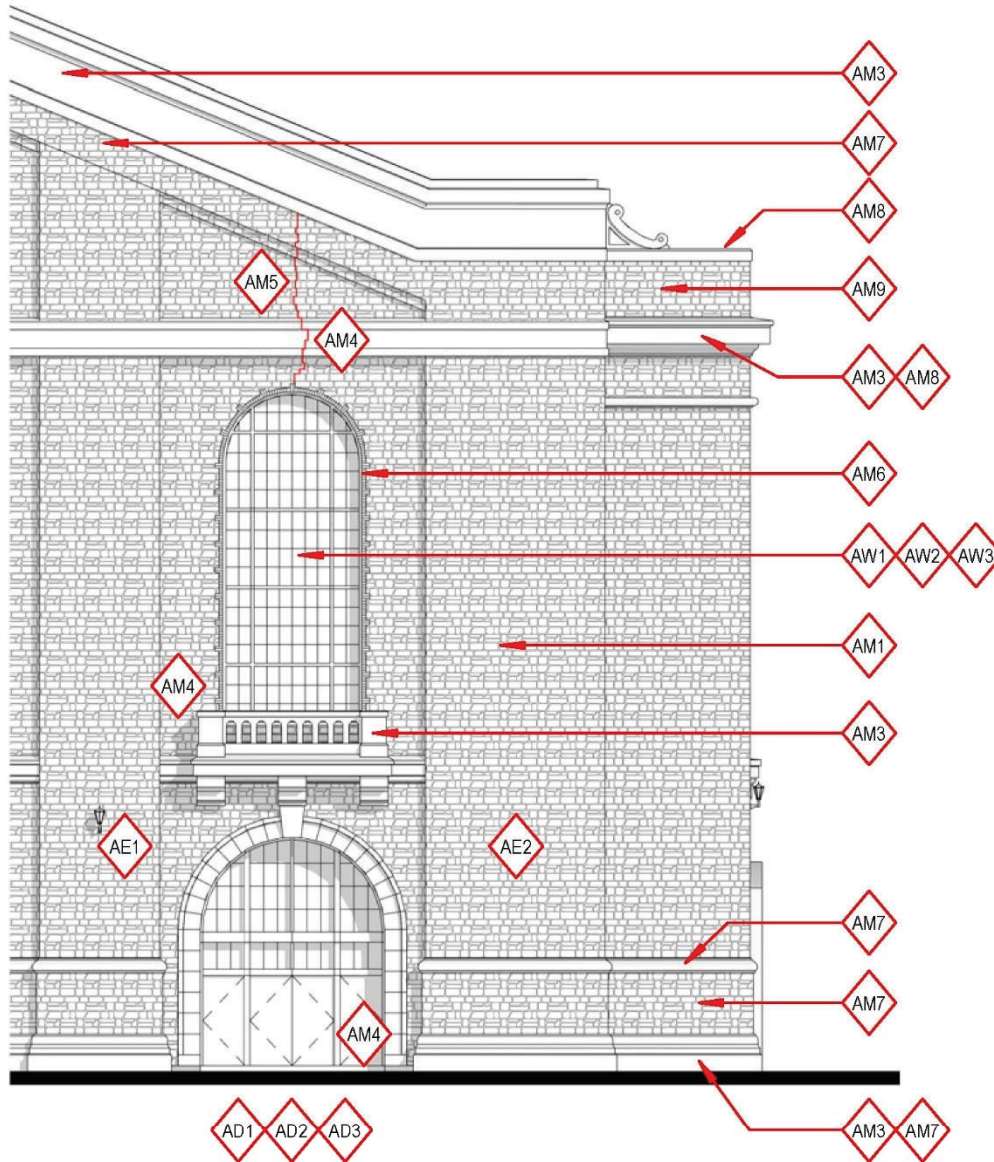
CONDITION ASSESSMENT SUMMARY - SOUTH ELEVATION - BAY S3

DOORS	ELECTRICAL	MASONRY	WINDOWS
AD1 NON-ORIGINAL HOLLOW METAL DOORS ARE IN GOOD CONDITION	AE1 NON-ORIGINAL LIGHT FIXTURE - ORIGINAL FIXTURE MOUNTING HARDWARE REMAINS	AM1 EVIDENCE OF PREVIOUS TUCKPOINTING EFFORT WITH NON-MATCHING MORTAR	AW1 DETERIORATED FINISH AT METAL WINDOW FRAME
AD2 ORIGINAL WOOD FRAME IN FAIR CONDITION WITH DETERIORATION PRESENT AT GRADE	AE2 LIGHT FIXTURE MISSING - ORIGINAL FIXTURE MOUNTING HARDWARE REMAINS	AM3 EVIDENCE OF TERRA COTTA SPALLING	AW2 GLAZING UNITS HAVE BEEN PAINTED ON THE INTERIOR FACE
AD3 SEALANT AT DOOR PERIMETER IN POOR CONDITION		AM4 FRACTURED TERRA COTTA UNIT(S)	AW3 SEALANT AT WINDOW PERIMETER IN POOR CONDITION
		AM5 DIAGONAL STEP CRACKING PRESENT	
		AM6 BRICK AT THE PERIMETER OF THE WINDOW APPEARS TO BE IN GOOD CONDITION	
		AM7 MASONRY STAINING PRESENT	
		AM8 DETERIORATION OF SKYWARD FACING JOINTS OBSERVED	
		AM9 DETERIORATED MORTAR JOINTS PRESENT

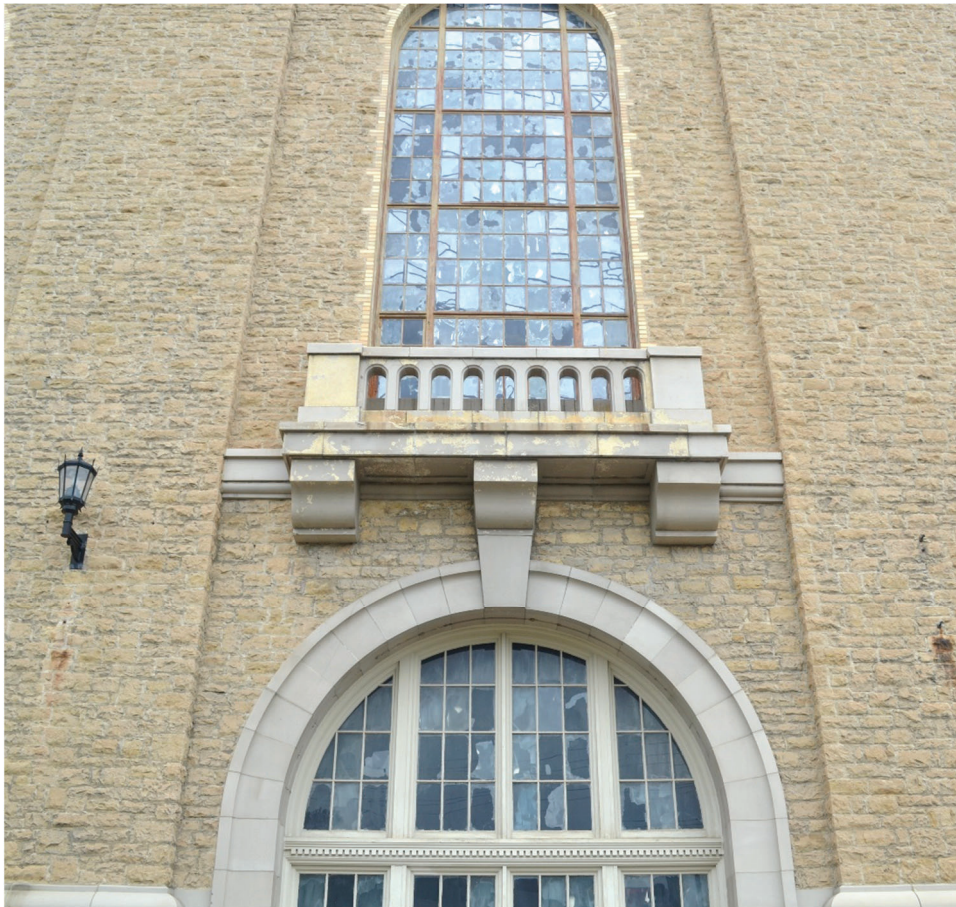
Figure 58: Field House Southeast Window Balcony
(River Architects July 12, 2018)

The photo to the left represents a common theme of the Field House's exterior condition. The rubble stone is generally in good condition while the terra cotta has suffered from glaze spalling and is continuing to deteriorate. Fractures in the masonry wall are evident at the window heads and sill areas while staining is commonly present near the base of the wall. Areas are observed where previous tuckpointing efforts were made with a non-matching mortar. Window frames are generally in good condition but are in need of refinishing.

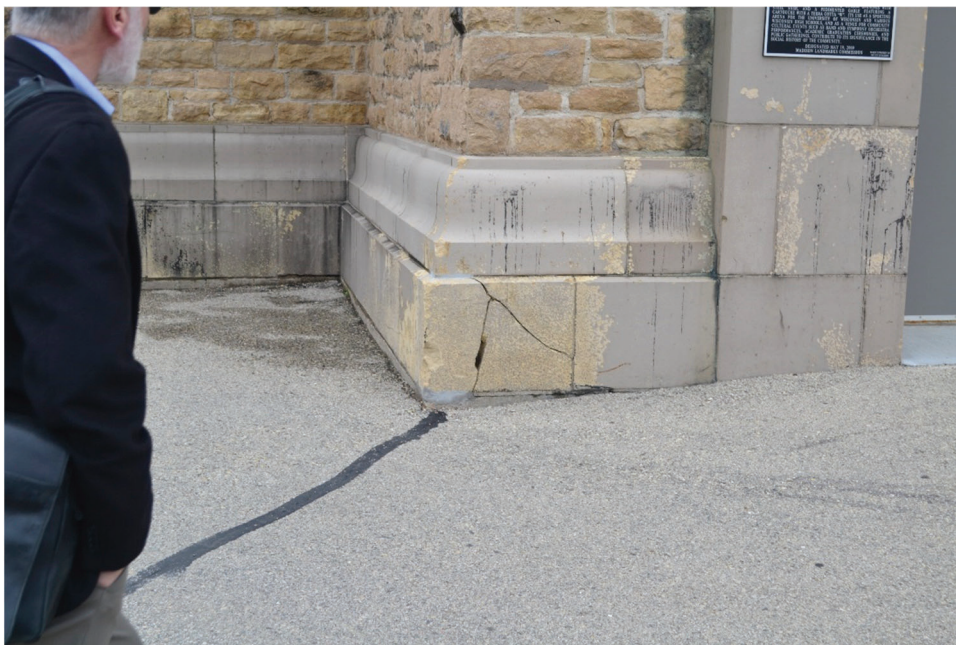
Figure 59: Field House Southwest
(River Architects May 3, 2018)

Terra cotta detailing used at grade and near door openings has suffered extreme deterioration over the years. Glaze spalling and fractures can be found on many units. Staining of the masonry is most evident near the base of the wall on the south elevation.

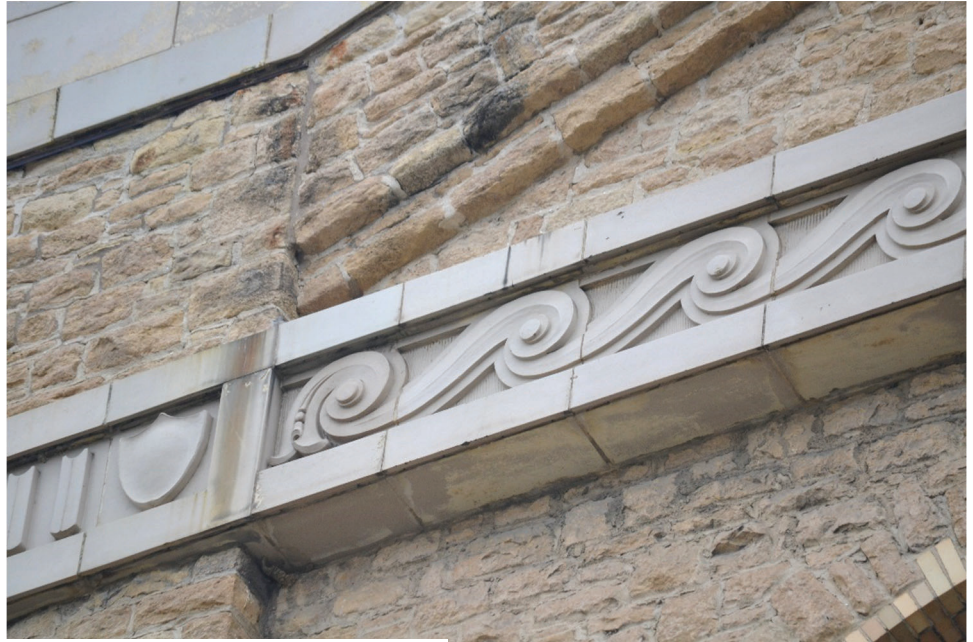
Figure 60: Southwest Corner of Field House
(River Architects May 3, 2018)

Glaze spalling can be seen at the underside of the decorative terra cotta banding in the photo to the right. Close observations of the rubble stone indicate mortar separation occurring.

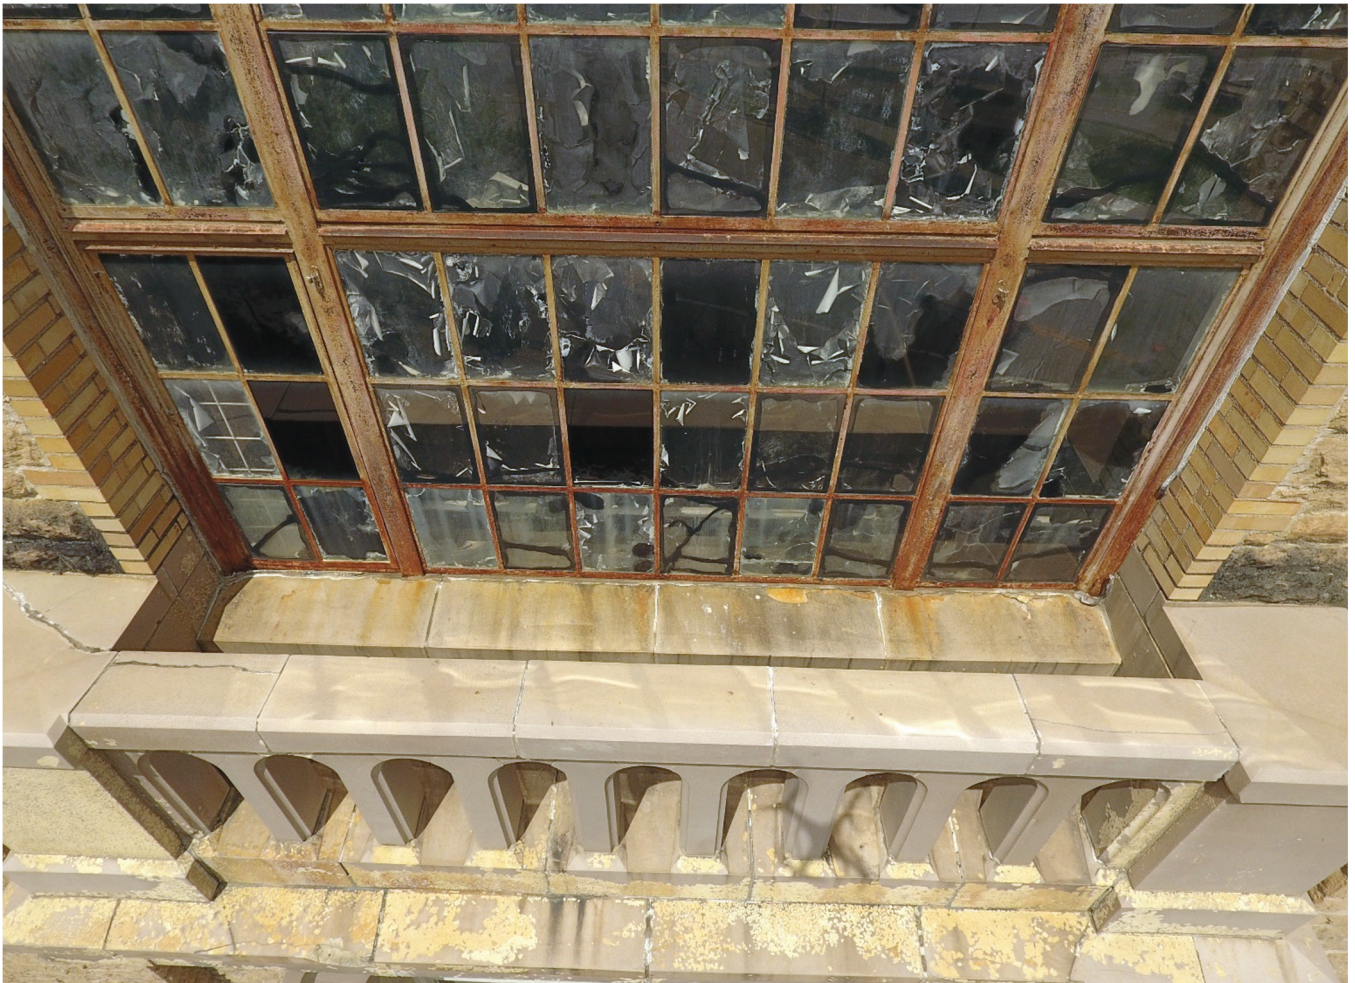
Figure 61: Southeast Window Balcony
(JP Cullen May 17, 2018)

The bottom photo is a good example of the typical conditions found at the windows. Window frames are in relatively good condition while the sealants and adjacent masonry is often in poor condition. The terra cotta sills and balconies at the south elevation need immediate repair.

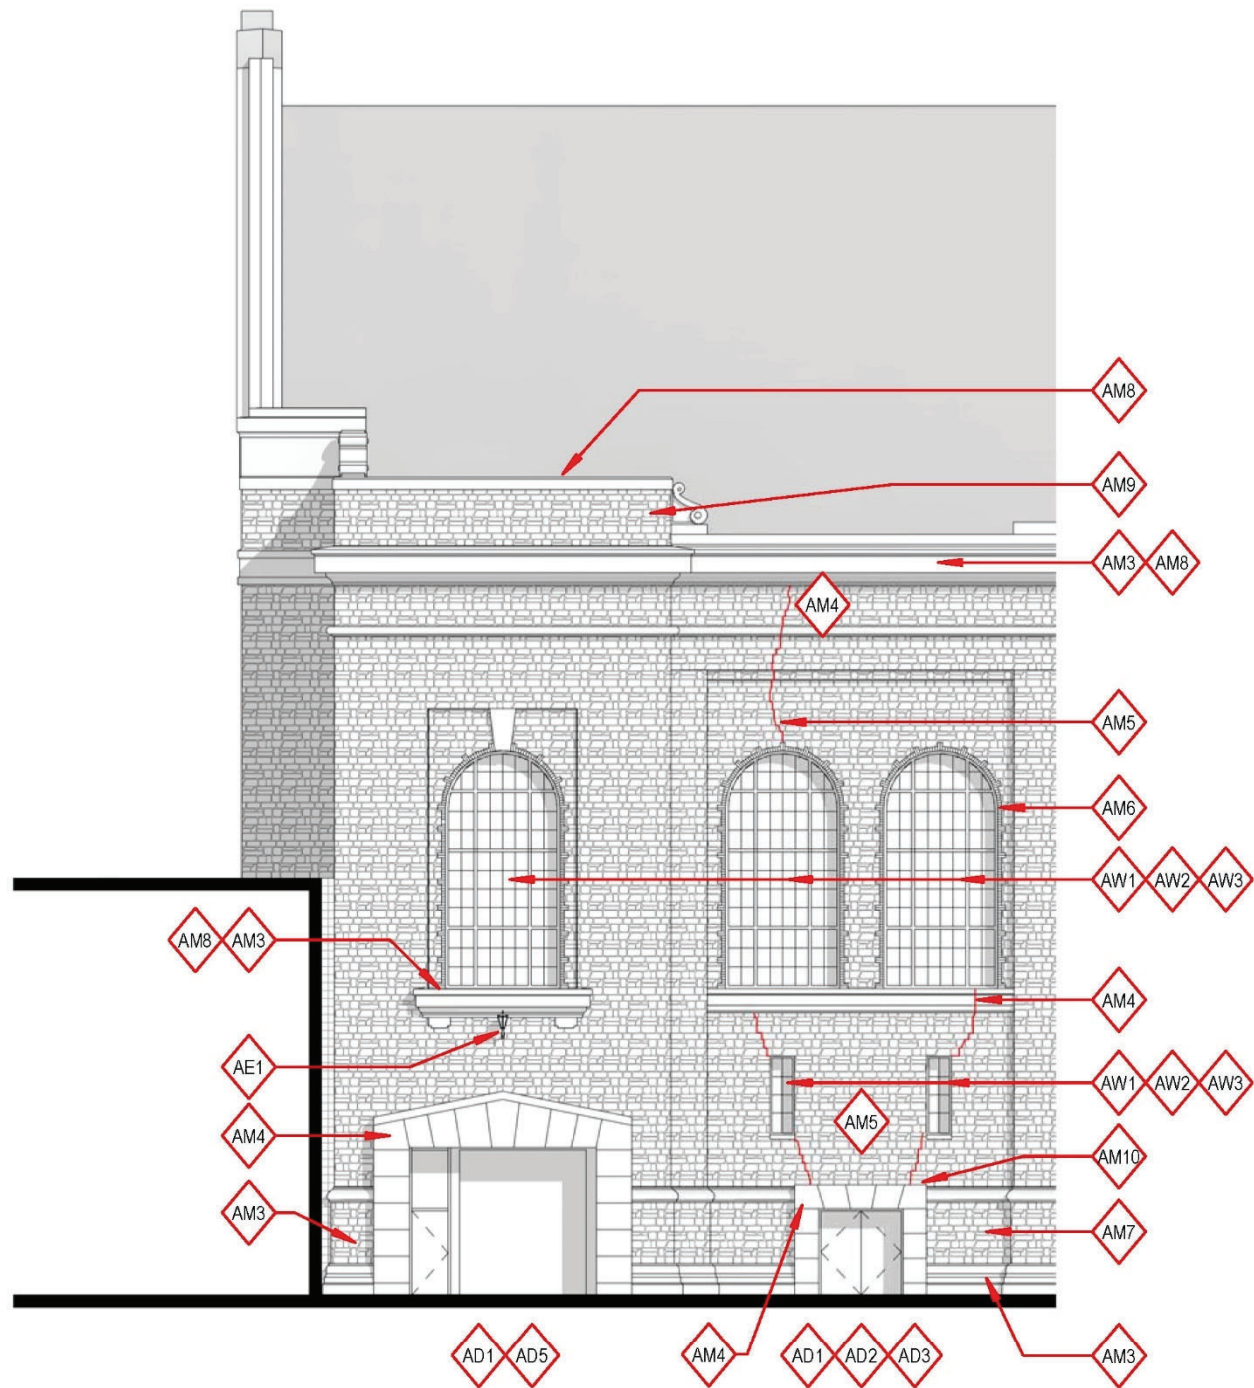
CONDITION ASSESSMENT SUMMARY - WEST ELEVATION - BAY W1

DOORS	ELECTRICAL	MASONRY	WINDOWS
AD1 NON-ORIGINAL HOLLOW METAL DOORS ARE IN GOOD CONDITION	AE1 NON-ORIGINAL LIGHT FIXTURE - ORIGINAL FIXTURE MOUNTING HARDWARE REMAINS	AM3 EVIDENCE OF TERRA COTTA SPALLING	AW1 DETERIORATED FINISH AT METAL WINDOW FRAME
AD2 ORIGINAL WOOD FRAME IN FAIR CONDITION WITH DETERIORATION PRESENT AT GRADE		AM4 FRACTURED TERRA COTTA UNIT(S)	AW2 GLAZING UNITS HAVE BEEN PAINTED ON THE INTERIOR FACE
AD3 SEALANT AT DOOR PERIMETER IN POOR CONDITION		AM5 DIAGONAL STEP CRACKING PRESENT	AW3 SEALANT AT WINDOW PERIMETER IN POOR CONDITION
AD5 NON-ORIGINAL SECTIONAL DOOR IN GOOD CONDITION		AM6 BRICK AT THE PERIMETER OF THE WINDOW APPEARS TO BE IN GOOD CONDITION	
		AM7 MASONRY STAINING PRESENT	
		AM8 DETERIORATION OF SKYWARD FACING JOINTS OBSERVED	
		AM9 DETERIORATED MORTAR JOINTS PRESENT	
		AM10 FLASHING AND SEALANT IN POOR CONDITION

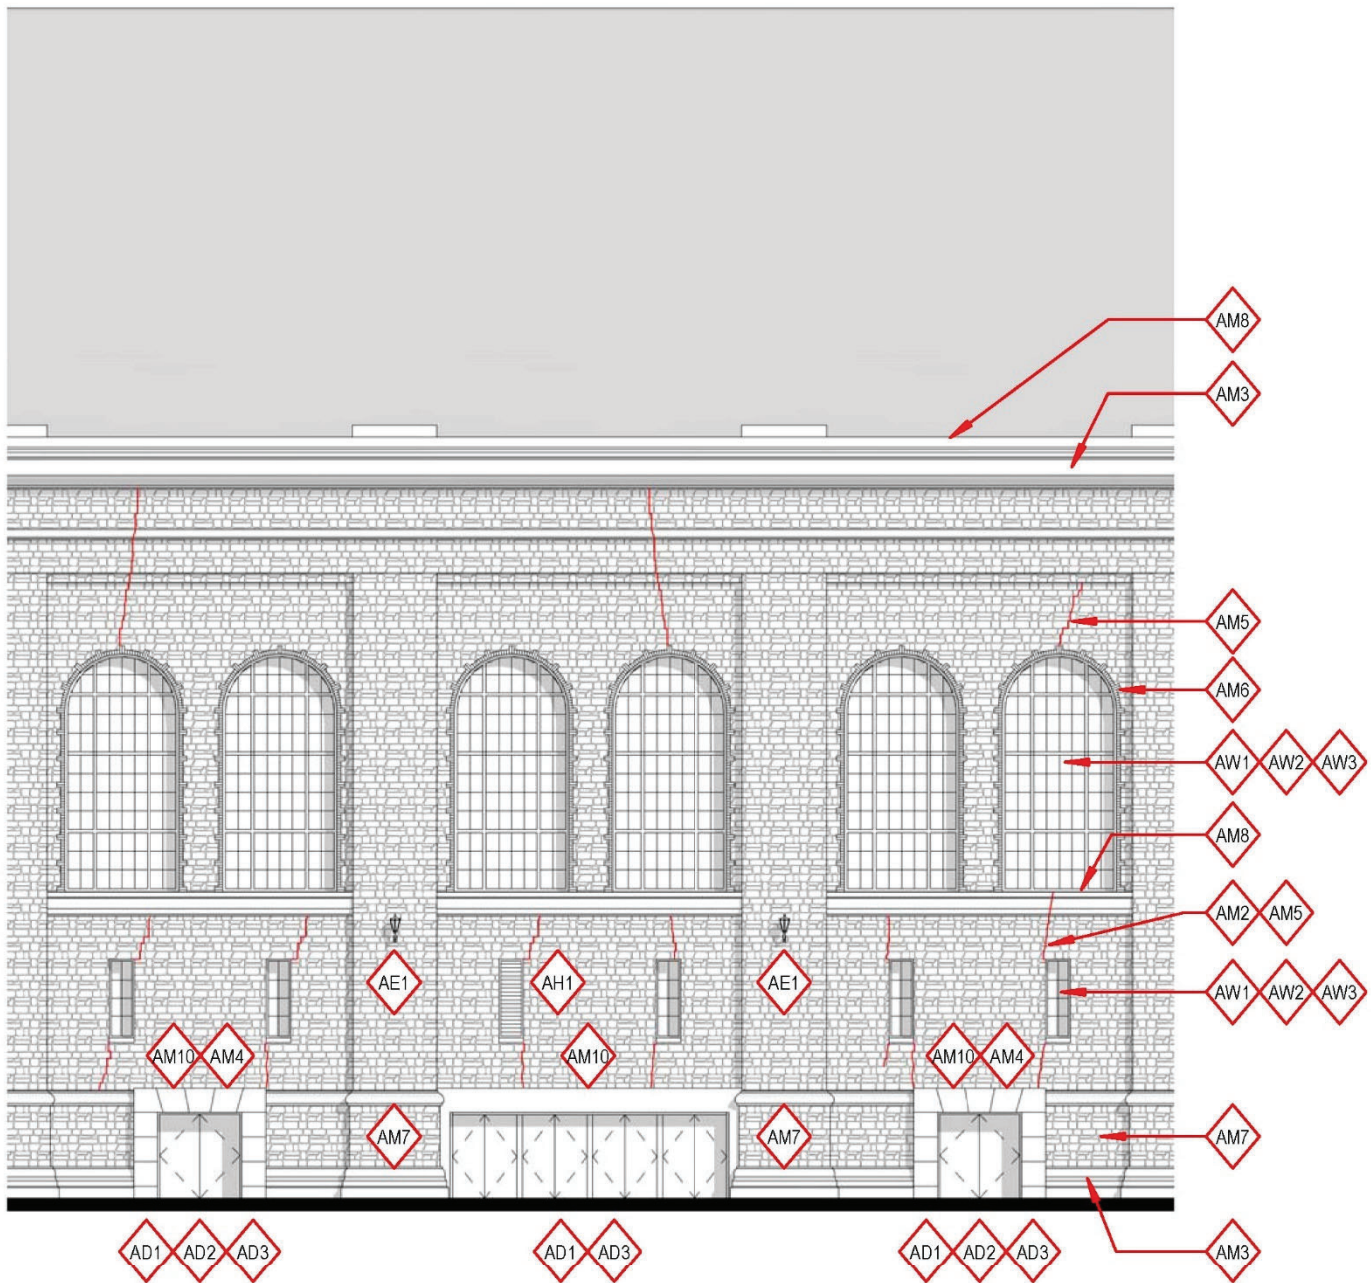
CONDITION ASSESSMENT SUMMARY - WEST ELEVATION - BAY W2

DOORS	ELECTRICAL	MASONRY	WINDOWS
AD1 NON-ORIGINAL HOLLOW METAL DOORS ARE IN GOOD CONDITION	AE1 NON-ORIGINAL LIGHT FIXTURE - ORIGINAL FIXTURE MOUNTING HARDWARE REMAINS	AM2 FRACTURED RUBBLE STONE UNIT(S)	AW1 DETERIORATED FINISH AT METAL WINDOW FRAME
AD2 ORIGINAL WOOD FRAME IN FAIR CONDITION WITH DETERIORATION PRESENT AT GRADE		AM3 EVIDENCE OF TERRA COTTA SPALLING	AW2 GLAZING UNITS HAVE BEEN PAINTED ON THE INTERIOR FACE
AD3 SEALANT AT DOOR PERIMETER IN POOR CONDITION		AM4 FRACTURED TERRA COTTA UNIT(S)	AW3 SEALANT AT WINDOW PERIMETER IN POOR CONDITION
	HVAC	AM5 DIAGONAL STEP CRACKING PRESENT	
	AH1 NON-ORIGINAL LOUVER AND SEALANT IN GOOD CONDITION	AM6 BRICK AT THE PERIMETER OF THE WINDOW APPEARS TO BE IN GOOD CONDITION	
		AM7 MASONRY STAINING PRESENT	
		AM8 DETERIORATION OF SKYWARD FACING JOINTS OBSERVED	
		AM10 FLASHING AND SEALANT IN POOR CONDITION

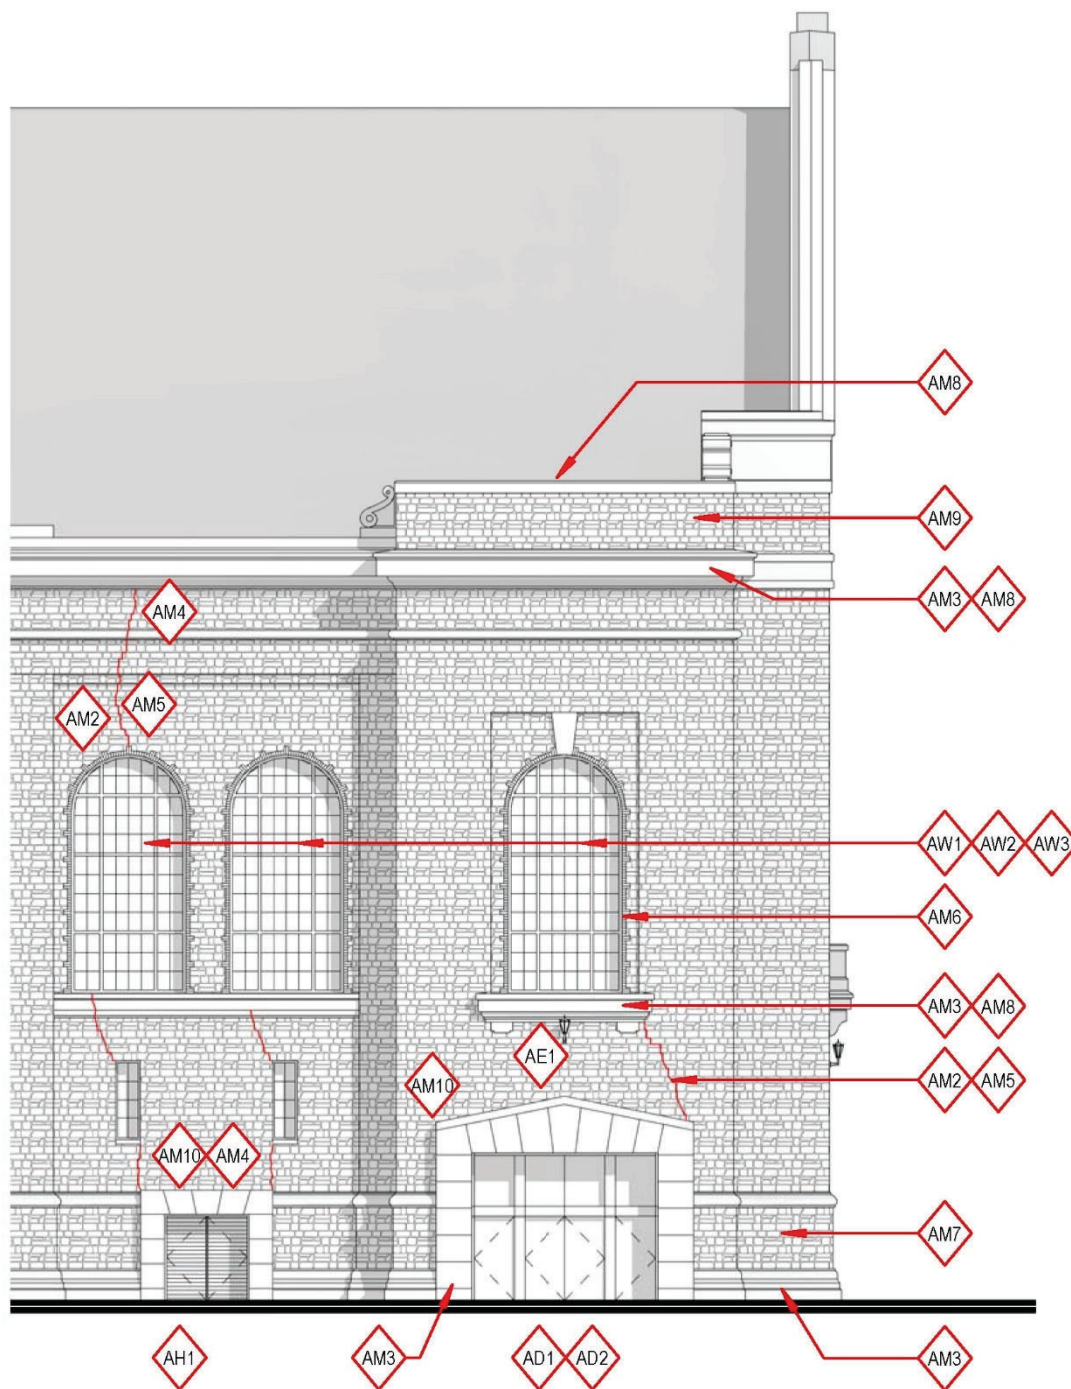
DOORS		ELECTRICAL	MASONRY	WINDOWS
AD1	NON-ORIGINAL HOLLOW METAL DOORS ARE IN GOOD CONDITION	AE1 NON-ORIGINAL LIGHT FIXTURE - ORIGINAL FIXTURE MOUNTING HARDWARE REMAINS	AM2 FRACTURED RUBBLE STONE UNIT(S)	AW1 DETERIORATED FINISH AT METAL WINDOW FRAME
AD2	ORIGINAL WOOD FRAME IN FAIR CONDITION WITH DETERIORATION PRESENT AT GRADE		AM3 EVIDENCE OF TERRA COTTA SPALLING AM4 FRACTURED TERRA COTTA UNIT(S) AM5 DIAGONAL STEP CRACKING PRESENT AM6 BRICK AT THE PERIMETER OF THE WINDOW APPEARS TO BE IN GOOD CONDITION	AW2 GLAZING UNITS HAVE BEEN PAINTED ON THE INTERIOR FACE AW3 SEALANT AT WINDOW PERIMETER IN POOR CONDITION
		HVAC	AM7 MASONRY STAINING PRESENT AM8 DETERIORATION OF SKYWARD FACING JOINTS OBSERVED AM9 DETERIORATED MORTAR JOINTS PRESENT AM10 FLASHING AND SEALANT IN POOR CONDITION

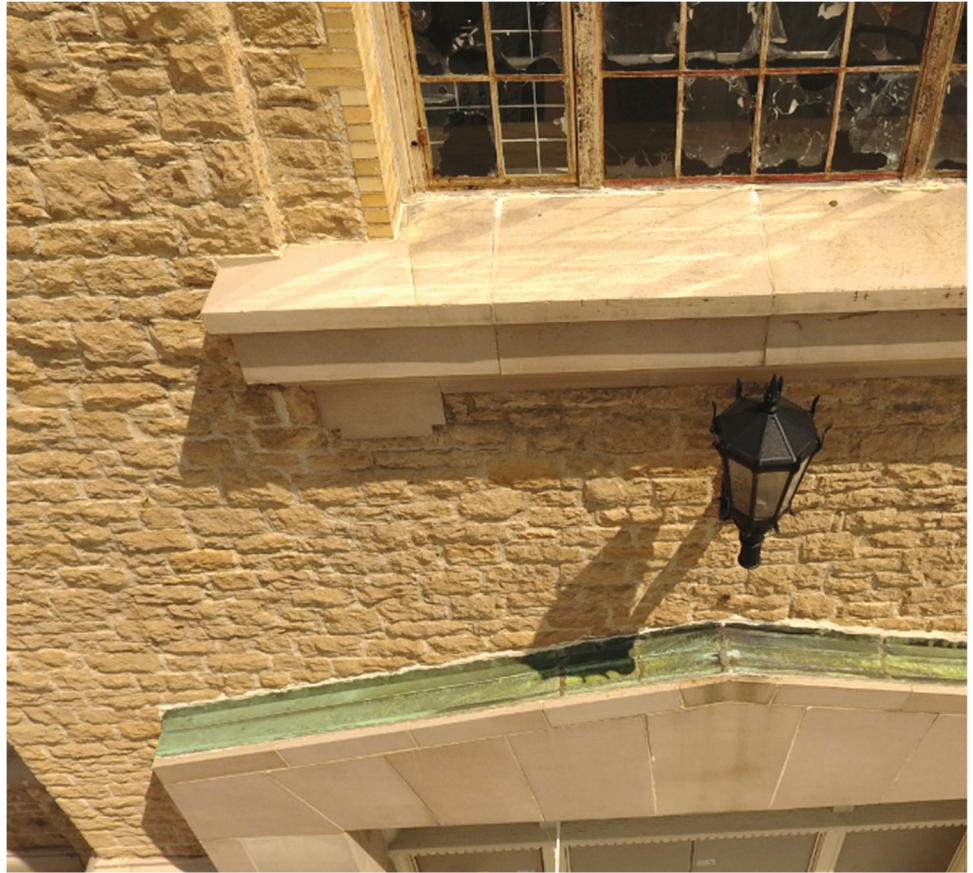
Figure 66: Southeast Entrance Flashing
(JP Cullen May 17, 2018)

The photo to the right is a good example of the poor condition of the sealant at the windows. Moisture infiltration is eminent at these areas and must be treated immediately. Sealant used at the terra cotta door surround has also deteriorated and needs to be replaced. There is no indication that these flashings are of thru-wall condition and as a result, moisture infiltration that occurs above at the window sill will migrate down through the wall system to the door opening.

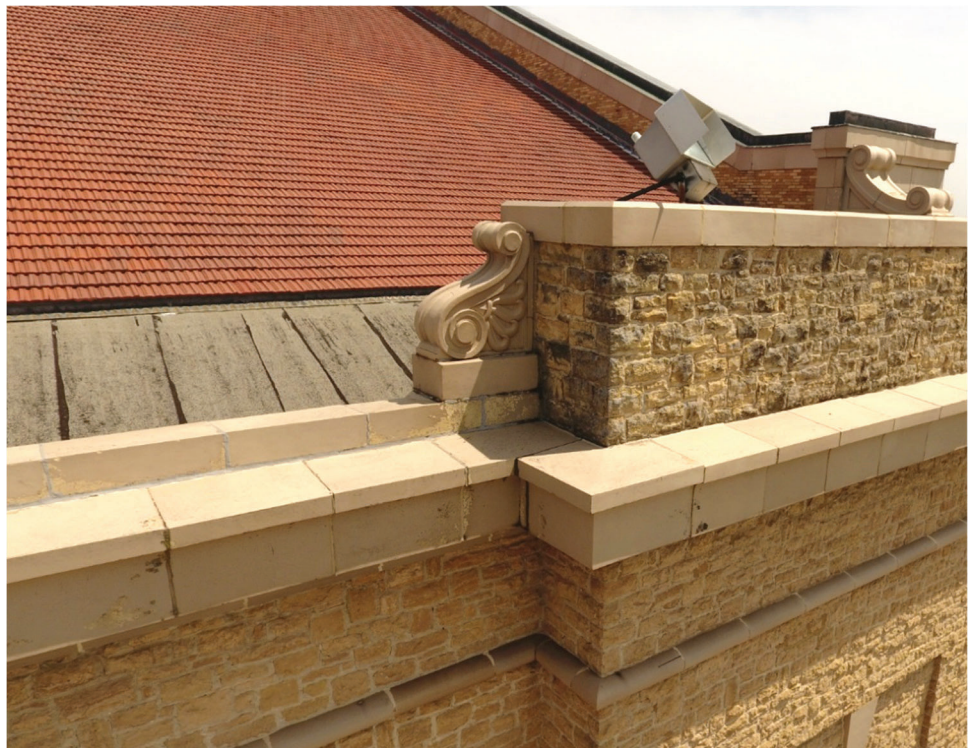
Figure 67: West Roof Parapet
(JP Cullen May 17, 2018)

Bottom photo is a closer view of the typical conditions at the roof edges and parapets. Open joints in the terra cotta cornice are allowing moisture into the wall system as are the deteriorated mortar joints in the rubble stone masonry. Glaze spalling and fractures can be found in many of the terra cotta copings and cornice units.

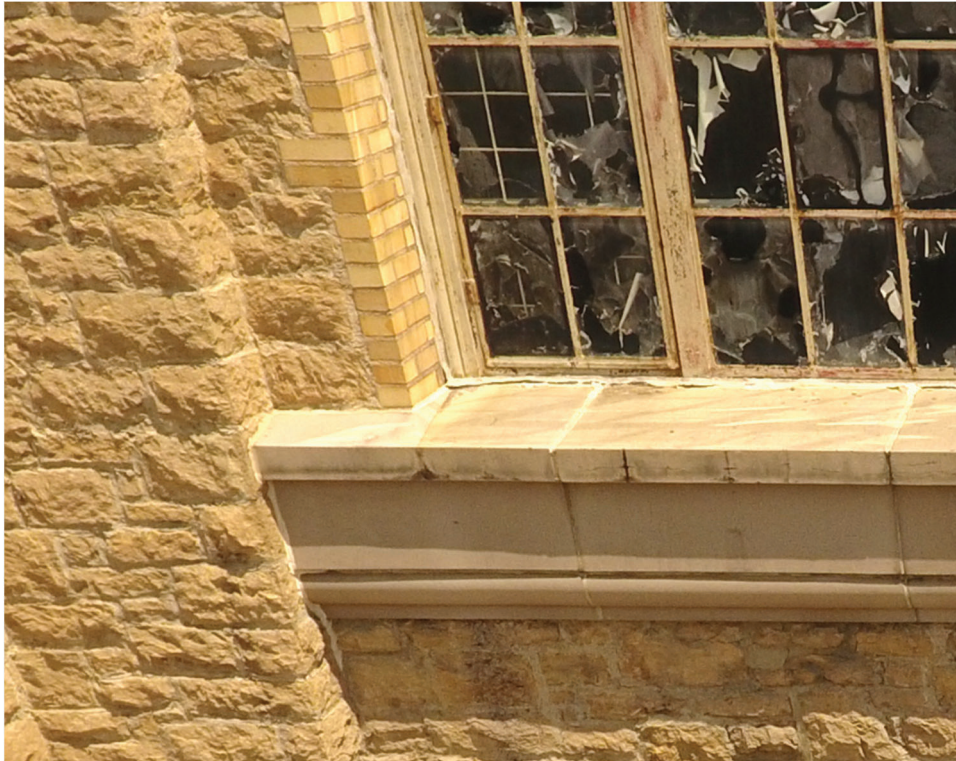
Figure 68: West Window Sill
(JP Cullen May 17, 2018)

Photo to left provides a closer look at the sill condition of the window. Open sealant joints and skyward facing mortar joints in the terra cotta are weak points in the wall system. Photo shows where sealant has been applied to prohibit moisture infiltration.

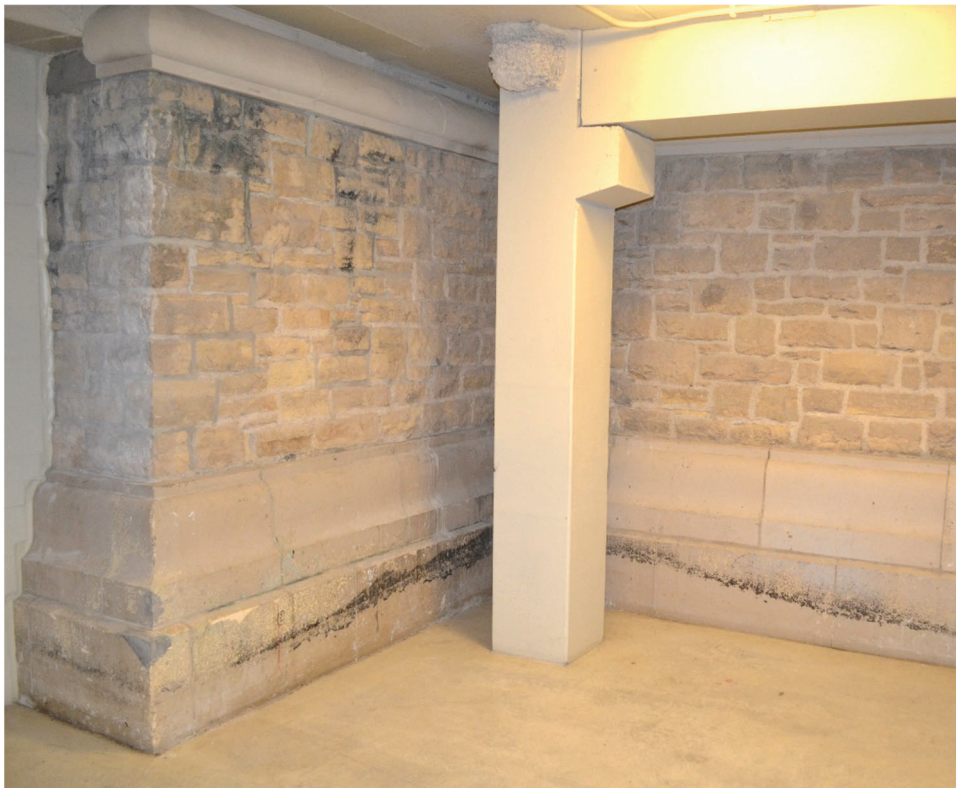
Figure 69: Northwest Corner of Original Field House
(River Architects July 12, 2018)

Bottom left photo shows the interior space at the northwest corner of the Field House where Camp Randall Stadium connects to the building structure. Original exterior walls remain exposed and exhibit the same issues as the masonry on the exterior.

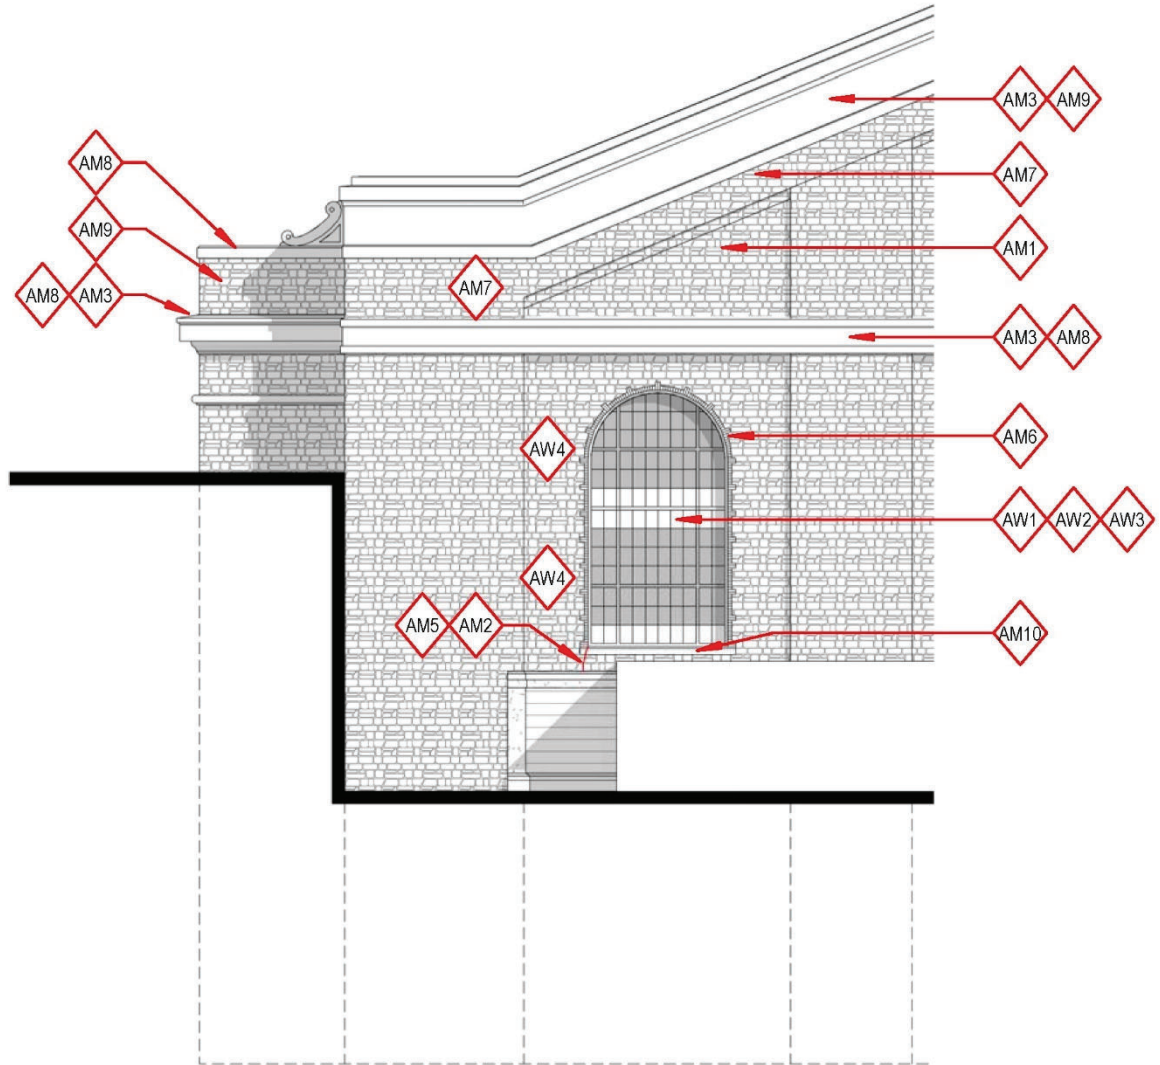
CONDITION ASSESSMENT SUMMARY - NORTH ELEVATION - BAY N1

AM1	EVIDENCE OF PREVIOUS TUCKPOINTING EFFORT WITH NON-MATCHING MORTAR
AM2	FRACTURED RUBBLE STONE UNIT(S)
AM3	EVIDENCE OF TERRA COTTA SPALLING
AM5	DIAGONAL STEP CRACKING PRESENT
AM6	BRICK AT THE PERIMETER OF THE WINDOW APPEARS TO BE IN GOOD CONDITION
AM7	MASONRY STAINING PRESENT
AM8	DETERIORATION OF SKYWARD FACING JOINTS OBSERVED
AM9	DETERIORATED MORTAR JOINTS PRESENT
AM10	FLASHING AND SEALANT IN POOR CONDITION

AW1	DETERIORATED FINISH AT METAL WINDOW FRAME
AW2	GLAZING UNITS HAVE BEEN PAINTED ON THE INTERIOR FACE
AW3	SEALANT AT WINDOW PERIMETER IN POOR CONDITION
AW4	NON-ORIGINAL WINDOW INFILL

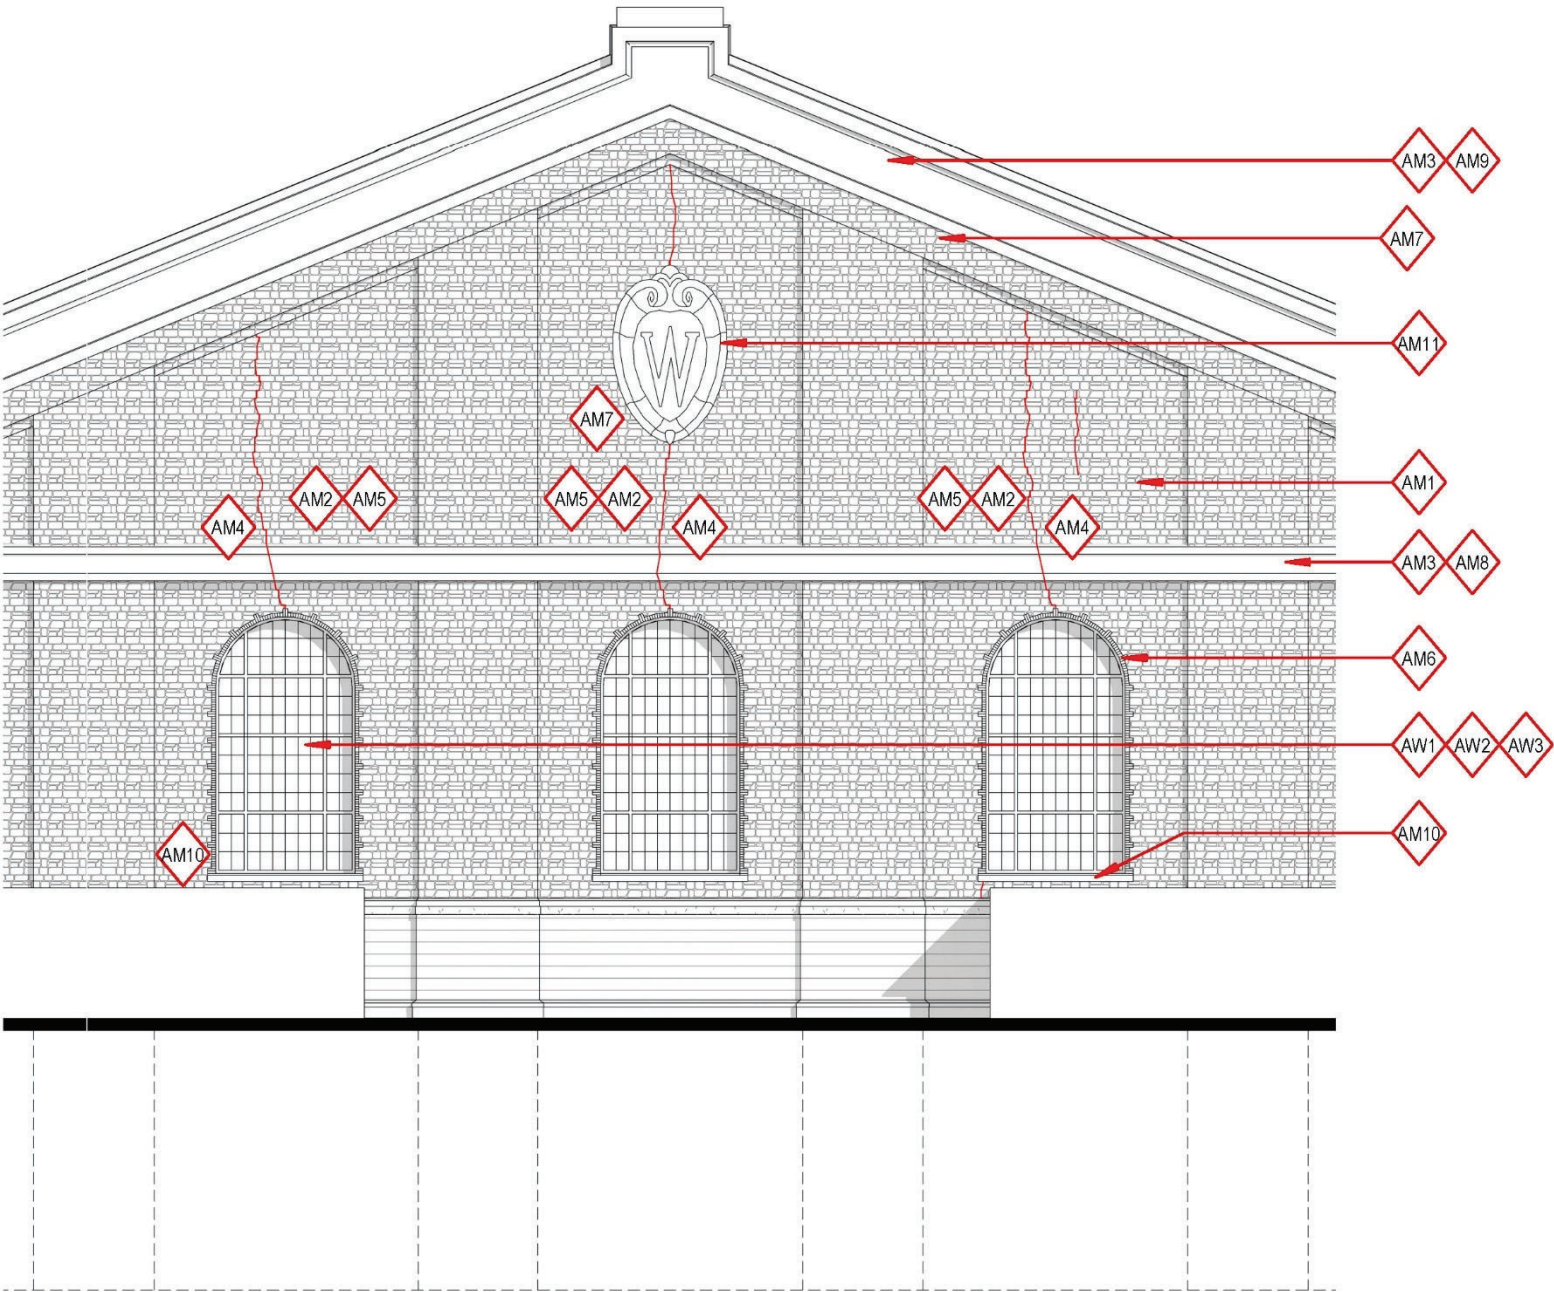
CONDITION ASSESSMENT SUMMARY - NORTH ELEVATION - BAY N2

- AM1 EVIDENCE OF PREVIOUS TUCKPOINTING EFFORT WITH NON-MATCHING MORTAR
- AM2 FRACTURED RUBBLE STONE UNIT(S)
- AM3 EVIDENCE OF TERRA COTTA SPALLING
- AM4 FRACTURED TERRA COTTA UNIT(S)
- AM5 DIAGONAL STEP CRACKING PRESENT
- AM6 BRICK AT THE PERIMETER OF THE WINDOW APPEARS TO BE IN GOOD CONDITION
- AM7 MASONRY STAINING PRESENT
- AM8 DETERIORATION OF SKYWARD FACING JOINTS OBSERVED
- AM9 DETERIORATED MORTAR JOINTS PRESENT
- AM10 FLASHING AND SEALANT IN POOR CONDITION
- AM11 CRACK OBSERVED IN "W" CARTOUCHE

- AW1 DETERIORATED FINISH AT METAL WINDOW FRAME
- AW2 GLAZING UNITS HAVE BEEN PAINTED ON THE INTERIOR FACE
- AW3 SEALANT AT WINDOW PERIMETER IN POOR CONDITION

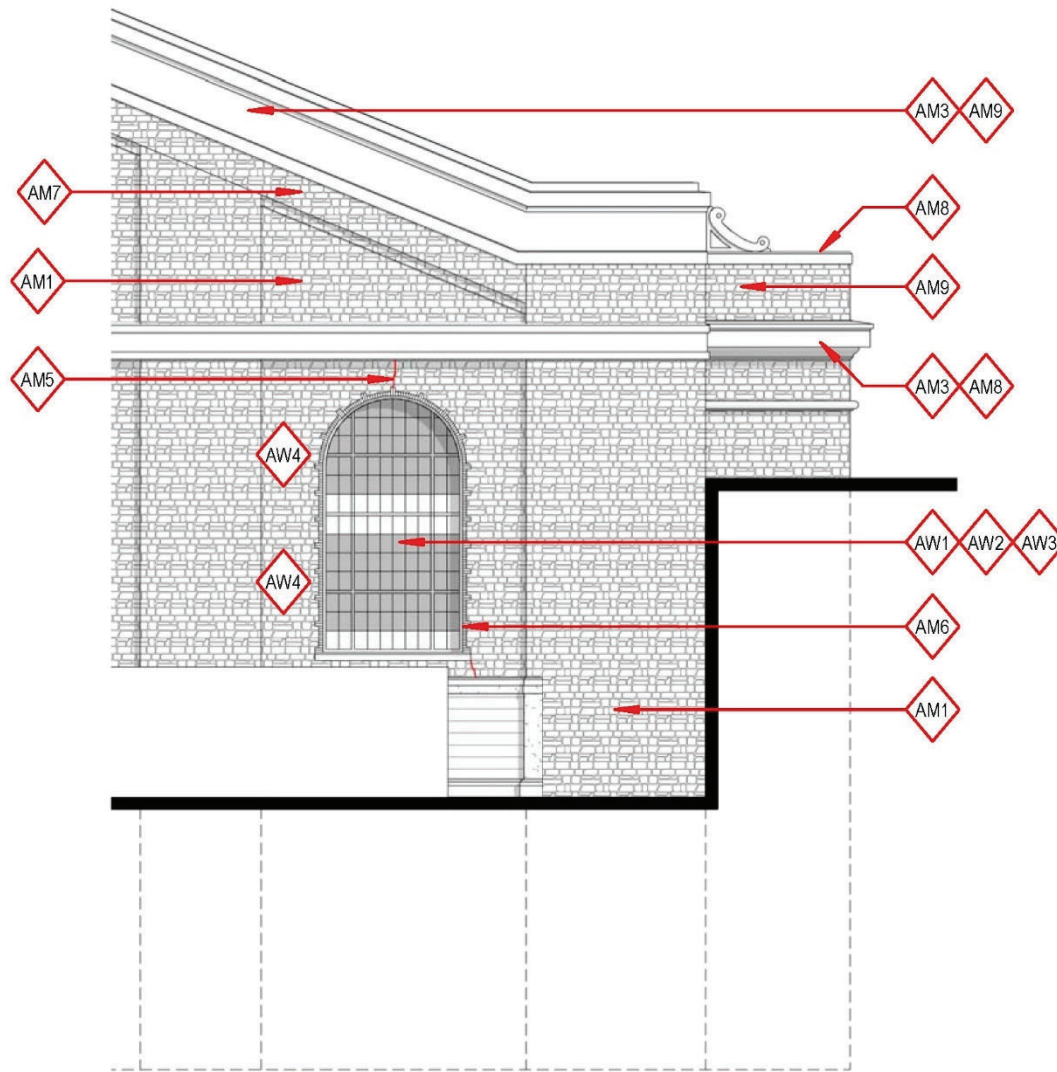
CONDITION ASSESSMENT SUMMARY - NORTH ELEVATION - BAY N3

- AM1 EVIDENCE OF PREVIOUS TUCKPOINTING EFFORT WITH NON-MATCHING MORTAR
- AM3 EVIDENCE OF TERRA COTTA SPALLING
- AM5 DIAGONAL STEP CRACKING PRESENT
- AM6 BRICK AT THE PERIMETER OF THE WINDOW APPEARS TO BE IN GOOD CONDITION
- AM7 MASONRY STAINING PRESENT
- AM8 DETERIORATION OF SKYWARD FACING JOINTS OBSERVED
- AM9 DETERIORATED MORTAR JOINTS PRESENT

- AW1 DETERIORATED FINISH AT METAL WINDOW FRAME
- AW2 GLAZING UNITS HAVE BEEN PAINTED ON THE INTERIOR FACE
- AW3 SEALANT AT WINDOW PERIMETER IN POOR CONDITION
- AW4 NON-ORIGINAL WINDOW INFILL
