EXTERIOR CONDITION ASSESSMENT

For the purposes of this Historic Structure Report, all assessments were made through on-site visual observations conducted in May and July of 2018, high definition photography, and drone photography. Original drawings from 1929 were analyzed and compared to as-built conditions throughout the entire process in an effort to better understand and assess the design intent versus the actual constructed environment.

South Elevation Assessment

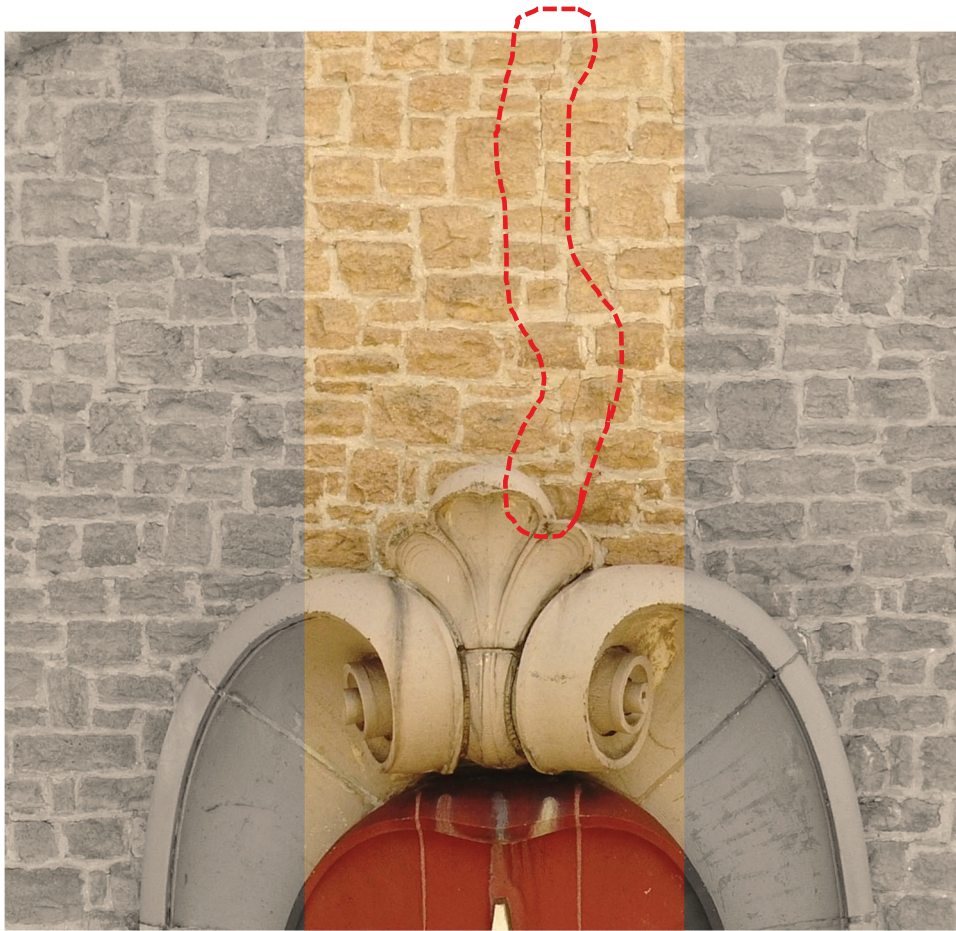
Figure 74: North Elevation Cartouche
(JP Cullen May 17, 2018)

Photo to the left is a good example of the conditions at the Field House. It is only through close observation or high-resolution photography that these hairline cracks can be observed. The fractures in these stone units must be evaluated more closely as it is unknown if the fracture continues through the entire stone unit or if it is only a surface fracture. Fractures above window and door openings likely started as a hairline crack similar to this and continued to deteriorate and separate over the years.

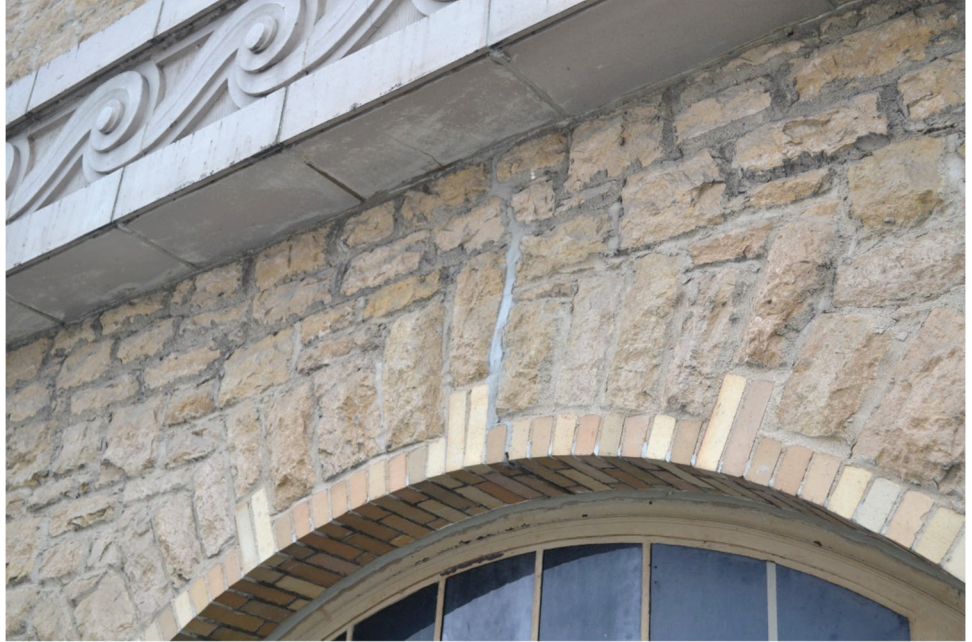
Figure 76: North Elevation Window Head
(River Architects May 3, 2018)

The north wall provides an up-close look at the conditions commonly observed at the Field House. Glaze spalling of the terra cotta trim, deteriorated mortar joints, and fractured rubble stone can all be seen in this photo in the upper right.

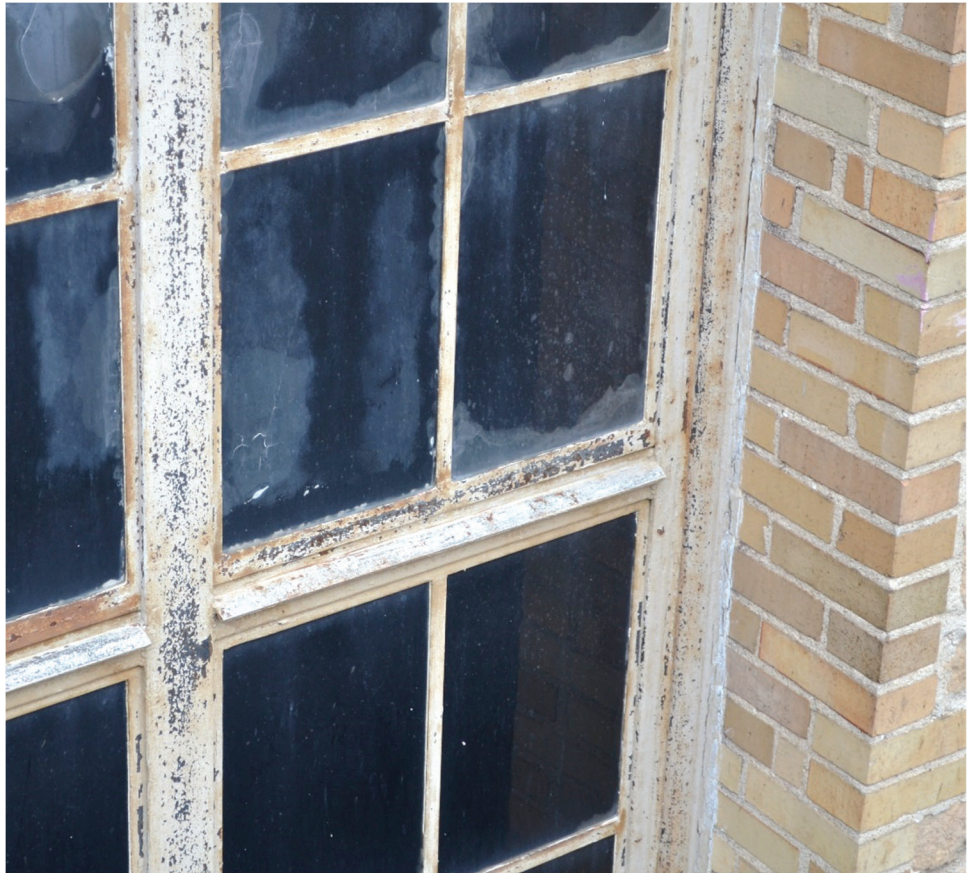
Figure 77: North Elevation Window Jamb
(River Architects May 3, 2018)

The lower right photo is a good example of the typical conditions at the existing windows. Deteriorated paint finishes, open sealant joints, and corrosion of the metal frames. The brick jambs at the windows are commonly found to be in good condition.

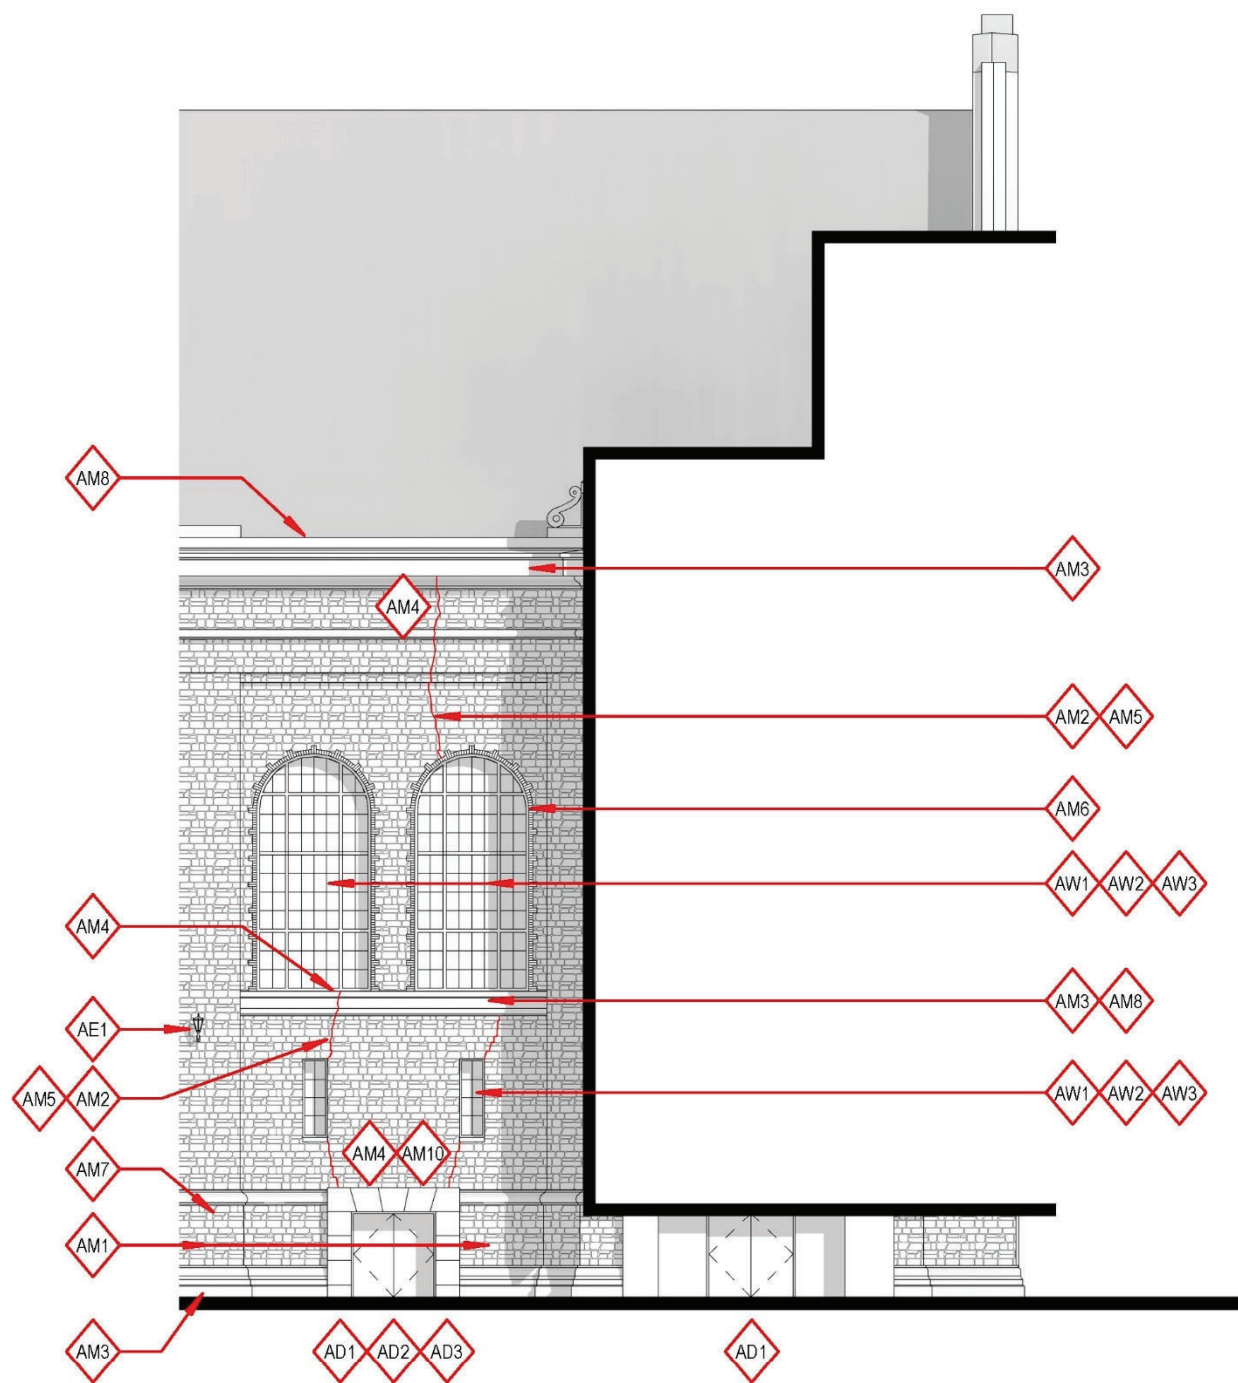
CONDITION ASSESSMENT SUMMARY - EAST ELEVATION - BAY E1

DOORS	ELECTRICAL	MASONRY	WINDOWS
AD1 NON-ORIGINAL HOLLOW METAL DOORS ARE IN GOOD CONDITION	AE1 NON-ORIGINAL LIGHT FIXTURE - ORIGINAL FIXTURE MOUNTING HARDWARE REMAINS	AM1 EVIDENCE OF PREVIOUS TUCKPOINTING EFFORT WITH NON-MATCHING MORTAR	AW1 DETERIORATED FINISH AT METAL WINDOW FRAME
AD2 ORIGINAL WOOD FRAME IN FAIR CONDITION WITH DETERIORATION PRESENT AT GRADE		AM2 FRACTURED RUBBLE STONE UNIT(S)	AW2 GLAZING UNITS HAVE BEEN PAINTED ON THE INTERIOR FACE
AD3 SEALANT AT DOOR PERIMETER IN POOR CONDITION		AM3 EVIDENCE OF TERRA COTTA SPALLING	AW3 SEALANT AT WINDOW PERIMETER IN POOR CONDITION
		AM4 FRACTURED TERRA COTTA UNIT(S)	
		AM5 DIAGONAL STEP CRACKING PRESENT	
		AM6 BRICK AT THE PERIMETER OF THE WINDOW APPEARS TO BE IN GOOD CONDITION	
		AM7 MASONRY STAINING PRESENT	
		AM8 DETERIORATION OF SKYWARD FACING JOINTS OBSERVED	
		AM10 FLASHING AND SEALANT IN POOR CONDITION

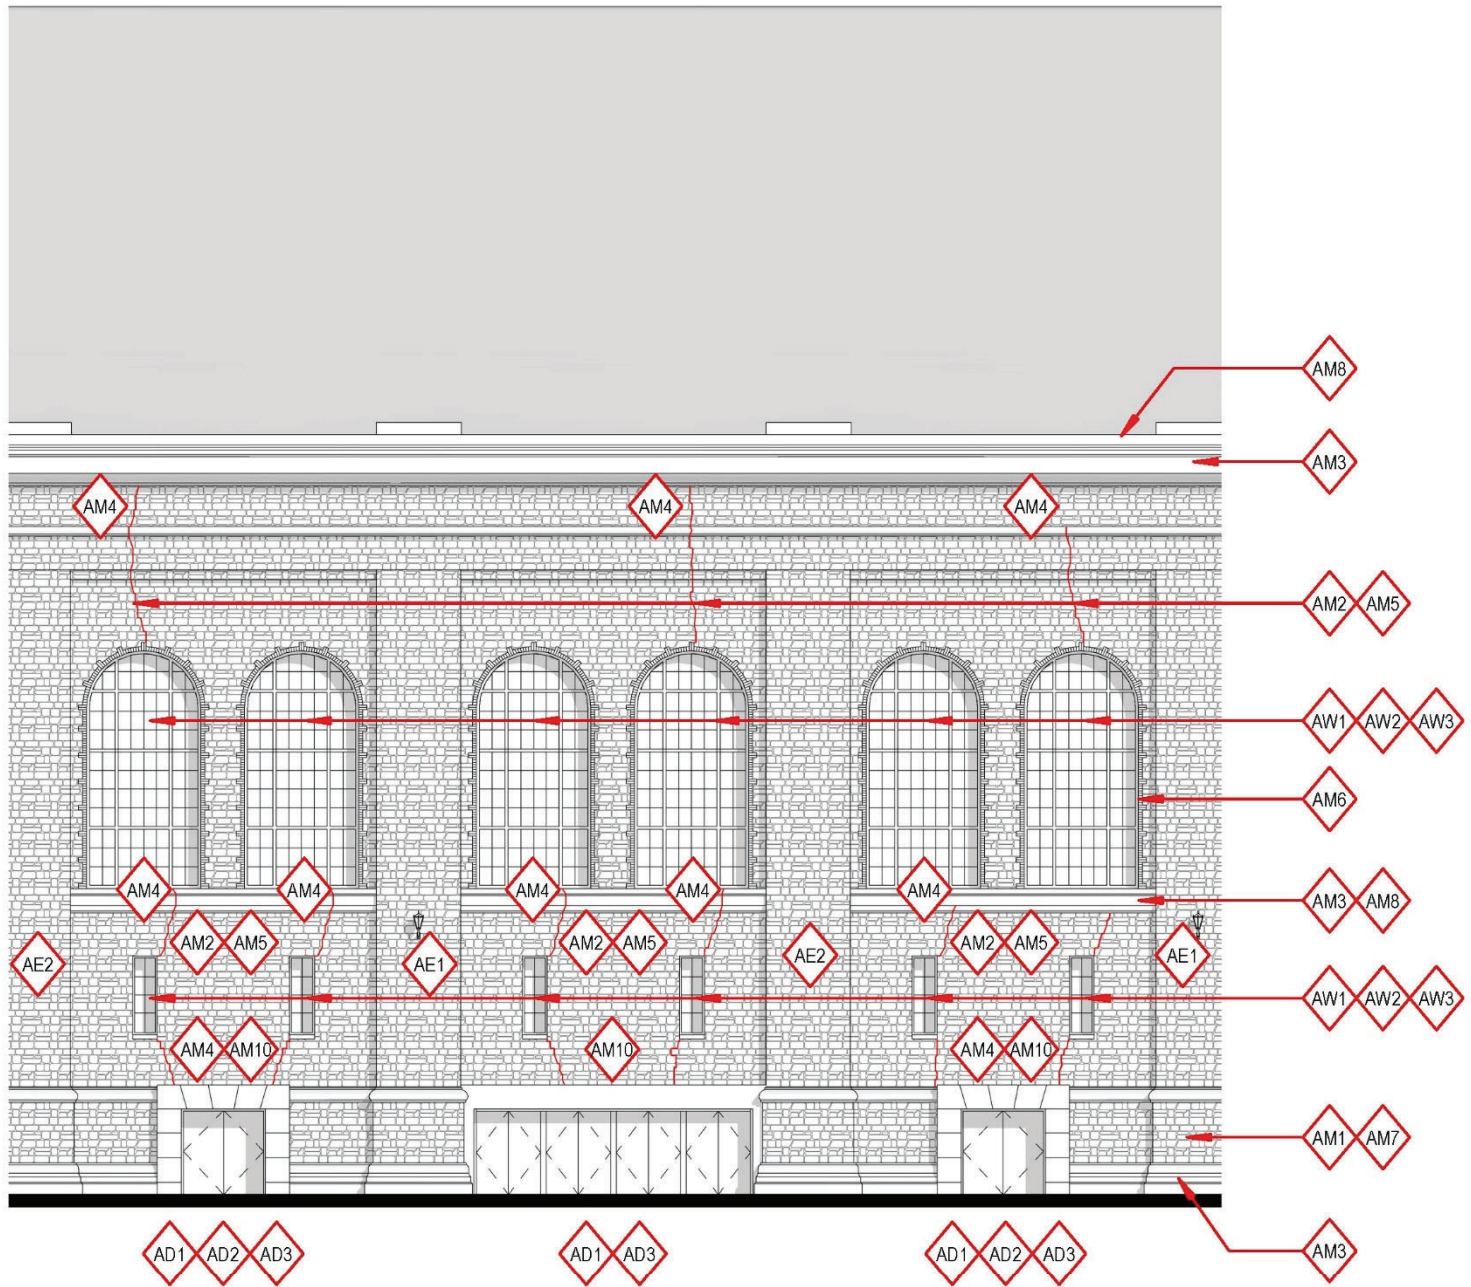
CONDITION ASSESSMENT SUMMARY - EAST ELEVATION - BAY E2

DOORS	ELECTRICAL	MASONRY	WINDOWS
AD1 NON-ORIGINAL HOLLOW METAL DOORS ARE IN GOOD CONDITION	AE1 NON-ORIGINAL LIGHT FIXTURE - ORIGINAL FIXTURE MOUNTING HARDWARE REMAINS	AM1 EVIDENCE OF PREVIOUS TUCKPOINTING EFFORT WITH NON-MATCHING MORTAR	AW1 DETERIORATED FINISH AT METAL WINDOW FRAME
AD2 ORIGINAL WOOD FRAME IN FAIR CONDITION WITH DETERIORATION PRESENT AT GRADE	AE2 LIGHT FIXTURE MISSING - ORIGINAL FIXTURE MOUNTING HARDWARE REMAINS	AM2 FRACTURED RUBBLE STONE UNIT(S)	AW2 GLAZING UNITS HAVE BEEN PAINTED ON THE INTERIOR FACE
AD3 SEALANT AT DOOR PERIMETER IN POOR CONDITION		AM3 EVIDENCE OF TERRA COTTA SPALLING	AW3 SEALANT AT WINDOW PERIMETER IN POOR CONDITION
		AM4 FRACTURED TERRA COTTA UNIT(S)	
		AM5 DIAGONAL STEP CRACKING PRESENT	
		AM6 BRICK AT THE PERIMETER OF THE WINDOW APPEARS TO BE IN GOOD CONDITION	
		AM7 MASONRY STAINING PRESENT	
		AM8 DETERIORATION OF SKYWARD FACING JOINTS OBSERVED	
		AM10 FLASHING AND SEALANT IN POOR CONDITION

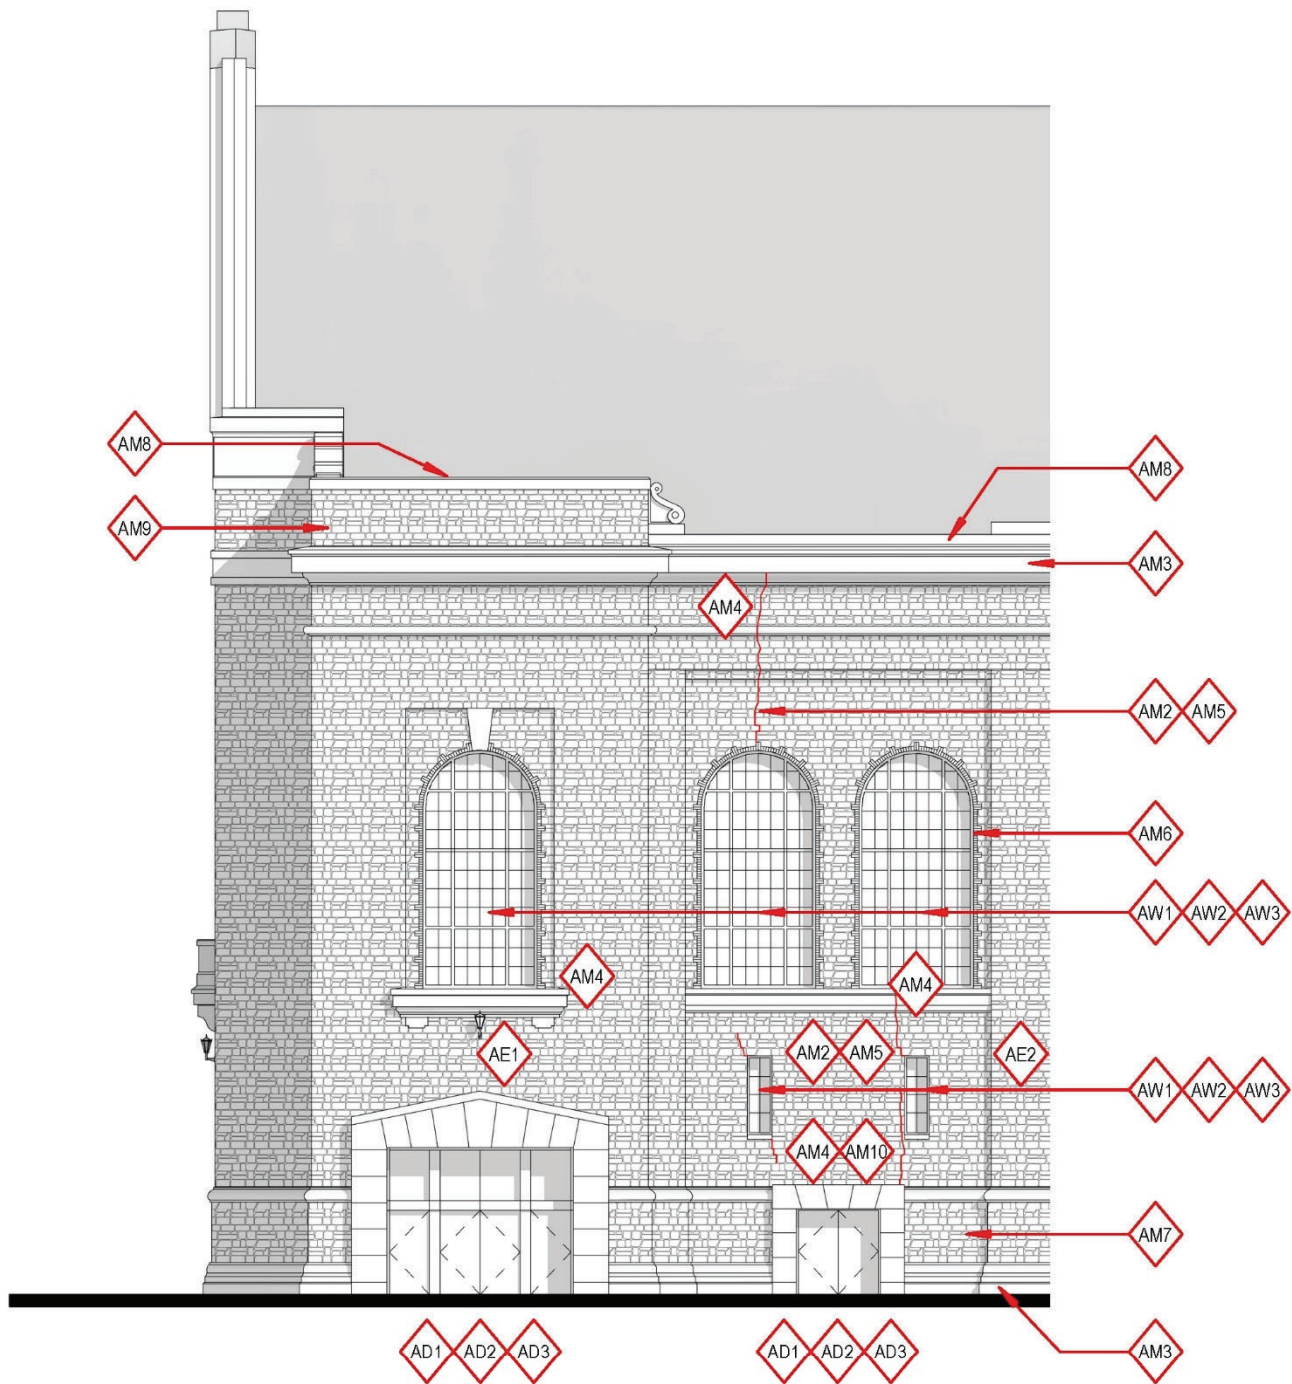
CONDITION ASSESSMENT SUMMARY - EAST ELEVATION - BAY E3

DOORS	ELECTRICAL	MASONRY	WINDOWS
AD1 NON-ORIGINAL HOLLOW METAL DOORS ARE IN GOOD CONDITION	AE1 NON-ORIGINAL LIGHT FIXTURE - ORIGINAL FIXTURE MOUNTING HARDWARE REMAINS	AM2 FRACTURED RUBBLE STONE UNIT(S)	AW1 DETERIORATED FINISH AT METAL WINDOW FRAME
AD2 ORIGINAL WOOD FRAME IN FAIR CONDITION WITH DETERIORATION PRESENT AT GRADE	AE2 LIGHT FIXTURE MISSING - ORIGINAL FIXTURE MOUNTING HARDWARE REMAINS	AM3 EVIDENCE OF TERRA COTTA SPALLING	AW2 GLAZING UNITS HAVE BEEN PAINTED ON THE INTERIOR FACE
AD3 SEALANT AT DOOR PERIMETER IN POOR CONDITION		AM4 FRACTURED TERRA COTTA UNIT(S)	AW3 SEALANT AT WINDOW PERIMETER IN POOR CONDITION
		AM5 DIAGONAL STEP CRACKING PRESENT	
		AM6 BRICK AT THE PERIMETER OF THE WINDOW APPEARS TO BE IN GOOD CONDITION	
		AM7 MASONRY STAINING PRESENT	
		AM8 DETERIORATION OF SKYWARD FACING JOINTS OBSERVED	
		AM9 DETERIORATED MORTAR JOINTS PRESENT	
		AM10 FLASHING AND SEALANT IN POOR CONDITION

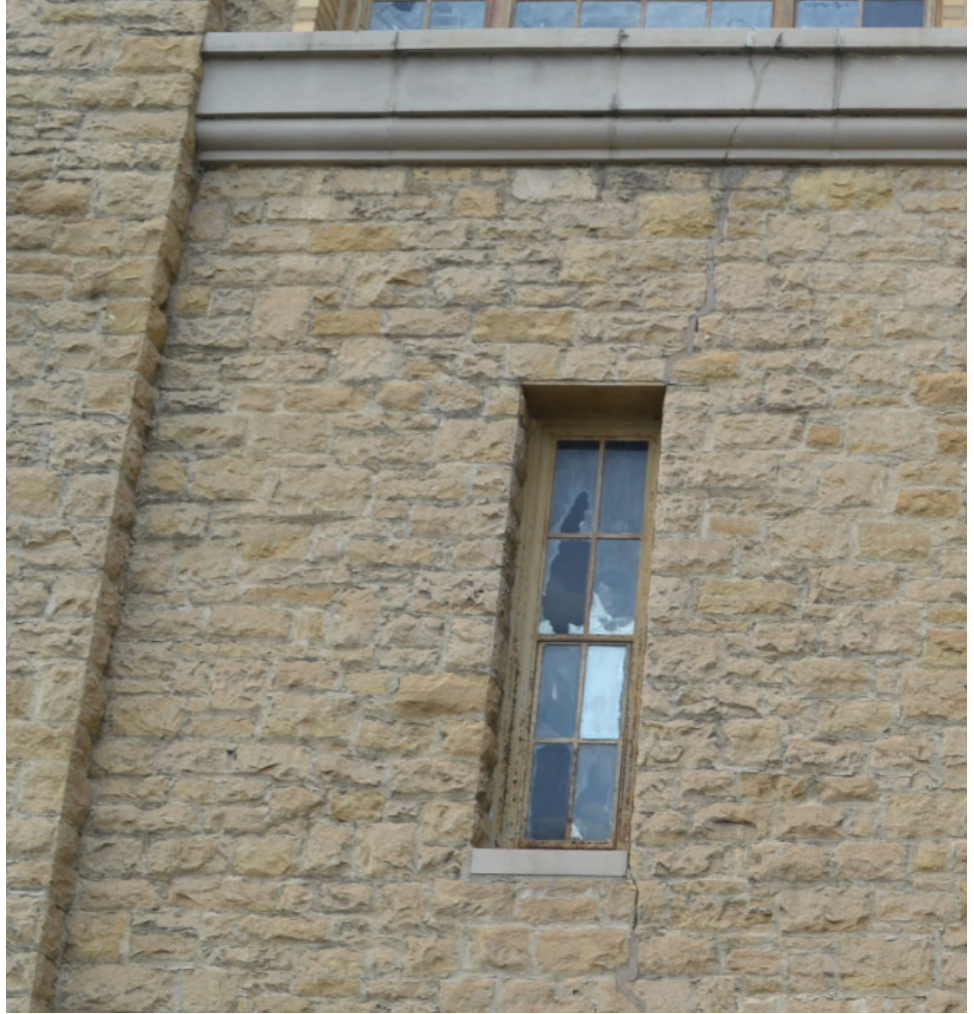
Figure 82: East Elevation Window
(River Architects July 12, 2018)

Common to many of the windows located between the ground floor and the first balcony, step cracking can be found at the lintel and continuing upward to the window and sill of the upper level. Step cracking can also be seen continuing downward from the sill to the door surround below. While this crack often times is found in the mortar joint, there are numerous fractures found in the rubble stone as well.

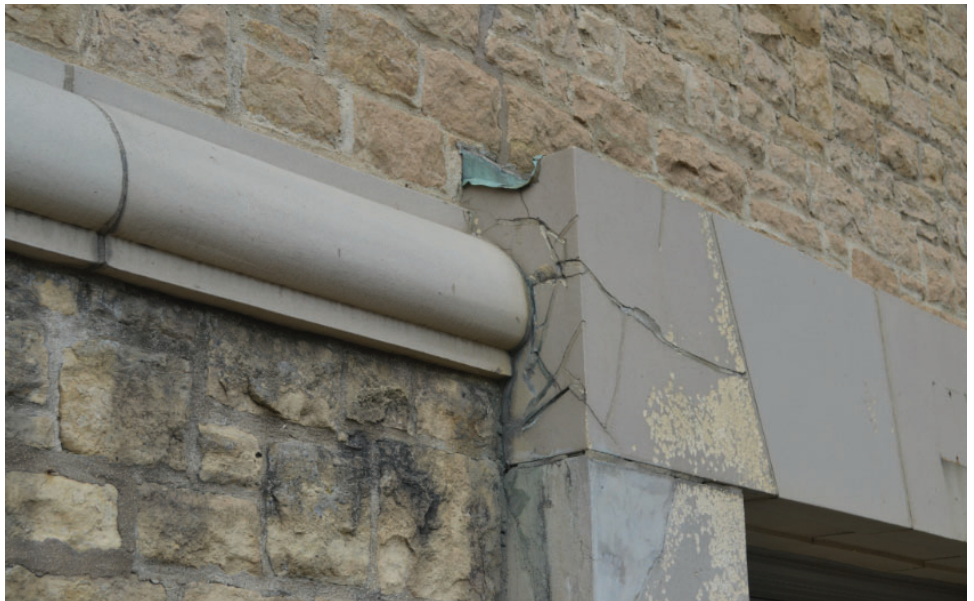
Figure 83: East Elevation Door Surround
(River Architects July 12, 2018)

Photo to the right shows just how deteriorated the terra cotta at the door surrounds can be. Evidence of previous repairs were observed. Flashing and sealant above the terra cotta is in poor condition. Fractures can be seen in the rubble stone from the step cracking above.
