INTERIOR CONDITION ASSESSMENT

STRUCTURAL SYSTEMS

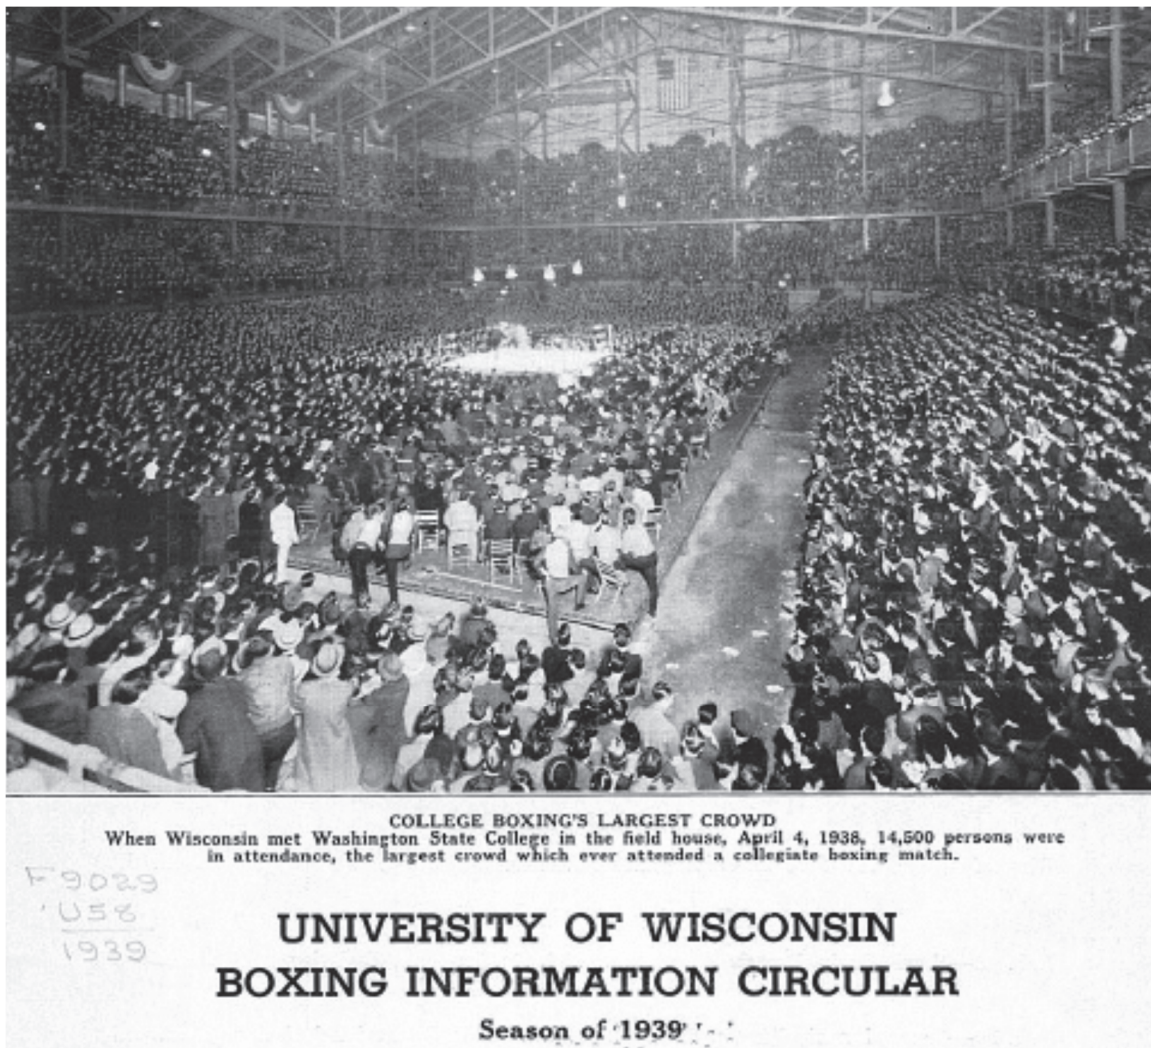
Figure 109: Field House with Bleachers and Floor Seating for Boxing Match
(UW Archives 1938)

Sheet 7 of the circa-1929 drawings shows seating at the lower level of the Field House. There is no seating shown on Sheet 7 inside of the upper balcony, although archival photos indicate that bleachers were used to provide additional seating for events where the 1/8 mile running track was not in use, as shown in Figure 4. We were unable to find information regarding these bleachers; it is possible that they were added after the original construction. The Wisconsin Historical Society shows some circa-1949 photos that indicate “new” wood bleachers, replacing whatever had been used up to that point. New permanent fixed seating on the north, west, and south sides of the Field House was added as part of circa-1976 renovations, along with retractable bleachers on the east side.

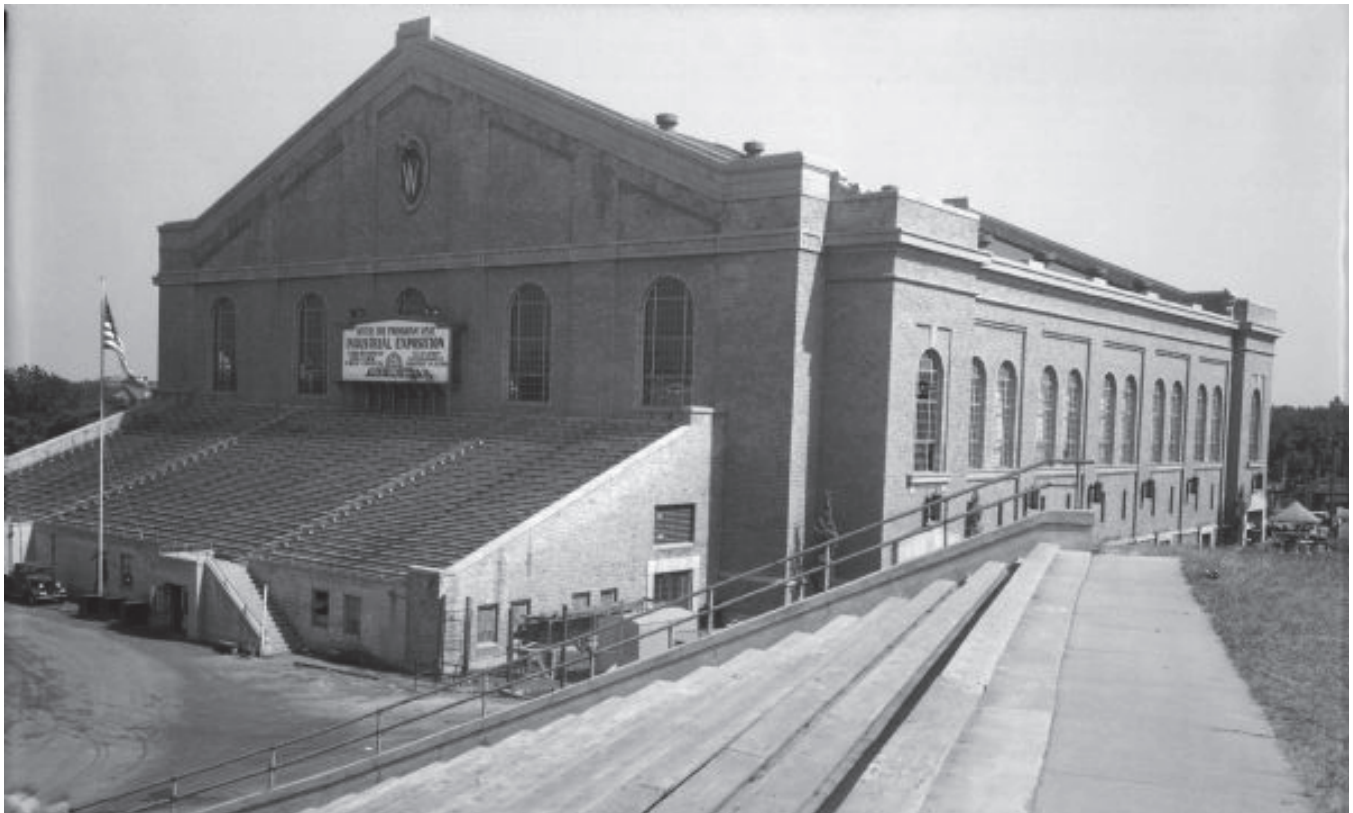
Figure 110: Fixed Seating on North End of Field House
(Wisconsin Historical Society 1936)

Sheet 8 of the circa-1929 drawings shows the upper balcony and the roof, including double glazed skylights at the three center bays. The roof plan indicates a total of (20) 36” diameter ventilation hoods (ten on each side; the hoods on the west side of the building are visible in Figure 110 below).

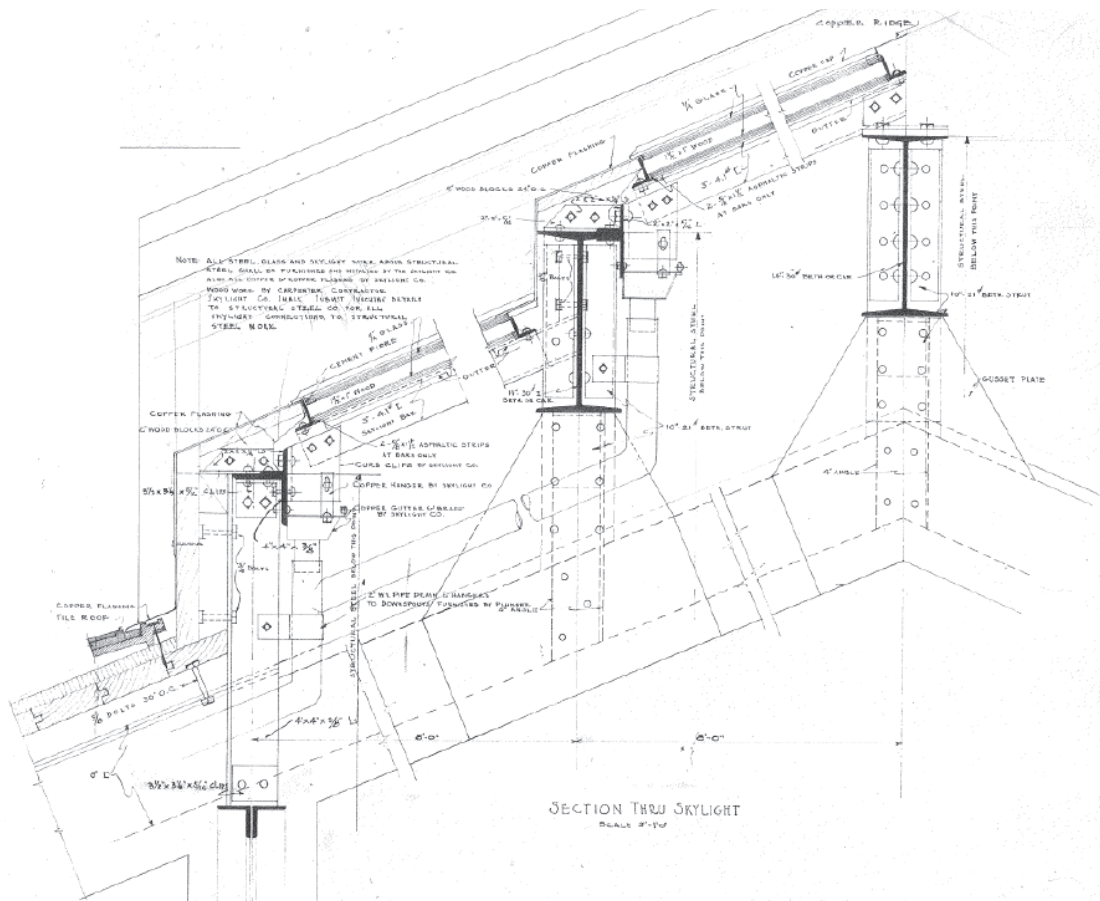
Figure 111: Skylight Framing (Original Construction Drawings 1929)

Sheets 10-13 of the circa-1929 drawings show how the structural framing relates to the exterior facade. Sheet 10 and 11 show that the door frames were anchored into the cast-in-place concrete backup walls. Sheet 12 shows window and skylight framing. It is understood that the skylights were later filled in, but drawings have not yet been located showing such work. It is uncertain whether the infill could be easily removed if ever desired. See Figure 111.
