Part II

Treatment and Work Recommendations

WISCONSIN
UNIVERSITY OF WISCONSIN-MADISON

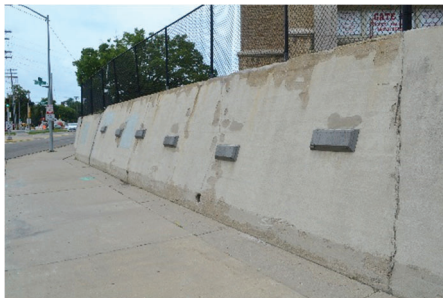
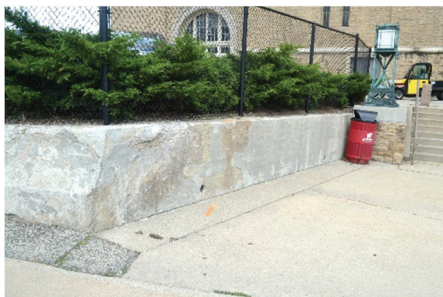
Figure 150: South Retaining Wall
(River Architects July 12, 2018)

Figure 151: South Retaining Wall
(River Architects July 12, 2018)

The concrete retaining wall consists of a board-formed texture that has been covered over the years with a cementitious parging. The wall is in poor condition overall.

Due to the amount of work being proposed for the south plaza area, the concrete stairs and metal railings are being proposed for replacement while this work is taking place.

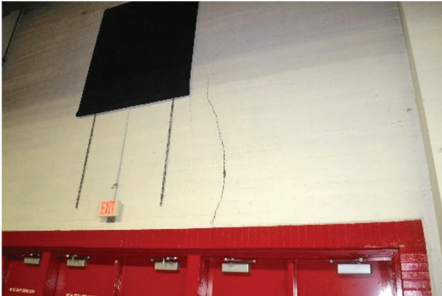
Figure 163: Exterior Wall Fracture
(River Architects July 12, 2018)

Priority	High
Degree of Integrity	High
Proposed Treatment	Preserve/Rehabilitate
Life Safety & Accessibility	Fractures in the exterior wall pose potential issues in the wall assembly if not treated properly.
Potential Impacts of Treatment	Treatment of these exterior walls will enhance the interior appearance of the building.

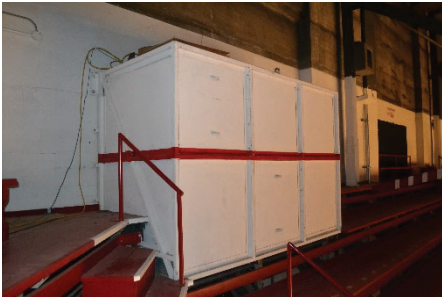
Figure 164: Abandoned Speaker Enclosure
(River Architects July 12, 2018)

Located at the north end of the Field House, abandoned loudspeaker enclosures at two of the large window openings are no longer serving any purpose. These non-original enclosures are in good condition overall.

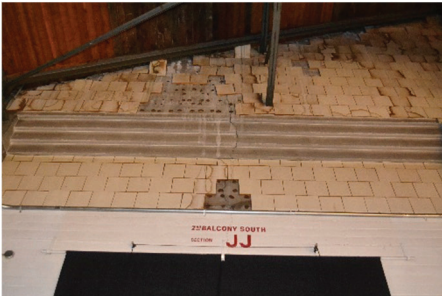
Deteriorated acoustical wall panels located at the south end of the arena are losing their bond to the exterior wall surface. It is suggested to remove these panels, provide a new wall paint and install new fabric wrapped, surface applied acoustical wall panels or some other form of surface-applied, non-permanent wall treatment.

Figure 165: Acoustical Wall Treatment
(River Architects July 12, 2018)

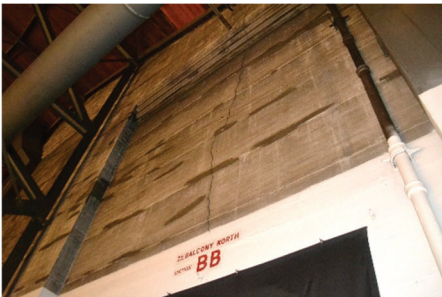
Figure 166: Exterior Wall Fracture
(River Architects July 12, 2018)
