Paint Analysis and Investigation
UNIVERSITY OF WISCONSIN
FIELD HOUSE

Madison, Wisconsin

Submitted by Ron Koenig, Conservator
Building Arts & Conservation

November 17, 2018

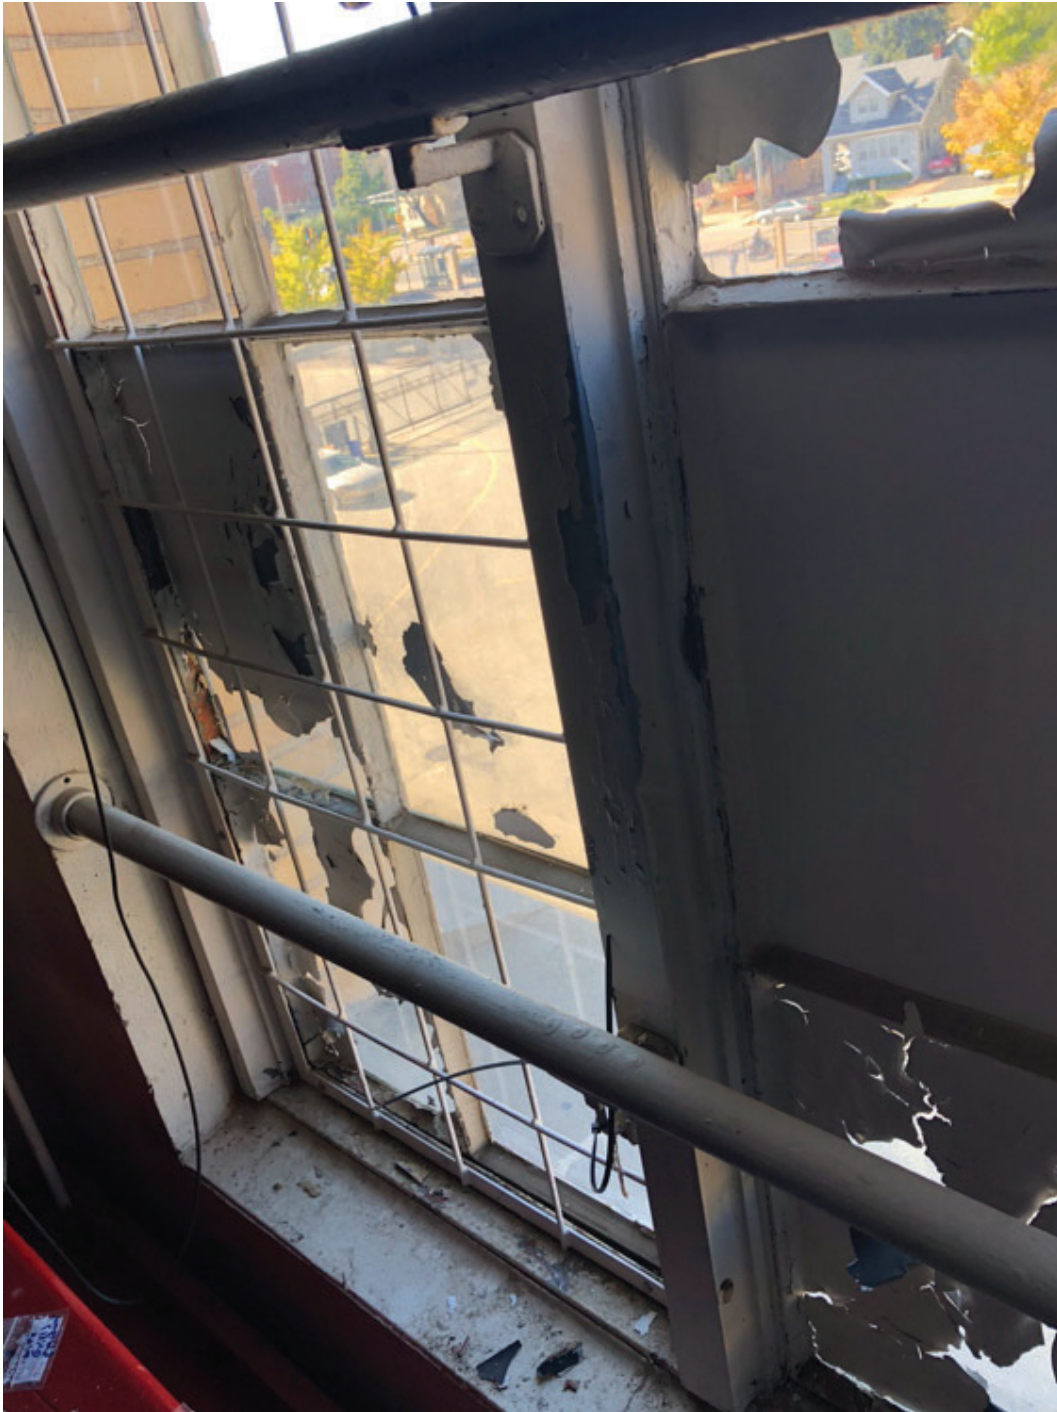
The upper, arched, steel casement windows have not fared well in Madison's harsh climate (Photo 01). Much of their paint has cracked and peeled, leaving areas of bare metal. Although some of the steel shows rust, the window units are generally in remarkably good condition, and with little restoration and reinstatement of their hardware could function as they were designed.

Plate 01: Much of The Paint On The Building's Upper Windows Is Failing, But The Windows Themselves Are In Relatively Good Overall Condition

All of the Field House's metal windows were first primed (probably at their factory) with a bright orange yellow chromate/red lead primer, inside and out. At some point in their history the inside window surfaces were coated in a lead-bearing gloss-black paint to darken the inside of the arena, but most of this paint has failed. Remediation and professional abatement should be carried out through first manually removing loose fragments, then following with chemical paint strippers to remove any remaining LBP (Lead-Based Paint). A good choice for paint remover is MasonRE S-303®, manufactured by Cathedral Stone Products, in Hanover, MD. This paint remover is non-toxic, environmentally friendly, and will very effectively remove the paint without causing the level of lead hazard dry removal would create. All paint removal procedures should of course be carried out by certified, abatement professionals.

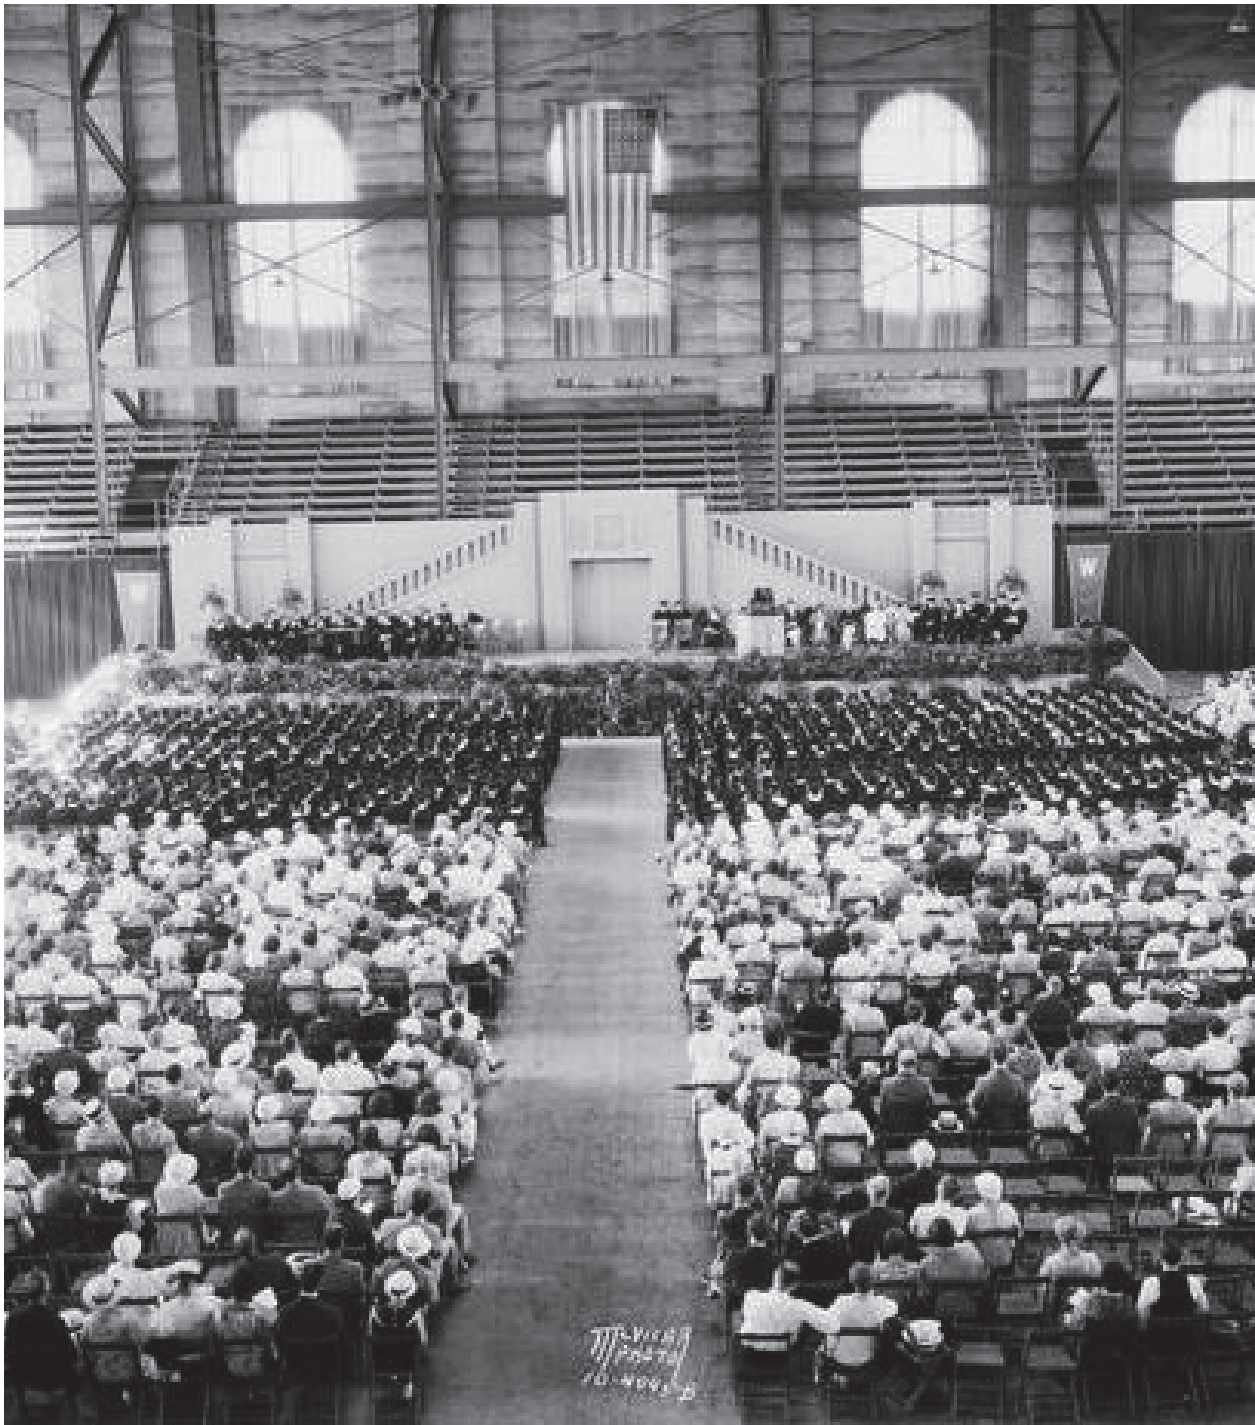
Plate 04: Graduation In The Field House In 1933; The Walls Appear To Have Been Unfinished

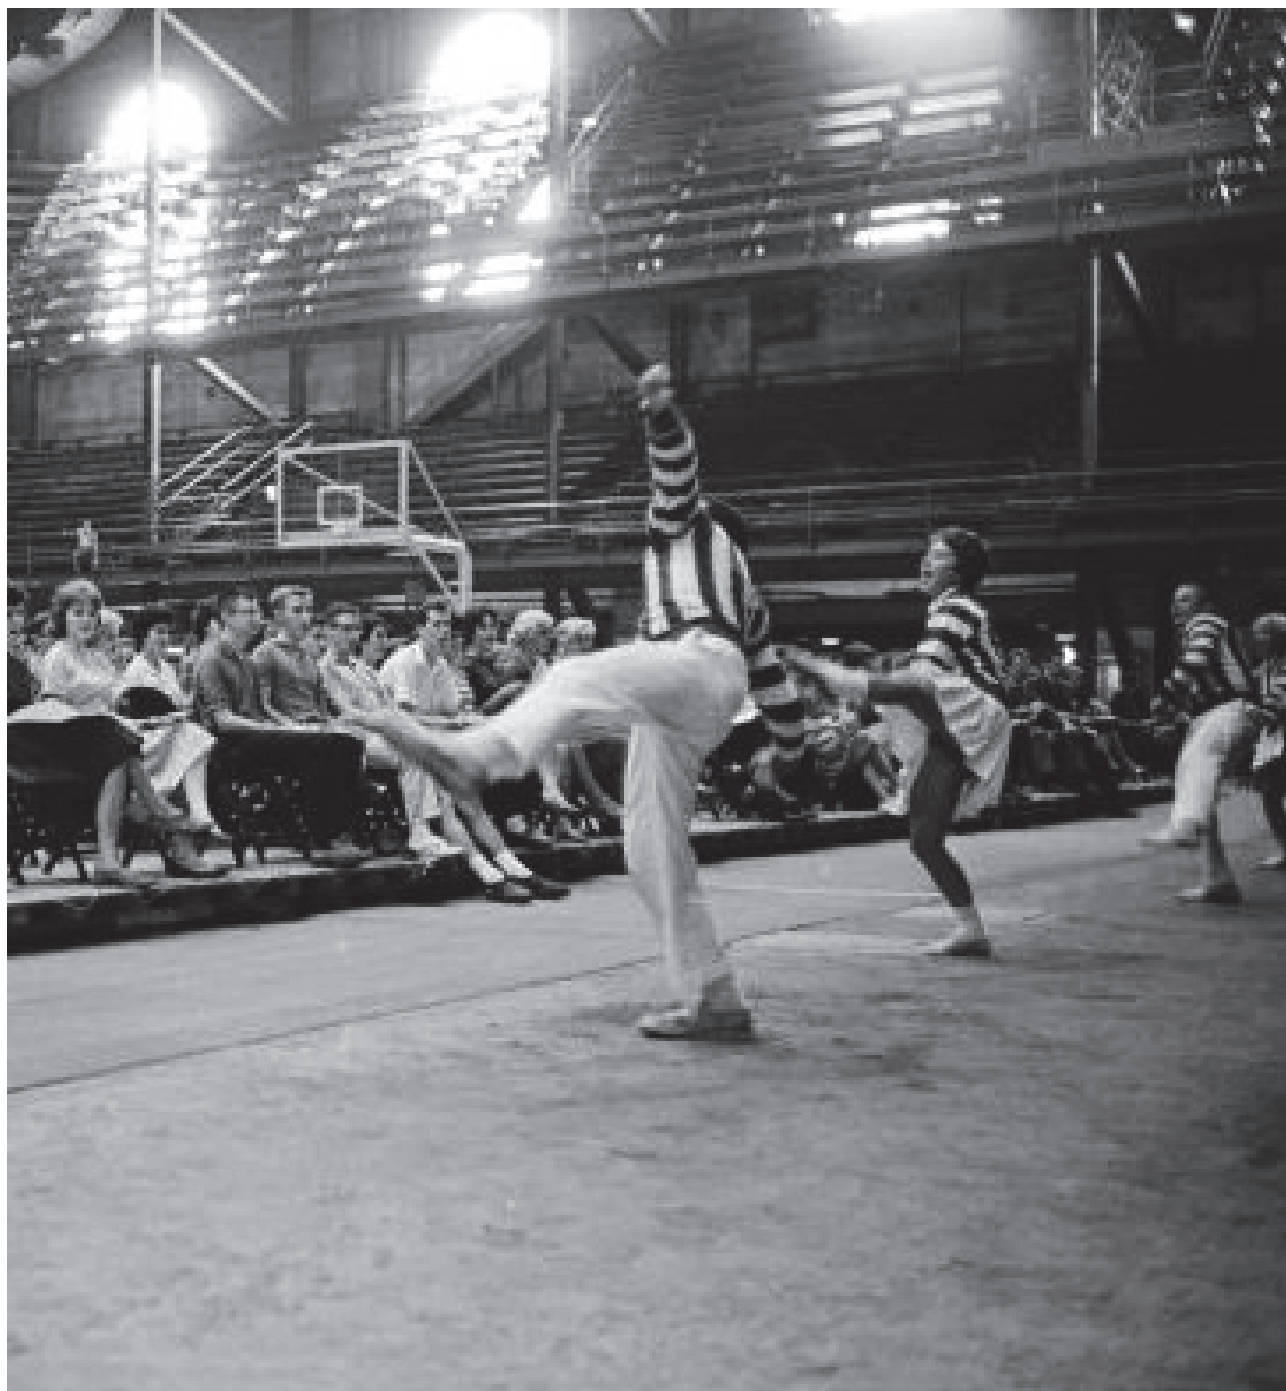
Plate 05: The Walls Still Appear To Be Unfinished In This 1961 Cheerleading Photograph

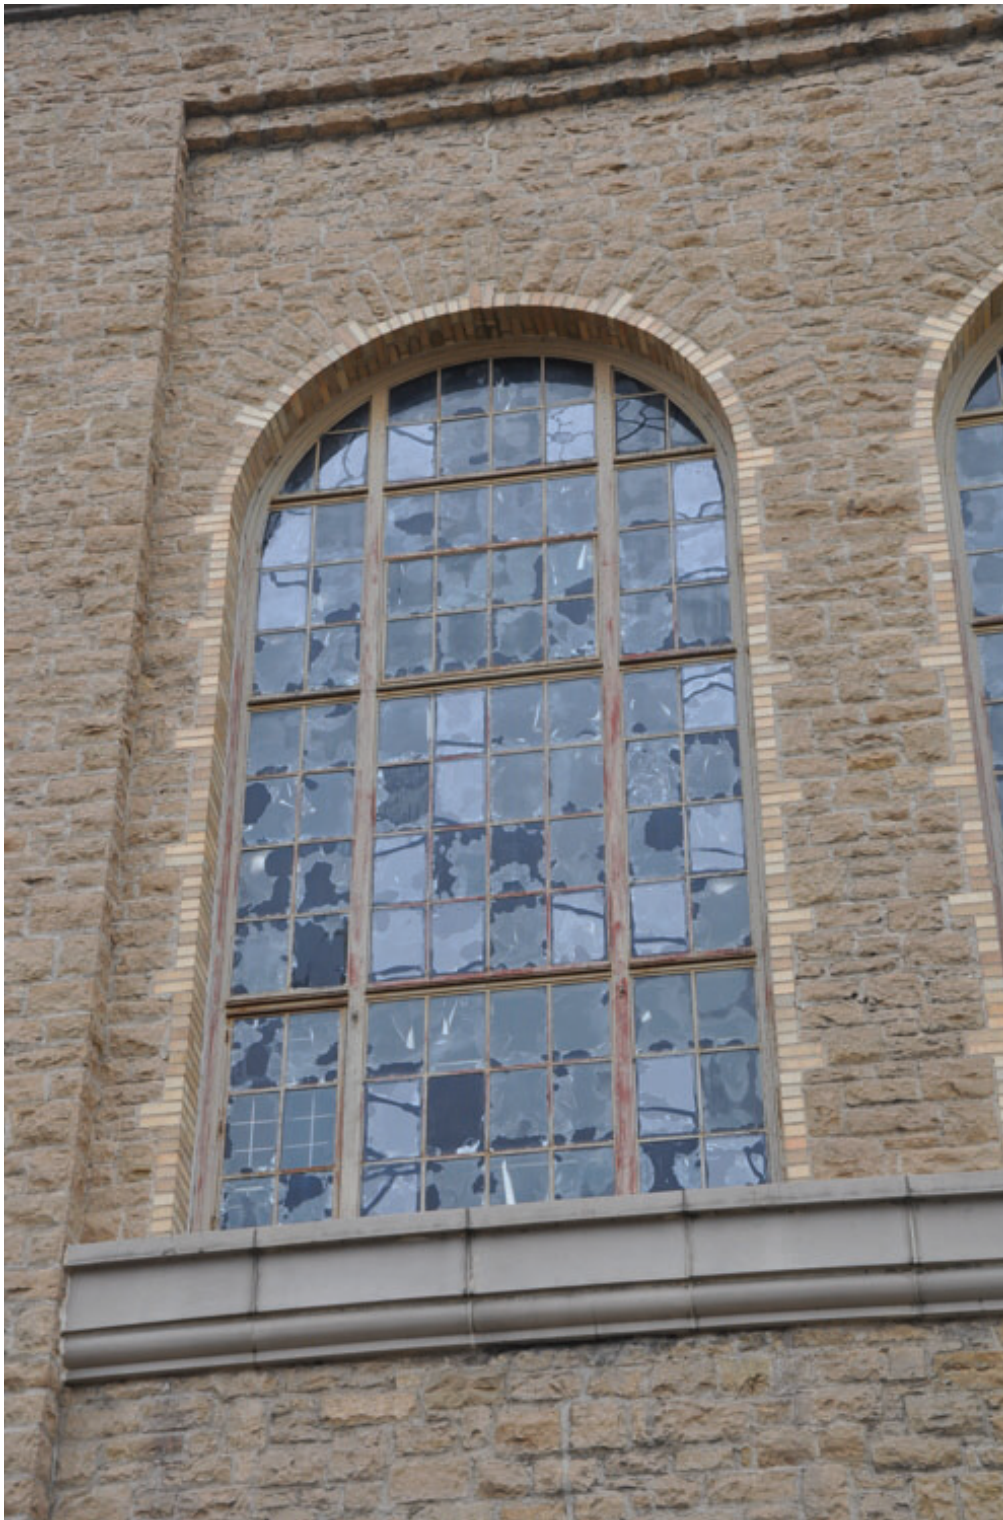
The outside surfaces of the Field House windows are in a similar condition to their inside surfaces, showing an appreciable percentage of soiling, cracking, peeling, and general loss (Photo 6). Both the upper and lower windows had the same stratigraphy; they were first painted a light gray-green (SW 6177), followed shortly after by a medium-yellow buff (SW 7691); after some time, they were repainted a light gray, then later a light gray-brown, and finally their current off-white color (Photo 07).

Plate 06: The Field House Windows Are In Good Structural Condition, But Much Of Their Exterior Paint Has Failed

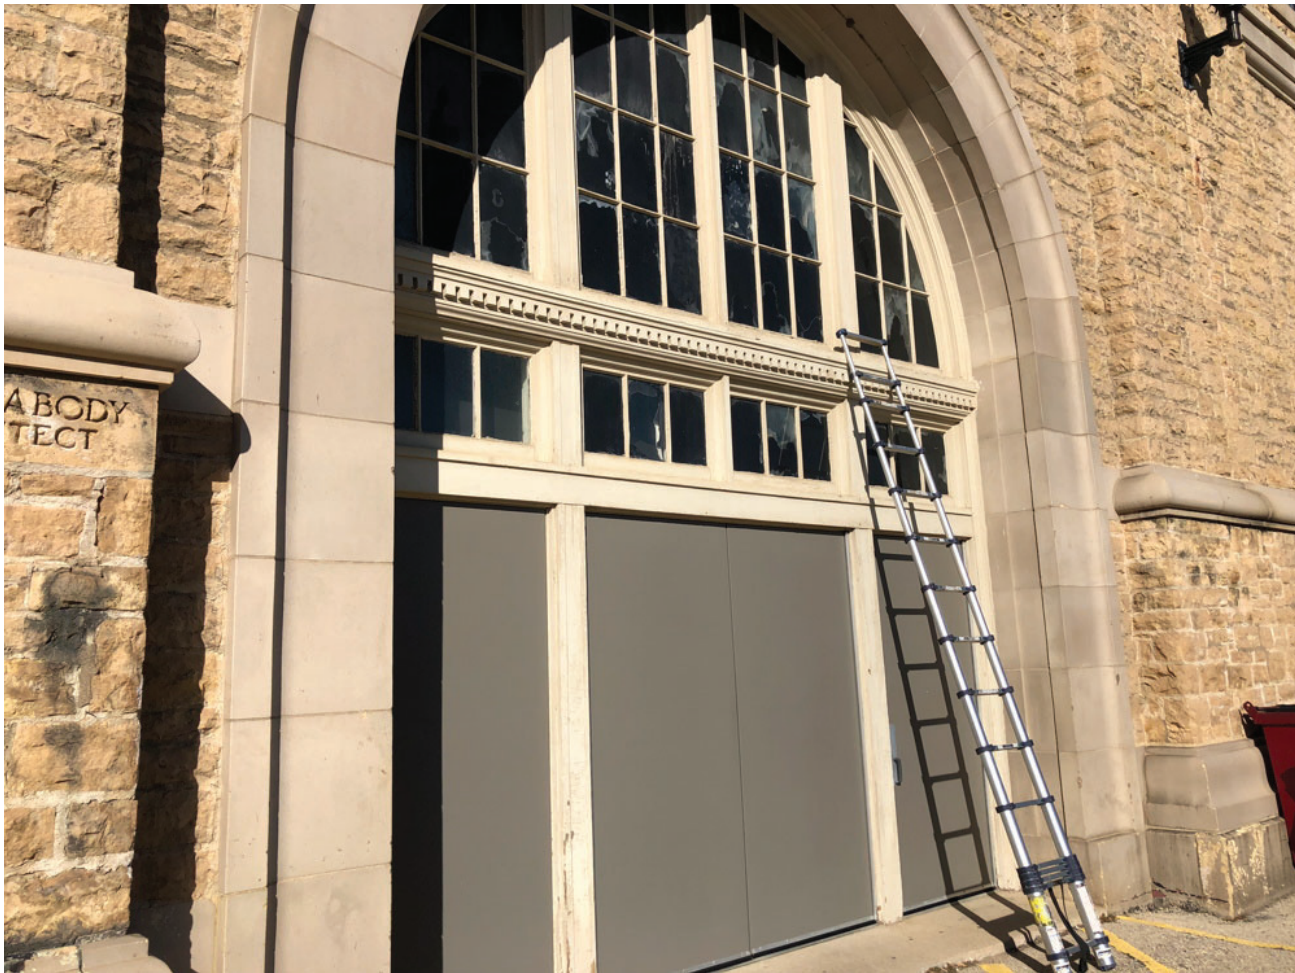
Photo 10: Other Than Their Doors, The South Doorways Have Retained The majority Of Their Original Elements

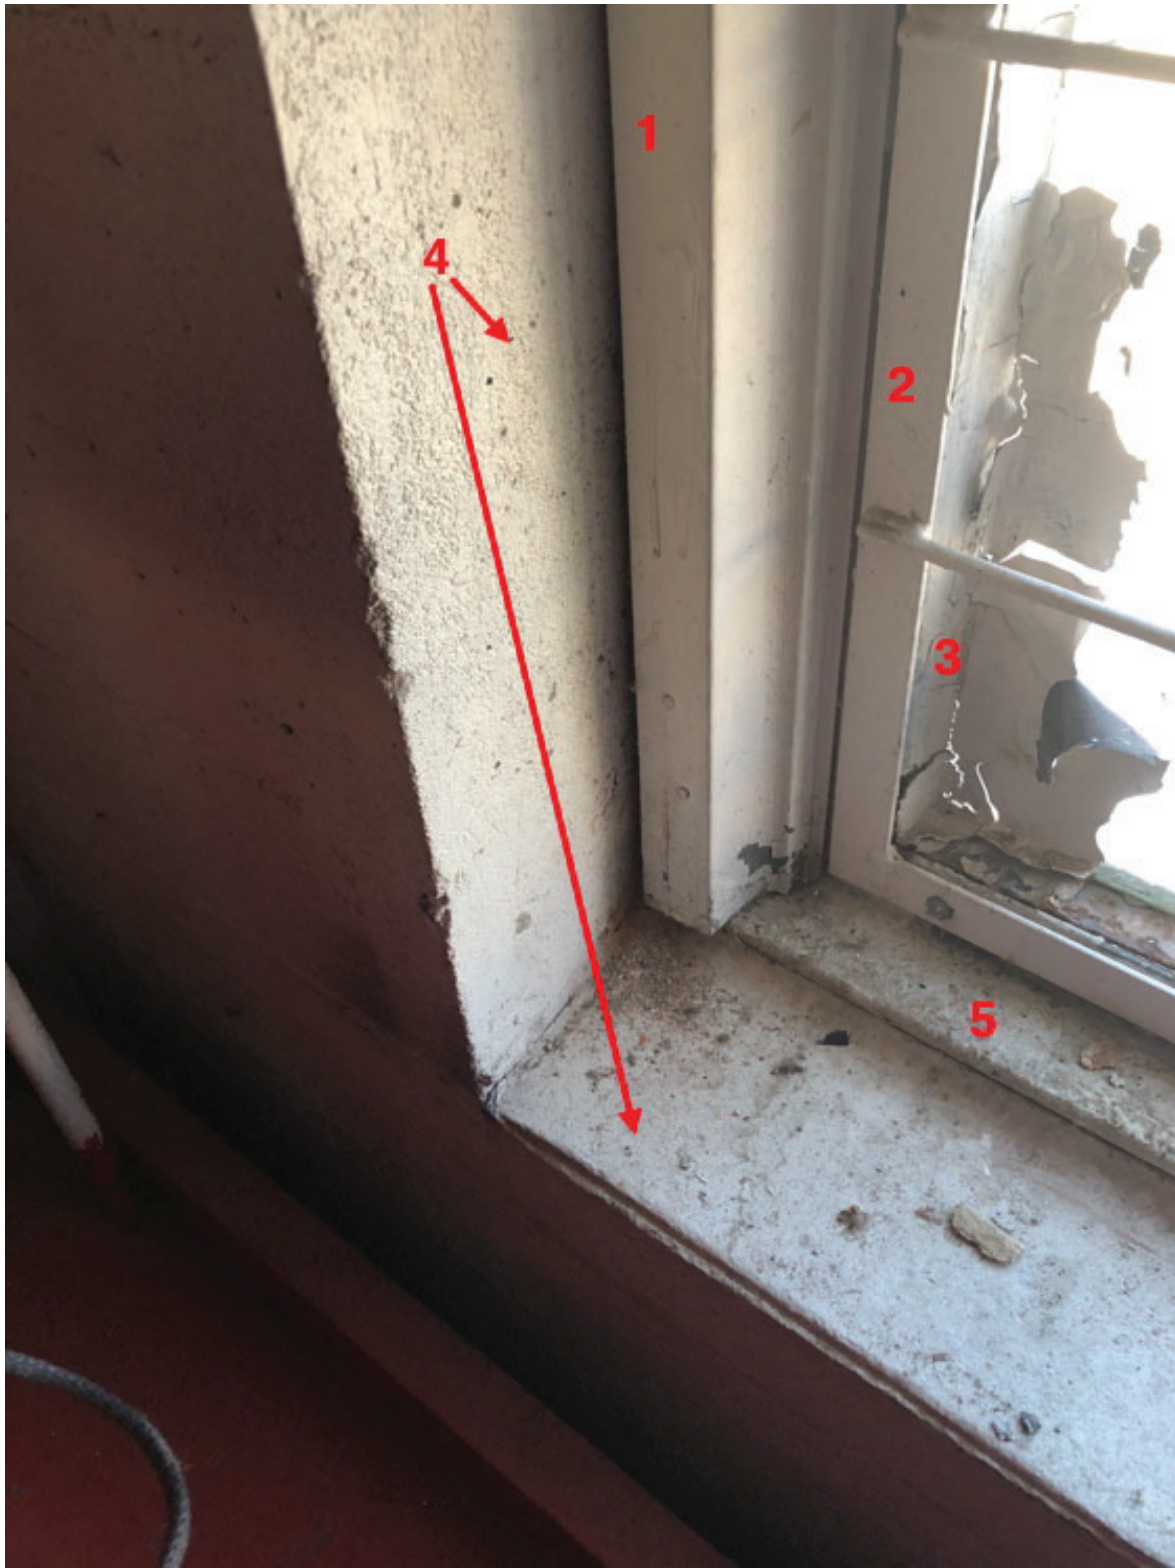
Diagram 2: Interior of Lower Elongated Windows

Area Sampled: Arena Lower West Elongated Windows (See Diagram 2)

Layer	Color	Match	Notes
1) Metal substrate			
2) Dirt			
3) Primer	Orange		
4) Paint	Light Gray-Green	SW 6176 (Liveable Green)	Original Paint*
5) Dirt			
6) Paint	Medium Gray	SW 7067 (Cityscape)	2 nd Campaign
7) Paint	Black	SW 6258 (Tricorn Black)	Window Black-out
8) Paint	White		Current Layer

Layer	Color	Match	Notes
1) Metal primer	Orange		
2) Putty (substrate)	Yellow		
3) Primer	Gray		
4) Paint	Black	SW 6258 (Tricorn Black)	Original Paint*
5) Paint	White		Current Layer

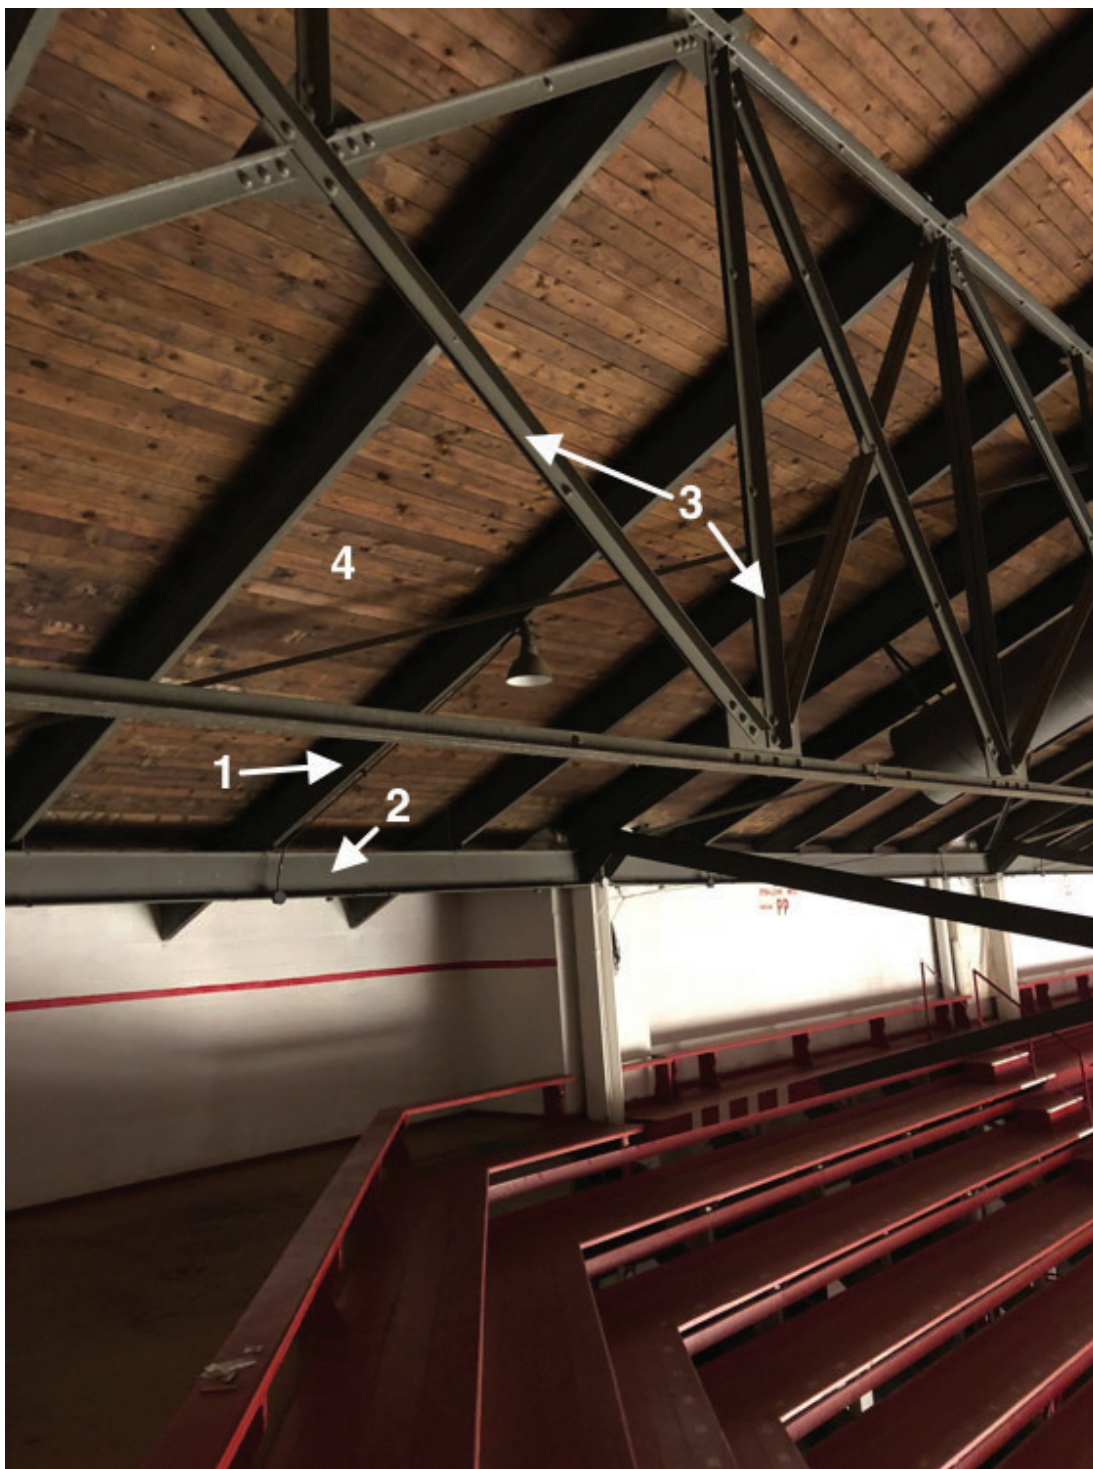
Diagram 3: Upper Structural Members & Sheathing

Area Sampled: Upper Superstructure: Rafters, Trusses, Sheathing, Etc (Diagram 3)
 Substrate: Metal/Wood

Layer	Color	Match	Notes
1) Metal substrate			
2) Oxidation	Red-Brown (Rust)		
3) Primer	Bright Orange	SW 6887 (Navel)	
4) Paint	Medium Gray	SW 7067 (Cityscape)	Original Paint*

Layer	Color	Match	Notes
1) Wood Substrate	Lt Red-Brown		
2) Oil Stain	Med Red Brown	SW 3114-P (Warm Chestnut)†	
3) Heavy Soiling

† Use Sikkens SRD 009 (Dk Oak) to match

The exposed structural members in Field House Arena are an essential part of its visual impact and their painting schemes are therefore highly significant to its look and feel. Microscopy of samples taken from the trusses and beams above the top balcony revealed they have never been repainted, and are therefore currently the color they were painted when the building was constructed (See Diagram 4 in Appendix 1 (*UW Field House Paint Analysis*)). The sheathing at the ceiling was originally stained a deep-brown (SW 3114-P). To match the ceiling's original color and matte sheen we recommend cleaning these surfaces, and then applying Sikkens SRD® exterior stain in Dark Oak®.

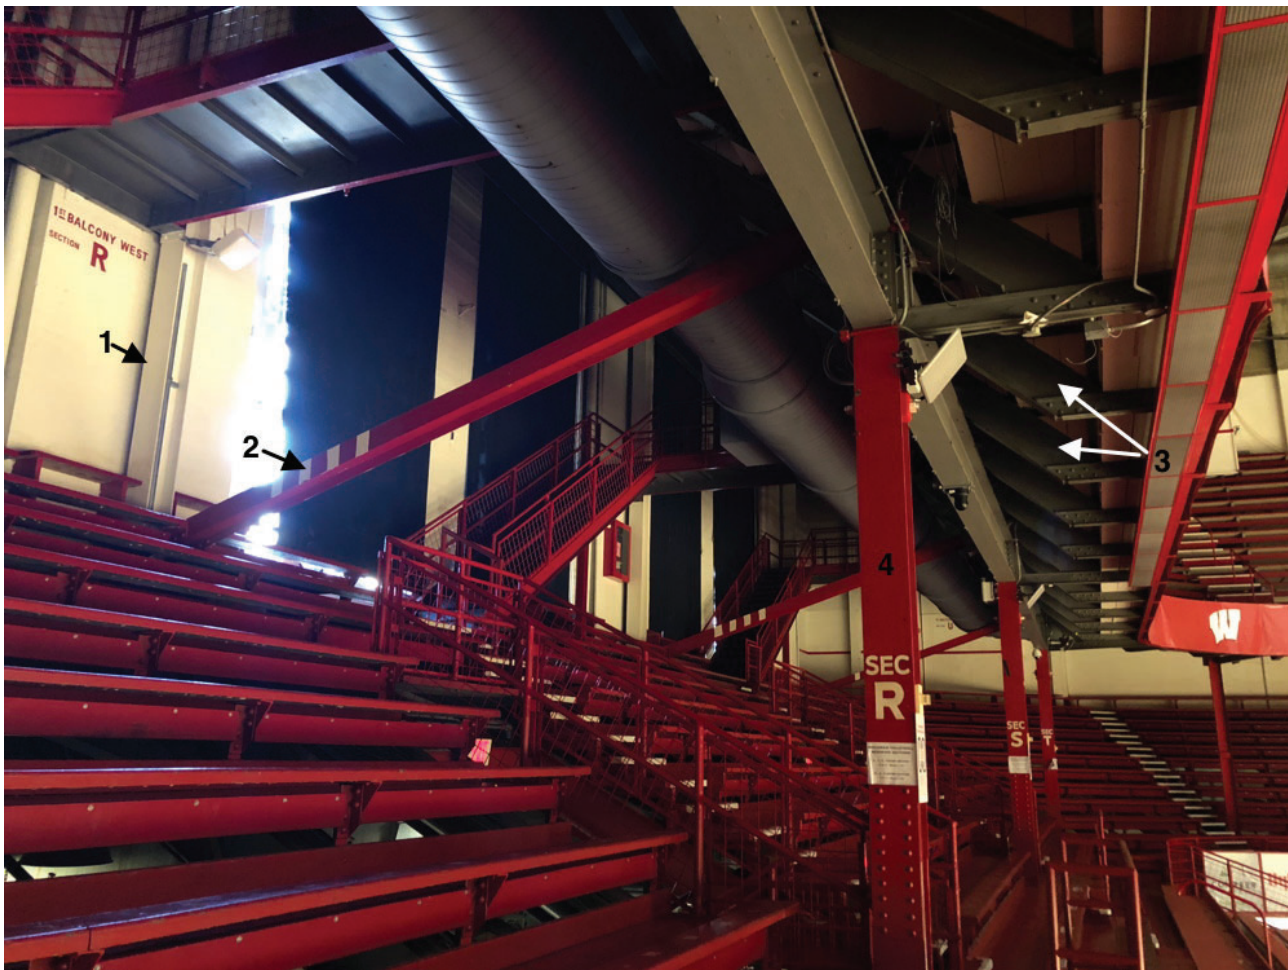
Diagram 4: Interior Lower Structural Members

Area Sampled: Lower Structural Columns and Beams (Diagram 4)

Layer	Color	Match	Notes
1) Metal substrate			
2) Oxidation	Black		
3) Primer	Bright Orange	SW 6887 (Navel)	
4) Paint	Black	SW 6258 (Tricorn Black)	Original Paint*
5) Paint	Beige	SW 6085 (Simply Beige)	2 nd Campaign
6) Paint	White		Current Layer

Layer	Color	Match	Notes
1) Metal substrate			
2) Primer	Bright Orange	SW 6887 (Navel)	
3) Paint	Medium Gray	SW 7067 (Cityscape)	Original Paint*
4) Dirt			
5) Paint	Deep Red	SW 6593 (Carol Bells)	Fragments
4) Paint	Bright Red	SW 2913 (Classy Red)	2 nd Campaign
7) Paint	White		Striping

Although the “H” beams under the balcony seating remain their original color (SW 7067), the other lower structural members have been repainted in new colors (See Diagram 3 in Appendix 1 (*UW Field House Paint Analysis*)). Their original paint scheme was as follows:

- 1) Vertical “H”-beam Columns at the wall were originally painted a deep black (SW 6258), and later were painted their current lighter color (SW 6085).
- 2) Primary Diagonal “I”-beams were originally painted a medium gray (SW 7067), but were later painted a deep-red (SW 6593), then a bright-red (SW 2913), which was striped white.
- 3) Lower “H”-beam balcony support columns were originally painted a medium gray, but later painted their current bright-red (SW 2913)

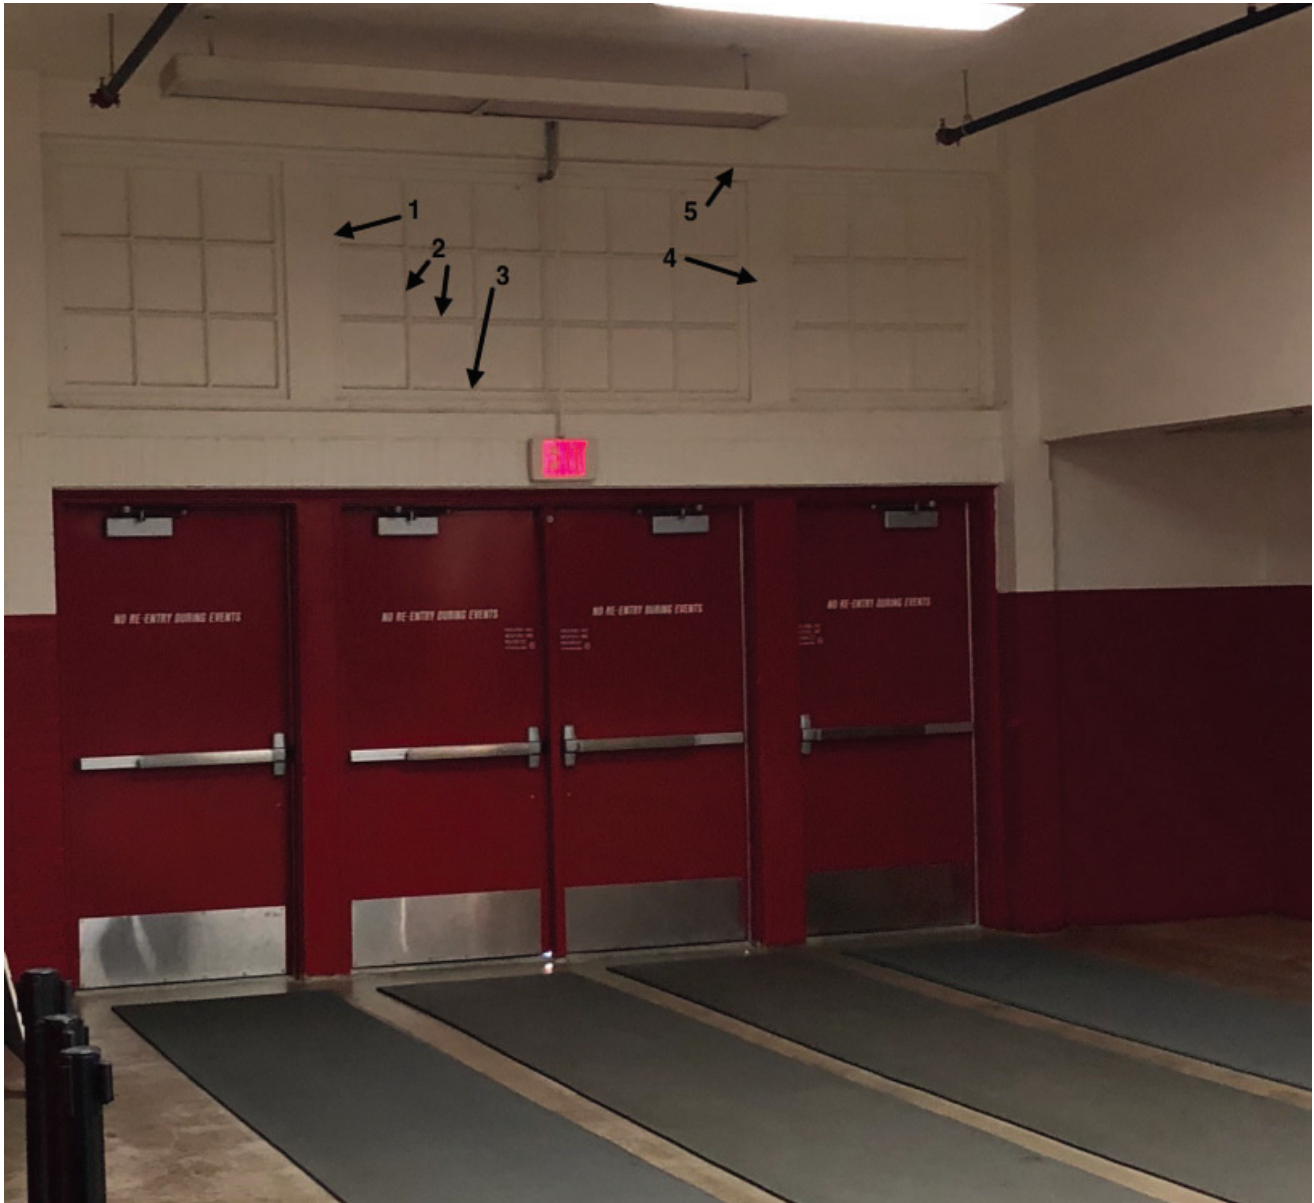
Area Sampled: Southwest Transom (Diagram 5)
Substrate: Wood

3) Paint	Medium Gray	SW 7067 (Cityscape)	Original Paint*
4) Soiling			
5) Paint	Black	SW 6993 (Black of Night)	2 nd Campaign
6) Paint	White		Current Layer

Diagram 5: Southeast Transom. Note Original Half-Light Doors Have Been Replaced

The southwest transom is now white, it was originally painted a medium gray (SW 7067). It's sashes, muntins, and stops were later painted charcoal-black, and its dividers and outyer moldings white. At a later date, the entire transom was painted its current hue of white.
