EXTERIOR CONDITION ASSESSMENT

For the purposes of this Historic Structure Report, all assessments were made through on-site visual observations conducted in May and July of 2018, high definition photography, and drone photography. Original drawings from 1929 were analyzed and compared to as-built conditions throughout the entire process in an effort to better understand and assess the design intent versus the actual constructed environment.

South Elevation Assessment

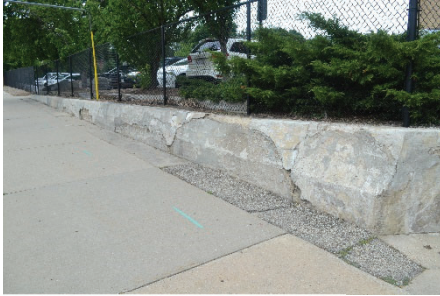
Figure 42: Field House Retaining Wall
(River Architects July 12, 2018)

A noticeable change in elevation occurs at the southeast corner of the site with a 10-foot decline to the parking lot of Kellner Hall. This change in grade is treated through the use of a concrete retaining wall along Monroe and Little Streets. In desperate need of repair, it is believed that this wall is of original construction. The east side of the Field House site is paved for fire truck access and includes a landscape area and stairs down to the plaza area south of Kellner Hall.

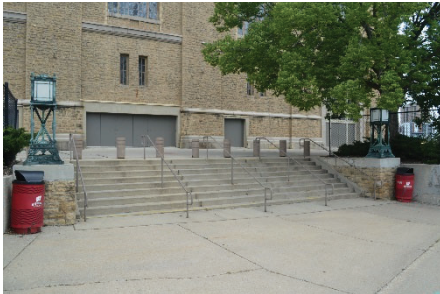
Figure 43: Field House Exterior Stairs
(River Architects July 12, 2018)

Central to the south elevation of the Field House, a 33-foot wide concrete stair structure ascends from the sidewalk along Little Street to the south plaza in front of the Field House. Painted metal pipe railings are located at the stair while wing walls original to the Field House structure flank the east and west edges of the stair. Precast concrete bollards are located at the top of the stair along the south edge of the plaza.

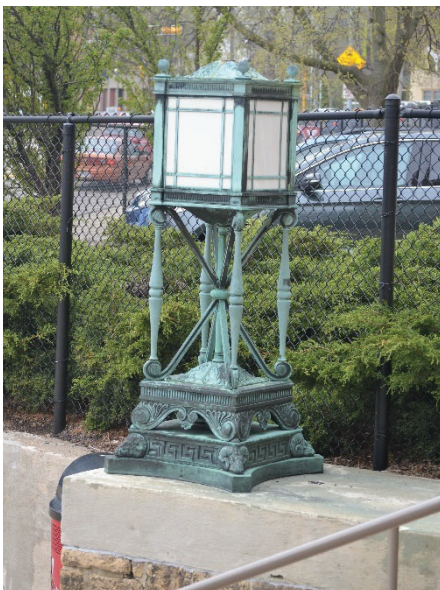
Figure 45: Field House Exterior Light Fixture
(River Architects May 3, 2018)

Ornamental light fixtures that are placed on top of the two stone wing walls at the concrete stair are believed to not be original to the Field House. Historic photographs collected of the Field House prior to 1960 do not appear to show these fixtures. However, photos taken during the 1960s, following a renovation and addition to the Wisconsin General Hospital in the late 1950s do appear to show these light fixtures.

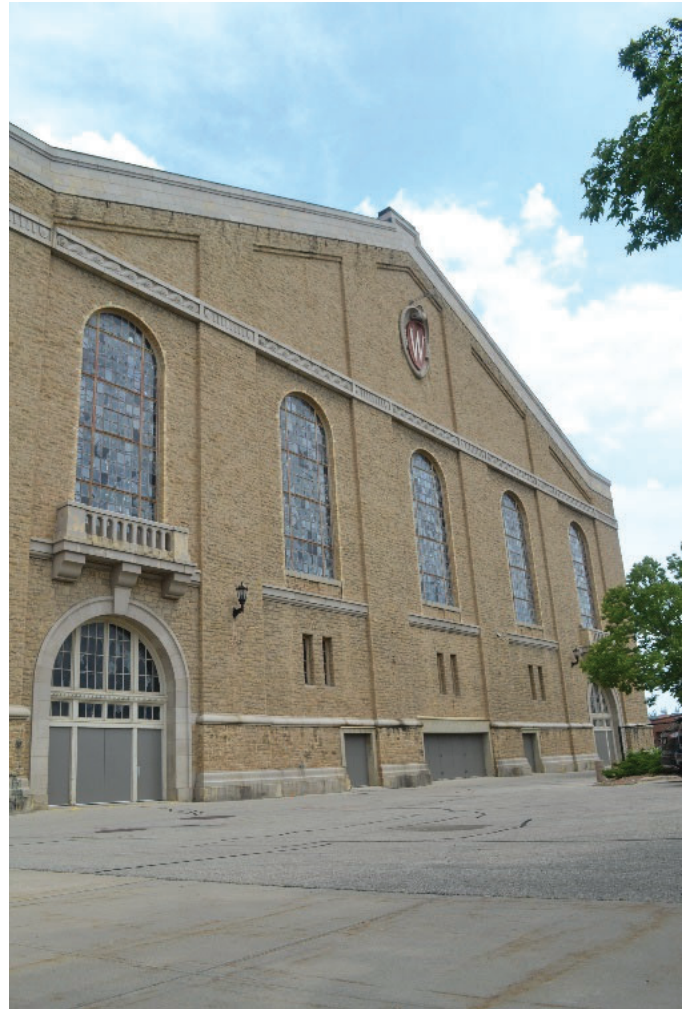
Figure 54: Field House South Elevation
(River Architects July 12, 2018)

The rubble stone in general appears to be in good condition. Staining is evident in a number of areas and is expected from a building of this age. There are numerous fractures in the masonry near the windows and doors, likely caused by movement in the structure, water infiltration, and absence of control joints.

The glazed terra cotta trim that provides intricate detailing to this elevation is in relatively poor condition. Numerous areas were observed where glaze spalling has occurred and as a result, the terra cotta has deteriorated. The step cracking that is found in the rubble stone is often transferred through the terra cotta trim, resulting in fractured units that require replacement.

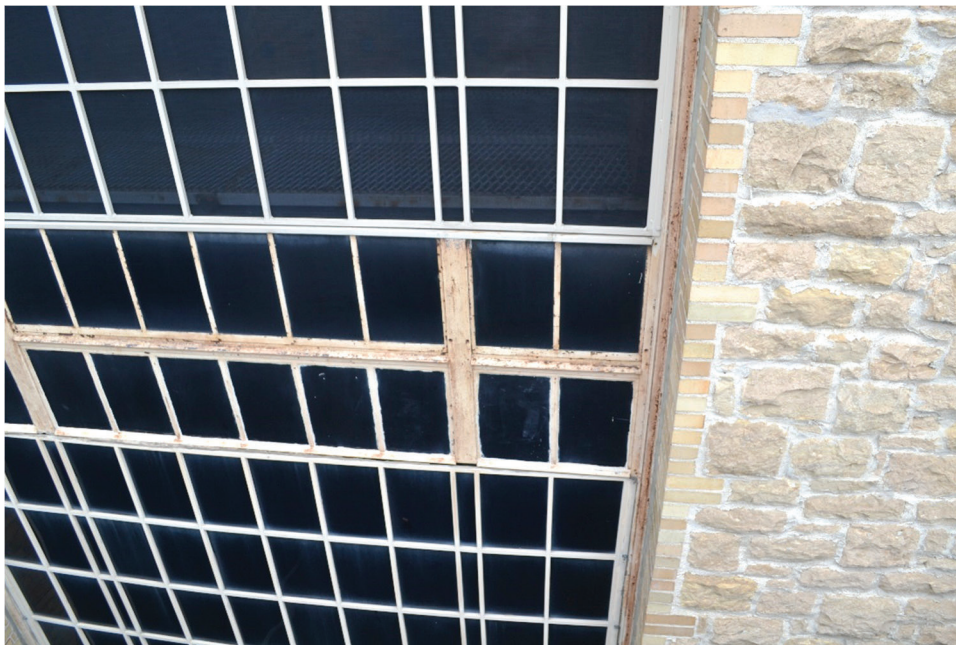
Figure 75: North Elevation Window Infill
(River Architects May 3, 2018)

Bottom left photo shows how the two windows on the north facade were infilled when the stadium loudspeaker system was removed and non-matching framing and glazing were used to fill the opening.
