INTERIOR CONDITION ASSESSMENT

STRUCTURAL SYSTEMS

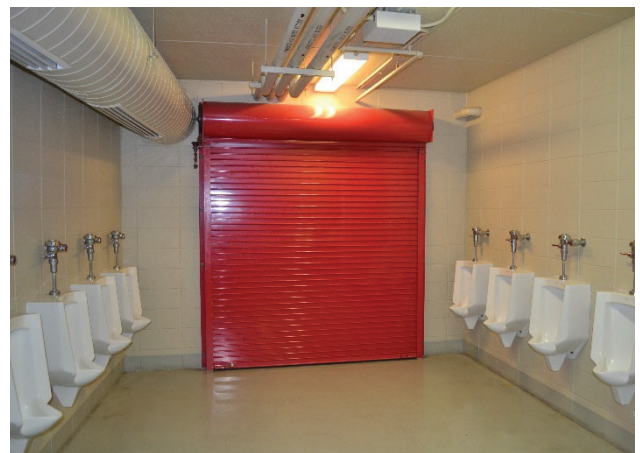
Figure 105: Field House Restroom
(River Architects July 12, 2018)

Much like the rest of the interior, the restrooms are utilitarian in nature and constructed of materials that require little to no maintenance. Durable surfaces such as concrete masonry walls and concrete floors with epoxy coatings allow custodial staff to easily clean the facilities after large events. The restrooms have modern-day fixtures and are in good condition. An overhead coiling door can be opened to another set of restroom fixtures on the opposite side of the wall during football games.
