Part II

Treatment and Work Recommendations

WISCONSIN
UNIVERSITY OF WISCONSIN-MADISON

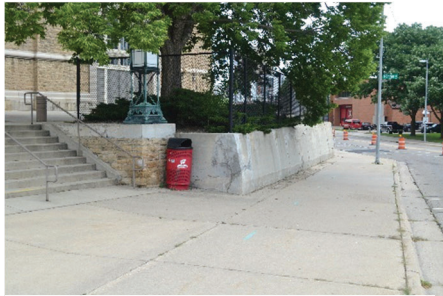
Figure 148: South Plaza Stair & Retaining Wall
(River Architects July 12, 2018)

The concrete retaining wall consists of a board-formed texture that has been covered over the years with a cementitious parging. The wall is in poor condition overall.

Due to the amount of work being proposed for the south plaza area, the concrete stairs and metal railings are being proposed for replacement while this work is taking place.

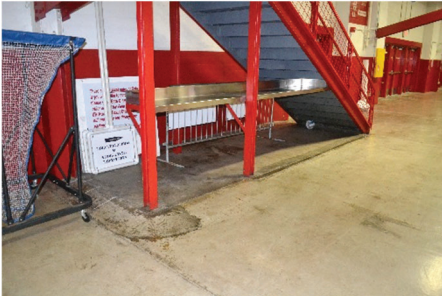
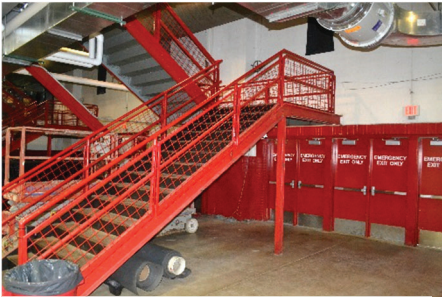
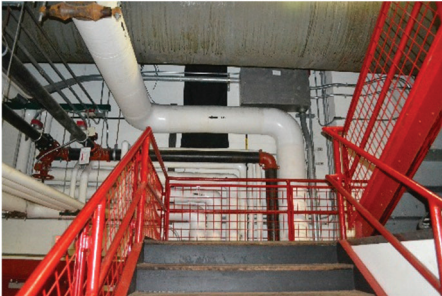
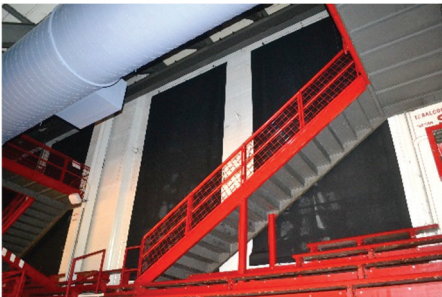
Figure 156: Interior Stairs
(River Architects July 12, 2018)

There is currently no intention of providing any work to the interior stairs. Future projects that include work to the stairs must take into consideration the life safety aspect of the railing systems. The height and extension of these railings is currently non-compliant and would need to be addressed should any work be considered.

Treatment proposed at the stairs is to preserve in-place as an original historic feature of the building.

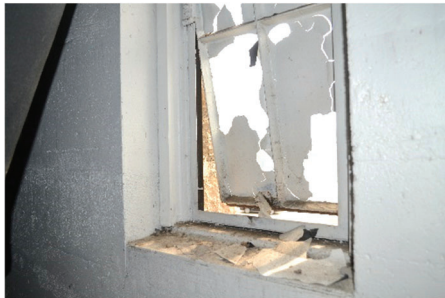
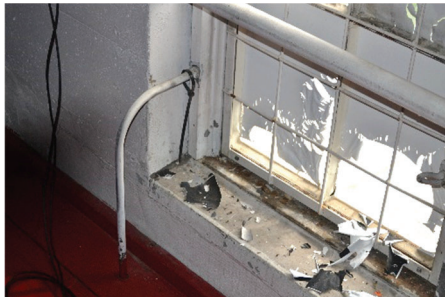
Figure 167: First Balcony Window
(River Architects July 12, 2018)

Figure 168: First Balcony Window
(River Architects July 12, 2018)

Priority	High
Degree of Integrity	Low
Proposed Treatment	Replacement
Life Safety, Accessibility, and Thermal Performance	Solar heat gain through the large original windows increases the load on the cooling systems.
Potential Impacts of Treatment	Window treatments will deter the viewing of the historic window units.

Existing window coverings are non-original and in good condition. The existing coverings are opaque and are commonly found to be operated by non-original methods.

It is recommended to remove the opaque window coverings currently located at each window unit. Replacement window treatments will need to take into consideration the amount of light during the daytime for both heat gain as well as glare during athletic events.

The intention from UW-Athletics is to have the ability to open the window coverings in the evening and showcase the Field House interior as viewed from the exterior. Historically sensitive hardware should be provided for the new window treatment operation.

The historic photographs of the interior show the ability of the Field House to illuminate from daylight. It is suggested that UW-Athletics test varying levels of window treatment opacity in an effort to meet the needs of both the athletic and cultural events.

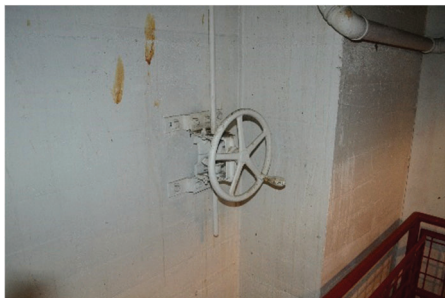
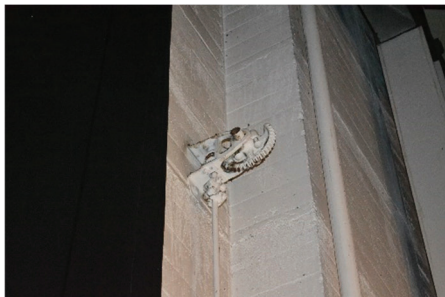
Figure 169: Window Operating Hardware
(River Architects July 12, 2018)

Figure 170: Window Operating Hardware
(River Architects July 12, 2018)

Although decommissioned, the original window hardware is in relatively good condition. Consideration should be given to preserving these unique devices in-place for future restoration.

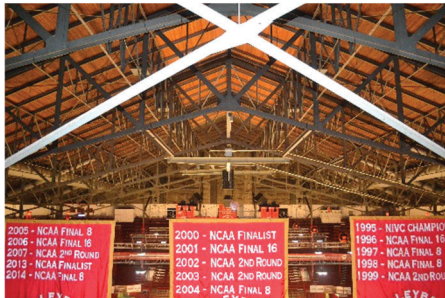
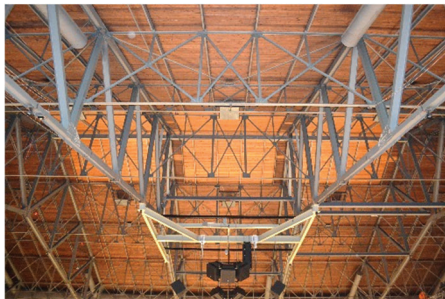
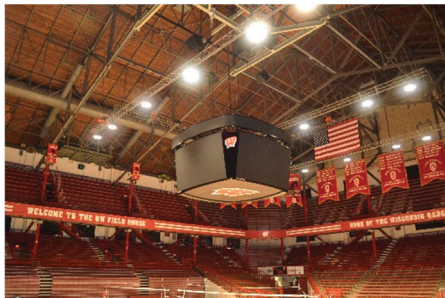
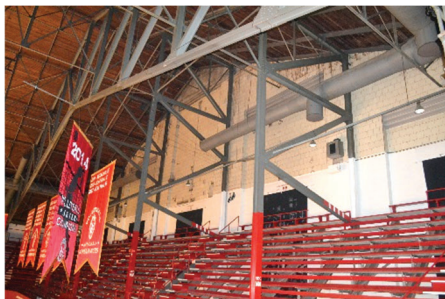
Figure 171: Arena Roof Structure
(River Architects July 12, 2018)

Figure 172: Arena Roof Structure & Skylight Infill
(River Architects July 12, 2018)

Figure 173: Arena Roof Structure
(River Architects July 12, 2018)

Figure 174: Arena Roof Structure
(River Architects July 12, 2018)

The original steel roof trusses are in good condition.

Although the majority of the wood decking is in good condition, the areas easily visible to spectators along the edges are in need of restoration and refinishing. Moisture infiltration has caused staining to be present along the roof/wall connection.

The original skylight opening was infilled with wood decking to match the rest of the roof structure. This wood appears to be in good condition overall.

There is currently no intention of providing any work to the steel roof trusses or wood decking. Treatment proposed at these original features is to preserve in-place as original historic features of the building.

Future work that may be considered includes the restoration of the original wood decking material.

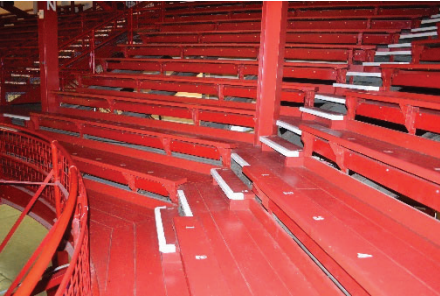
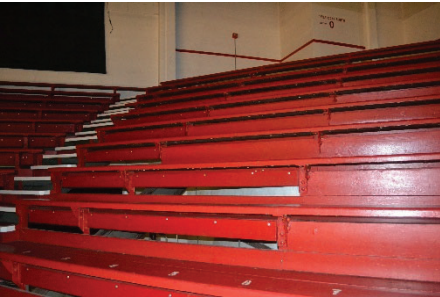
Figure 175: Arena Wood Seating
(River Architects July 12, 2018)

Figure 176: Arena Wood Seating
(River Architects July 12, 2018)

Original arena seating provided an open and unsafe environment between the seat and the floor at each row as seen in the picture above. These openings were treated with additional wood to reduce the opening and provide more safety. The seating was painted red as part of the 1970's project and adds to the overall branding of Wisconsin Athletics. While the seating is planned to be retained as original fabric to the building, any future work that might be considered must take into account all life safety aspects.

There are currently no plans of providing any work to the original arena seating. The area beneath the seats has been updated over the years in an effort to provide additional safety.

Treatment proposed at the arena seating is to preserve in-place as an original historic feature of the building.
