General Facility Repair and Maintenance Projects Pending

UW-Madison Gym-Natorium – Deferred Maintenance to YR 2025
October 23, 2013

Gym-Natorium – Facilities Condition Assessment DRAFT

June 2013

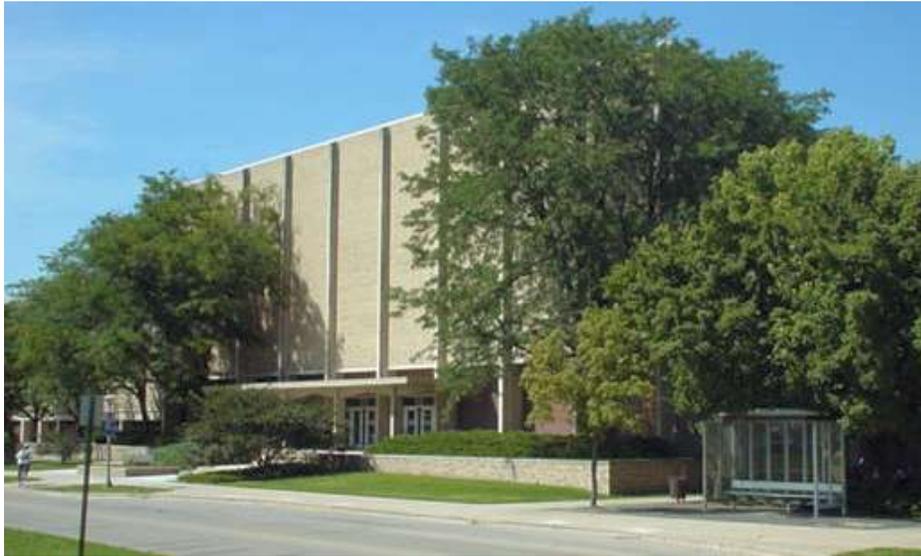
The Gym-Natorium, building #0031, located at 2000 Observatory Drive, Madison, Wisconsin, was constructed in the mid-1960 in two phases. Unit I included a 60'x75' racing pool, poolside bleachers for 500 spectators, a 43'x50' diving pool, a 140'x41' gymnasium, classrooms, and offices. Unit II included a 250'x 300' structure that wraps around Unit I on the east, west and north sides. Unit II is two levels high containing eight gymnasiums, squash and racquetball courts, locker room facilities, classrooms and a library. Gym-Nat currently houses the Department of Kinesiology, physical education classes, and an athletics/fitness center for students, faculty, and staff. Request was made by campus administration to complete an informal facility condition assessment to assist discussions of master planning, building use, maintenance, and funding.

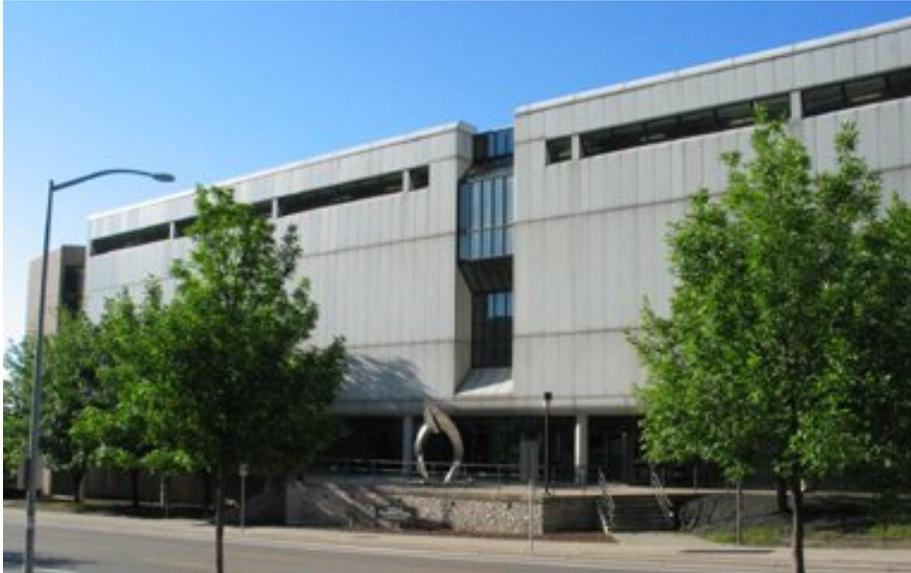
The Southeast Recreational Facility (SERF), building #0028, located at 715 West Dayton Street, Madison, Wisconsin, was constructed in 1982 as a four level rectangle 300 by 100 feet, framed in steel with concrete block walls, sheathed in face brick and aluminum wall panels. Level B contains twelve racquetball courts, mechanical systems, and storage areas. Level 1 houses weight rooms, the upper part of the lower courts, and part of the pool tank. The 65 meter pool (the University's largest) is on level 2, and can be partitioned by moveable bulkheads for simultaneous multiple uses. Locker rooms, offices, and the lobby are also on level 2. Level 3 contains two large (113 by 100 foot) gymnasiums, and the upper part of the pool area. Level 4 is a one-tenth mile running track suspended above the gymnasium area. In 1984, a large shelled space of level B was finished to provide extra weight training facilities. An addition to the facility was constructed on the west end in 2003.
